# Cisco Nexus 5000 Series and Cisco Nexus 2000 Series Release Notes, for Cisco NX-OS Release 5.0(2)N1(1), NX-OS Release 5.0(2)N2(1), and NX-OS Release 5.0(2)N2(1a)

**Release:** 5.0(2)N2(1a) May 6, 2011  
**Part Number:** OL-22747-02 K0  
**Current Release:** Cisco NX-OS Release 5.0(2)N2(1a)  
**Current Release:** Cisco NX-OS Release 5.0(2)N2(1)  
**Current Release:** Cisco NX-OS Release 5.0(2)N1(1)

This document describes the features, caveats, and limitations for Cisco Cisco Nexus 5000 Series switches and the Cisco Nexus 2000 Series Fabric Extenders. Use this document in combination with documents listed in the “[Related Documentation](#)” section on page 47.

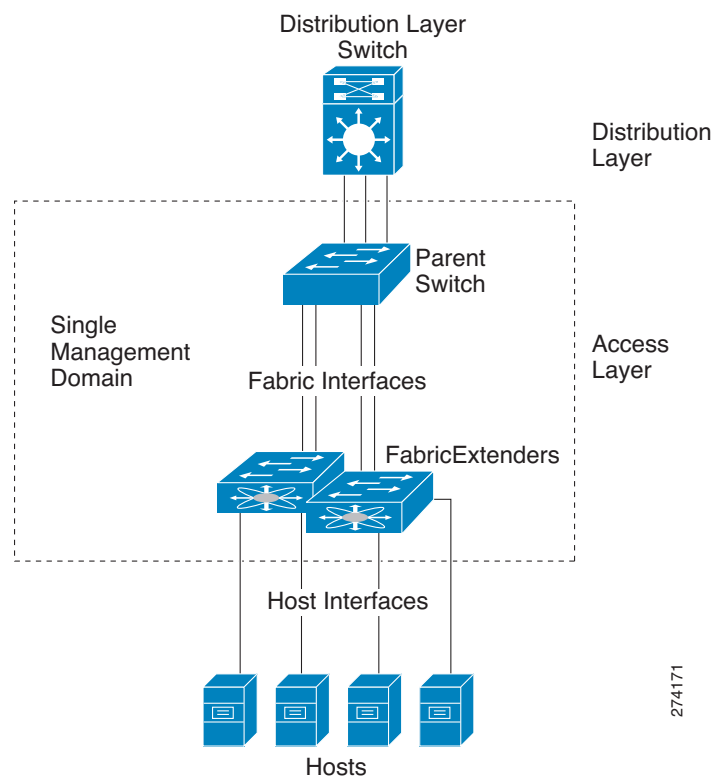
**Figure 1** Single Management Domain

The Fabric Extender integrates with its parent switch, allowing zero-touch provisioning as well as automatic configuration. This integration allows large numbers of servers and hosts to be supported using the same feature set as the parent Cisco Nexus 5000 Series switch, including security and quality of service (QoS) configuration parameters, with a single point of management as shown in [Figure 1](#). Spanning Tree Protocol (STP) is not required between the Fabric Extender and its parent switch, because the Fabric Extender and its parent switch allow you to enable a large multi-path, loop-free, active-active topology.
