# Cisco Nexus 5000 Series NX-OS Software Upgrade and Downgrade Guide, Release 5.1(3)N2(1)

This document describes how to upgrade or downgrade Cisco NX-OS software on Cisco Nexus 5000 Series switches and Cisco Nexus 2000 Series Fabric Extenders. Use this document in combination with documents listed in the [“Obtaining Documentation and Submitting a Service Request”](#) section on page 51.

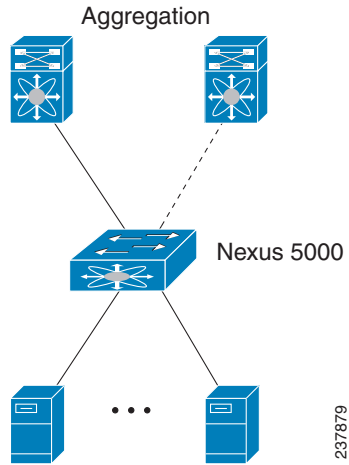
**Figure 1-2 Access Switch Topology**

The following figure shows an access switch topology.

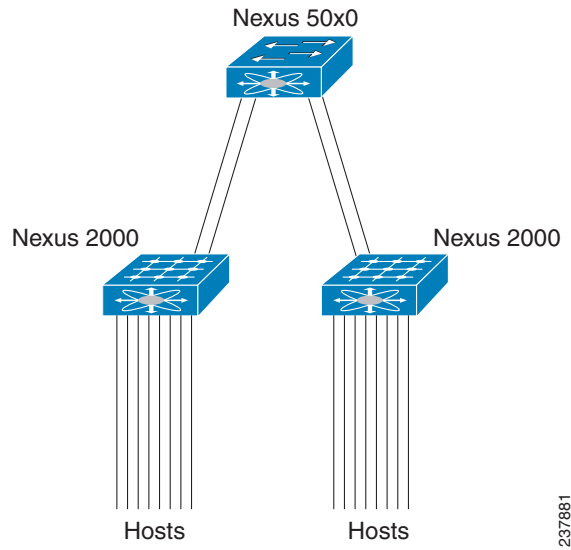
**Figure 1-4 Virtual Modular System With Static Fabric Connectivity For FEXs**

The following figure shows a virtual modular system with static fabric connectivity for FEXs.

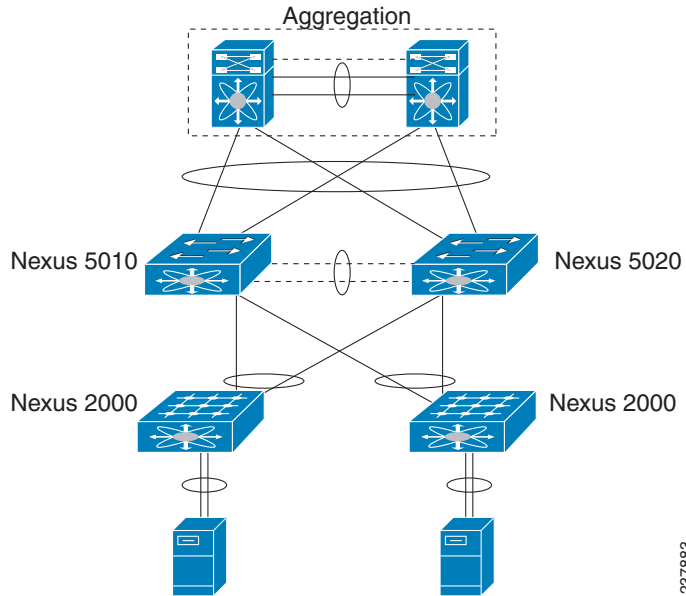
Figure 1-6 vPC-Peered Dual-Supervisor Virtual Modular System Dual-Homed FEXs

The following figure shows a vPC-peered dual-supervisor virtual modular system with dual-homed FEXs.

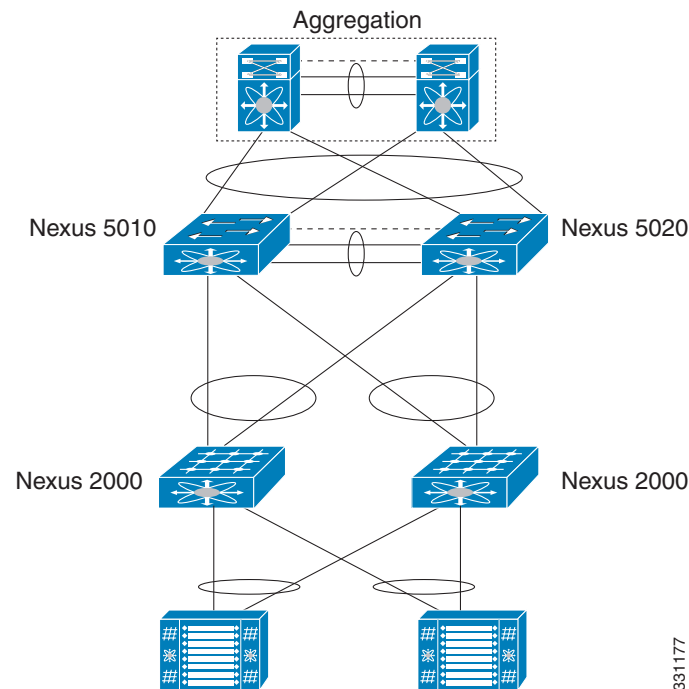
Figure 1-8 vPC Peered Dual-Supervisor Virtual Modular System Dual-Homed FEXs

The following figure shows a vPC-peered dual-supervisor virtual modular system with dual-homed FEXs.

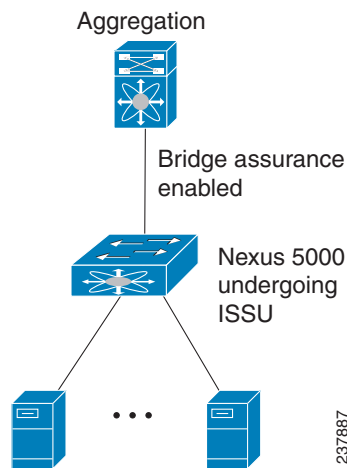
Figure 1-11 Cisco Nexus 5000 Series Switch Running Bridge Assurance with Another Switch

The following figure shows a Cisco Nexus 5000 Series switch that is running Bridge Assurance with another switch.

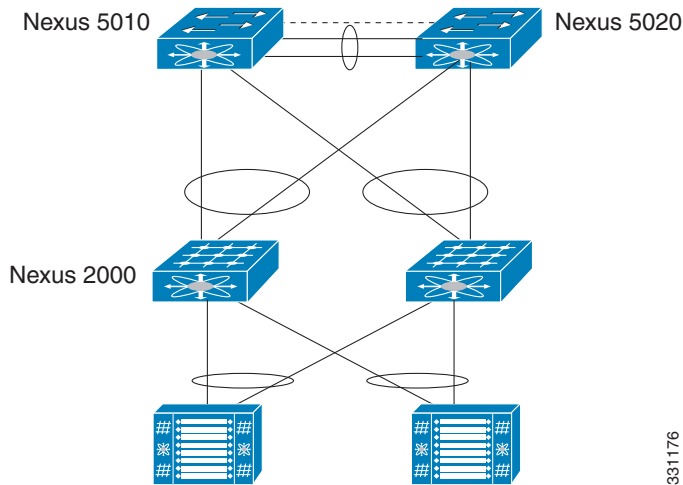
Figure 1-14 Dual-Homed FEX Connected to Stub Switches

The following figure shows a dual-homed FEX that is connected to stub switches.
