Cisco Nexus 5500 Series NX-OS Software Upgrade and Downgrade Guide, Release 6.0(2)N2(1)

This document describes how to upgrade or downgrade Cisco NX-OS software on Cisco Nexus 5500 Series switches and Cisco Nexus 2000 Series Fabric Extenders. Use this document in combination with documents listed in the [“Obtain Documentation and Submit a Service Request”](#) section on page 52.

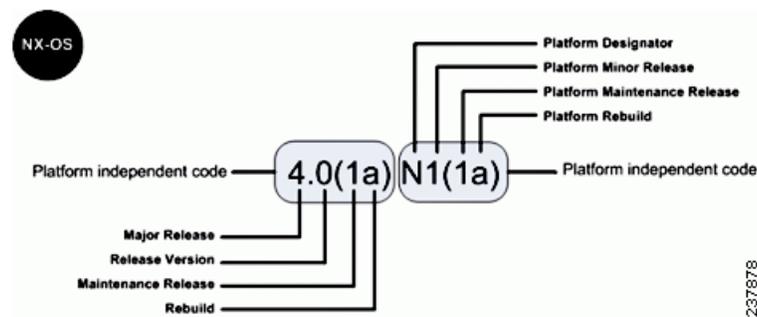
The Cisco NX-OS software consists of the kickstart image and the system image. The system image includes the software for the Cisco Nexus device and the Cisco Nexus Fabric Extenders (FEXs) that are connected to the switch. The images contain a major release identifier, a minor release identifier, and a maintenance release identifier. The images might also contain a rebuild identifier, which can be referred to as a support patch. The following figure shows the version identifiers that are used with a combination of platform-independent and platform-dependent schemes for the Cisco NX-OS software.

Figure 1 Cisco NX-OS Version Identifiers

The platform designator is N for the Cisco Nexus device. Applicable features, functions, and fixes in the platform-independent code are present in the platform-dependent release.

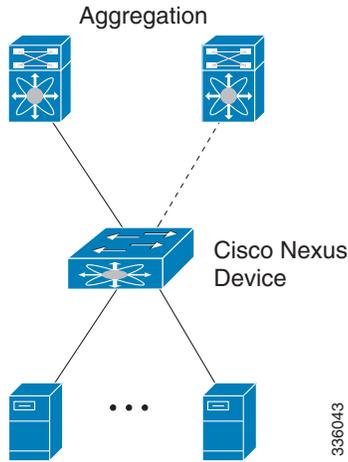
Figure 2 shows an access switch topology.

Figure 2 Access Switch Topology

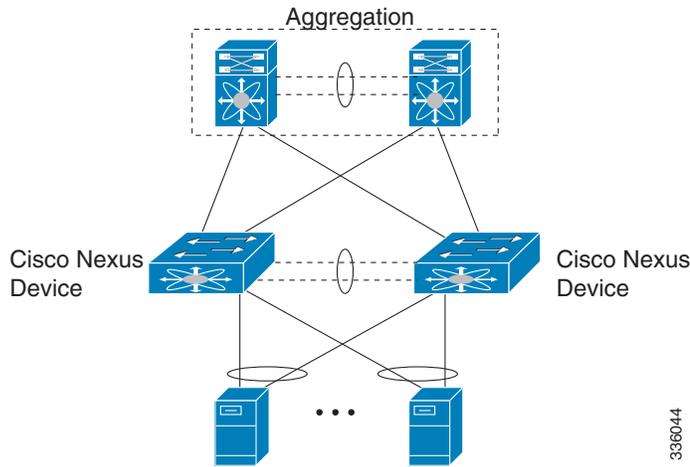
Figure 3 shows a vPC peering topology.

Figure 3 vPC Peering Topology

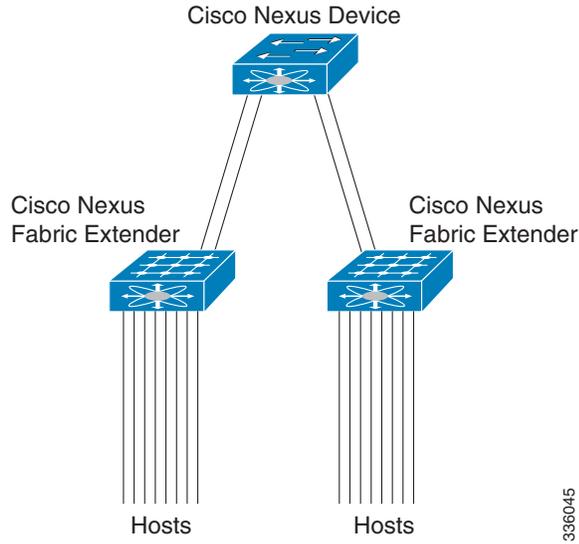
336045

Figure 4 shows a virtual modular system with static fabric connectivity for FEXs.

Figure 4 *Virtual Modular System with Static Fabric Connectivity for FEXs*

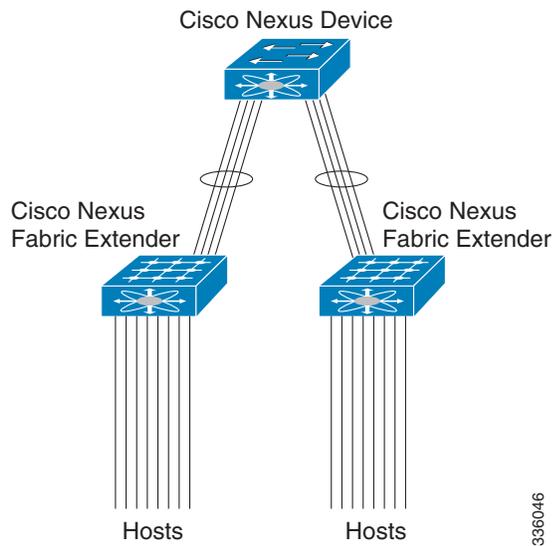
336046

Figure 5 shows a vertical modular system.

Figure 5 *Vertical Modular System*

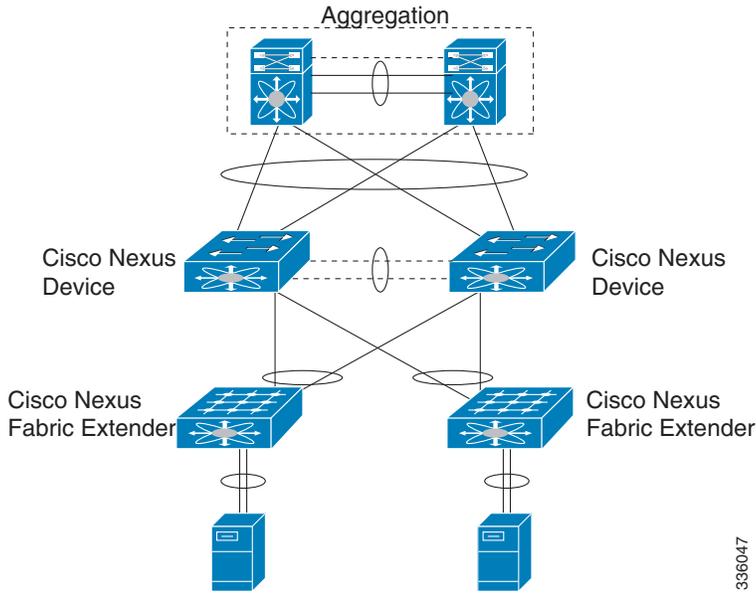
336047

Figure 6 shows a vPC-peered dual-supervisor virtual modular system with dual-homed FEXs.

Figure 6 *vPC-Peered Dual-Supervisor Virtual Modular System Dual-Homed FEXs*

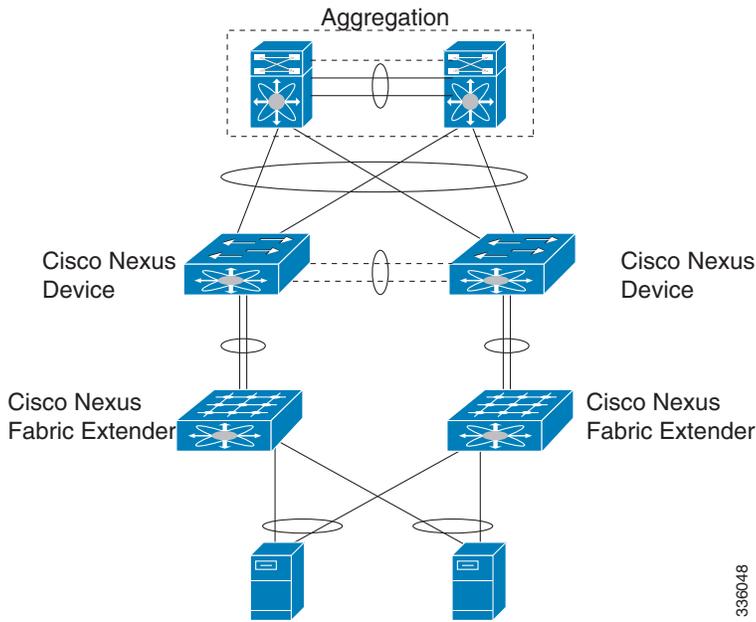
336048

Figure 7 figure shows a vPC-peered dual-supervisor virtual modular system with dual-homed and single-homed FEXs.

Figure 7 *vPC-Peered Dual-Supervisor Virtual Modular System Dual-Homed and Single-Homed FEXs*

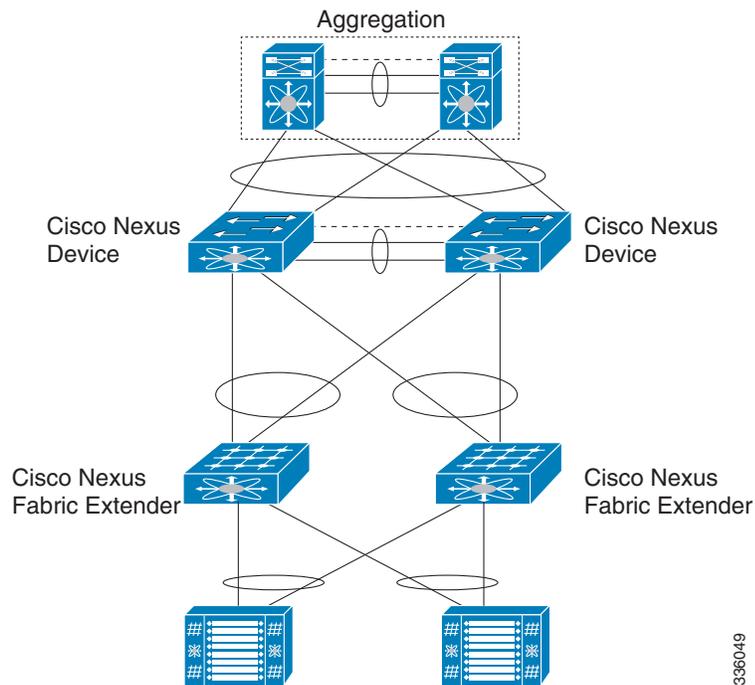
Figure 8 shows a vPC-peered dual-supervisor virtual modular system with dual-homed FEXs.

Figure 8 vPC Peered Dual-Supervisor Virtual Modular System Dual-Homed FEXs

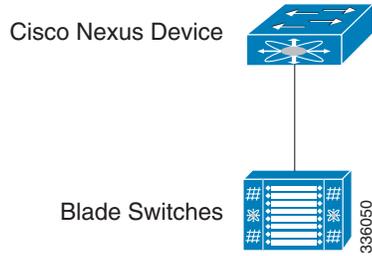
Figure 9 shows a Cisco Nexus device that is connected to a blade switch that is running STP.

Figure 9 Connection to a Blade Switch Running STP

If the STP conditions are not met, the installation check indicates that the upgrade would be disruptive. In this case, you can perform an upgrade at a later time after making the necessary changes to the topology to meet these conditions or perform a disruptive upgrade.

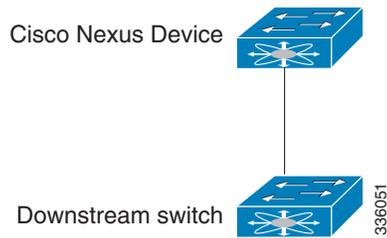
Figure 10 shows a Cisco Nexus device that is connected to a downstream switch that is running STP.

Figure 10 Connection to a Downstream Switch Running STP

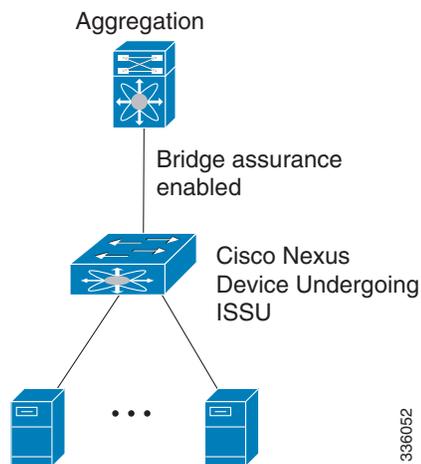
Figure 11 shows a Cisco Nexus device that is running Bridge Assurance with another switch.

Figure 11 Cisco Nexus Device Running Bridge Assurance with Another Switch

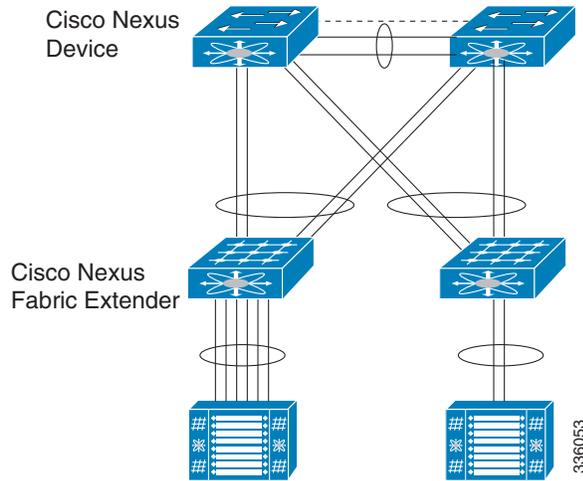
Figure 12 shows dual-homed FEXs connected to a stub switch.

Figure 12 *Dual-Homed FEXs Connected to a Stub Switch*

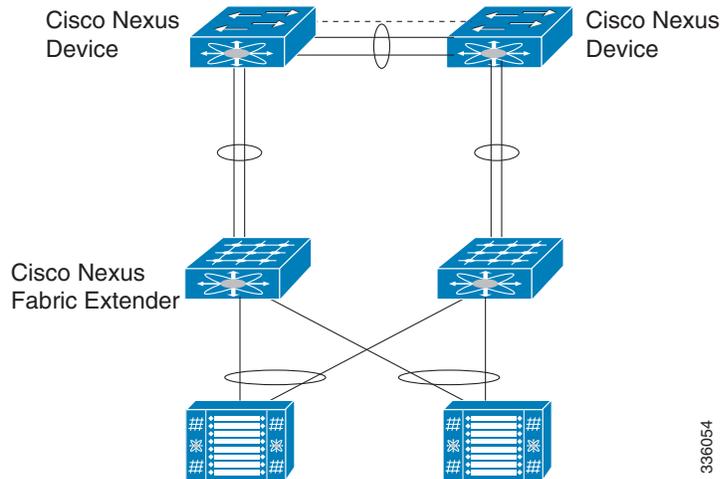
Figure 13 shows a single-homed FEX that is connected to stub switches.

Figure 13 *Single-Homed FEX Connected to Stub Switches*

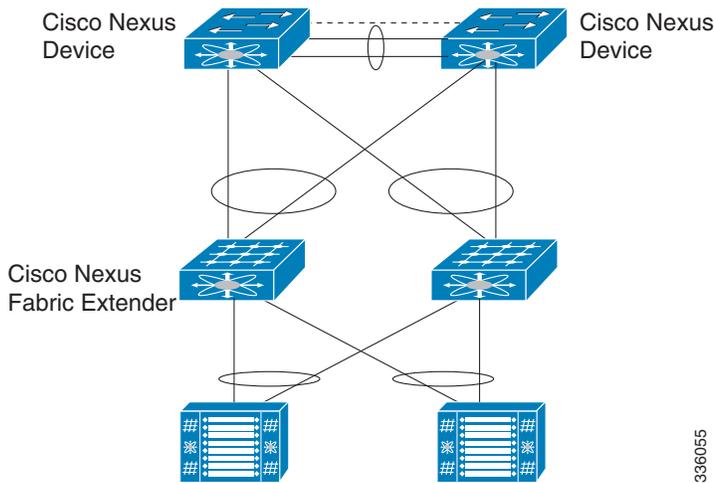
336055

Figure 14 shows a dual-homed FEX that is connected to stub switches.

Figure 14 *Dual-Homed FEX Connected to Stub Switches*

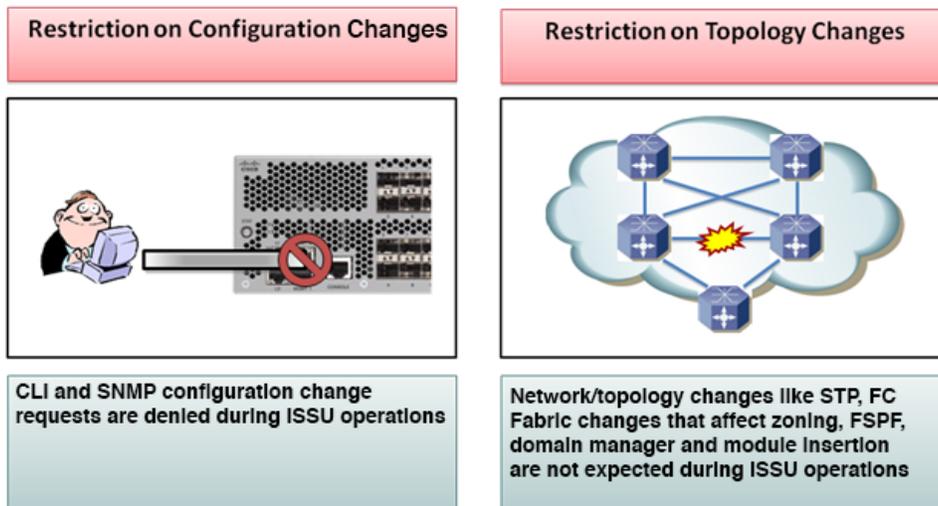
237881

Figure 15 shows upgrade restrictions.

Figure 15 *Upgrade Restrictions*

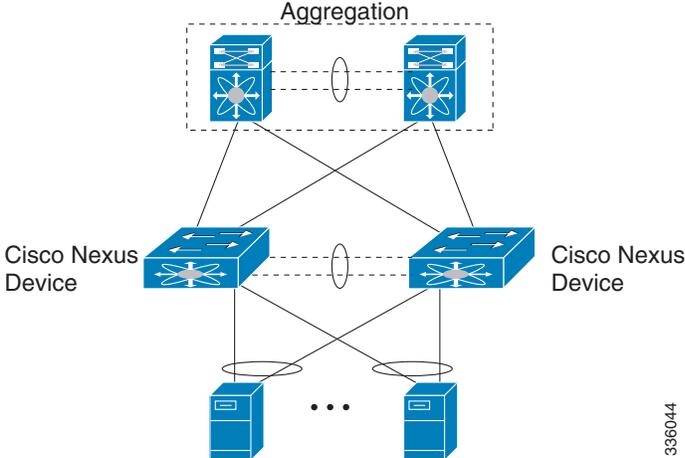
336044

The following figures show topologies in which the access layer includes a vPC configuration to hosts or downstream switches.

Figure 16 Hosts Directly Connected to vPC Peers

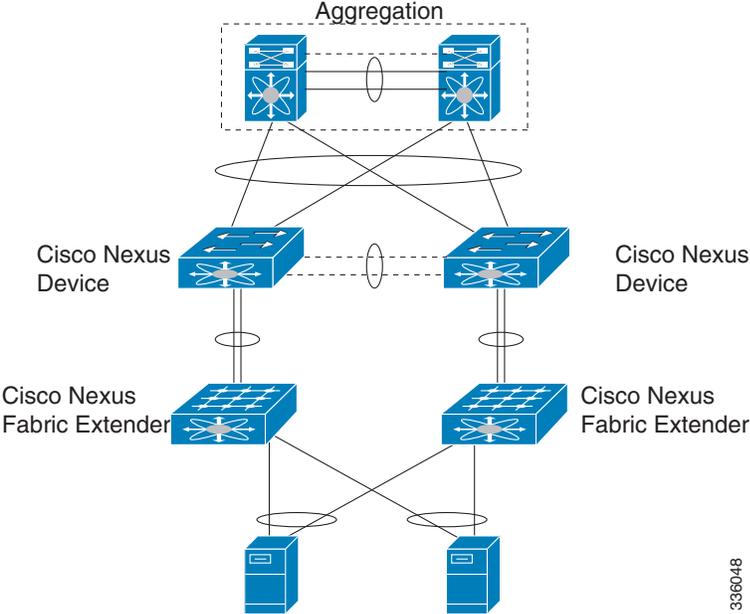
336048

Figure 17 vPC Peered Dual-Supervisor Virtual Modular System Dual-Homed FEXs and Singled-Homed FEXs

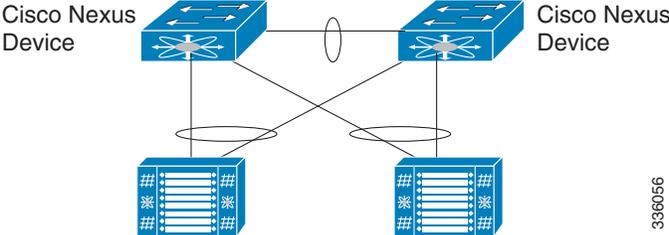
336056

Figure 18 Cisco Nexus Device Connected to Downstream Switches

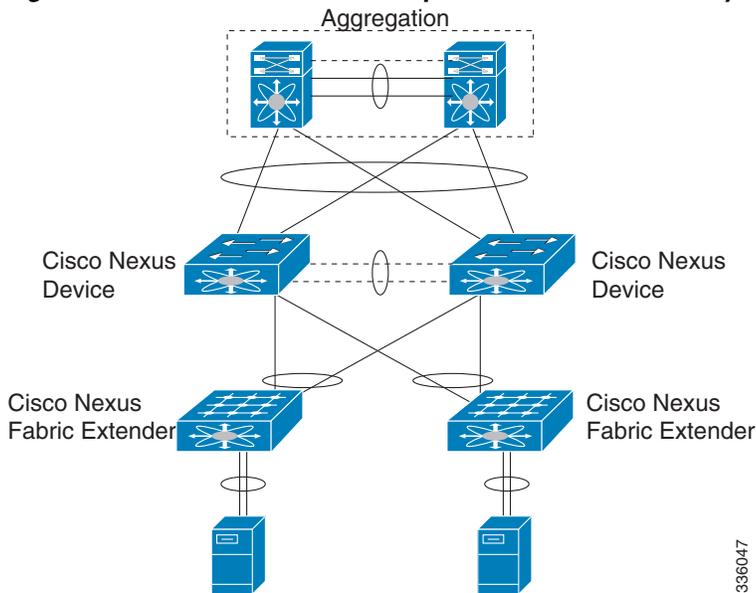
336047

The following figure shows a dual-homed FEX topology in which the access layer includes a vPC configuration to hosts or downstream switches.

Figure 19 vPC-Peered Dual-Supervisor Virtual Modular System Dual-Homed FEXs
