Cisco Nexus 9000 Series NX-OS Software Upgrade and Downgrade Guide, Release 7.x

Upgrading or Downgrading the Cisco Nexus 9000 Series NX-OS Software

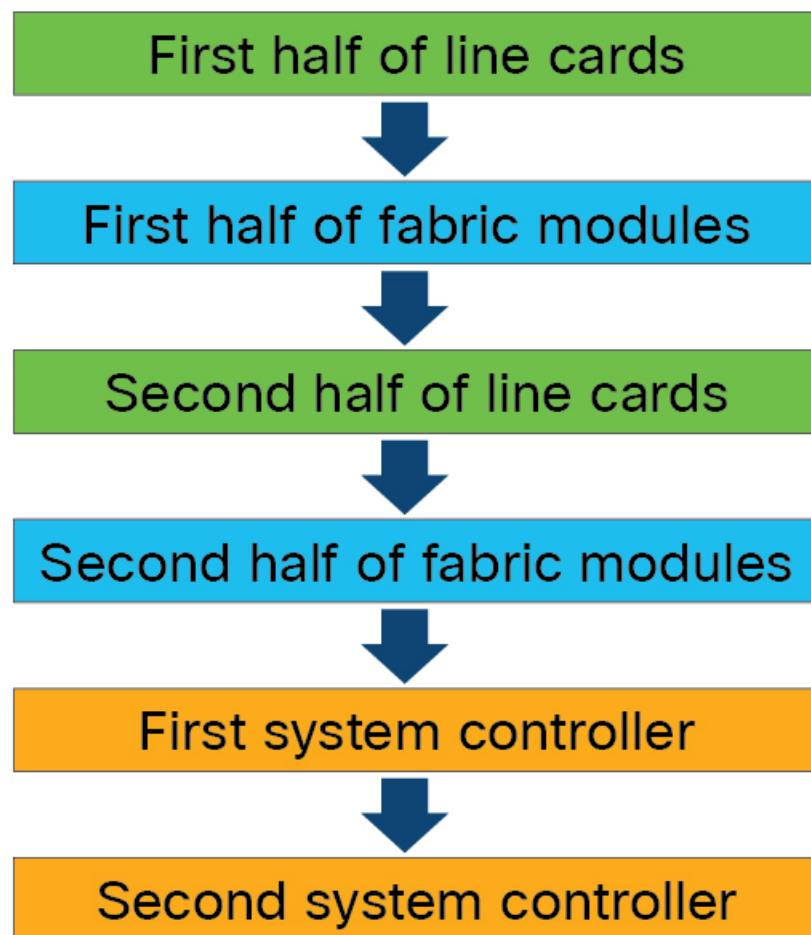
Figure 1: Parallel Upgrade Process for Cisco Nexus 9500 Series Switches

Cisco Nexus 9500 Parallel Upgrade Process

The steps for the parallel upgrade process on Cisco Nexus 9500 Series switches are:

- First the supervisors are upgraded (This procedure requires a switchover). Then the line cards, the fabric modules, the system controllers, and the FEX are upgraded.
- After the switchover is performed in a parallel upgrade, the secondary supervisor takes over. The installer determines the current line cards and the fabric modules.
- The installer then divides the components into the buckets. It places the first half of the line cards in the first bucket, the first half of the fabric modules in the second bucket, the second half of line cards in the
