Cisco Nexus 7000 Series NX-OS Release Notes, Release 5.1

Published: February 7, 2012
Part Number: OL-23608-07 E0
Current Release: 5.1(6)
Deferred Release: 5.1(2)

This document describes the features, caveats, and limitations for the Cisco NX-OS software for use on the Cisco Nexus 7000 Series switches. Use this document in combination with documents listed in the “[Related Documentation](#)” section on page 77.

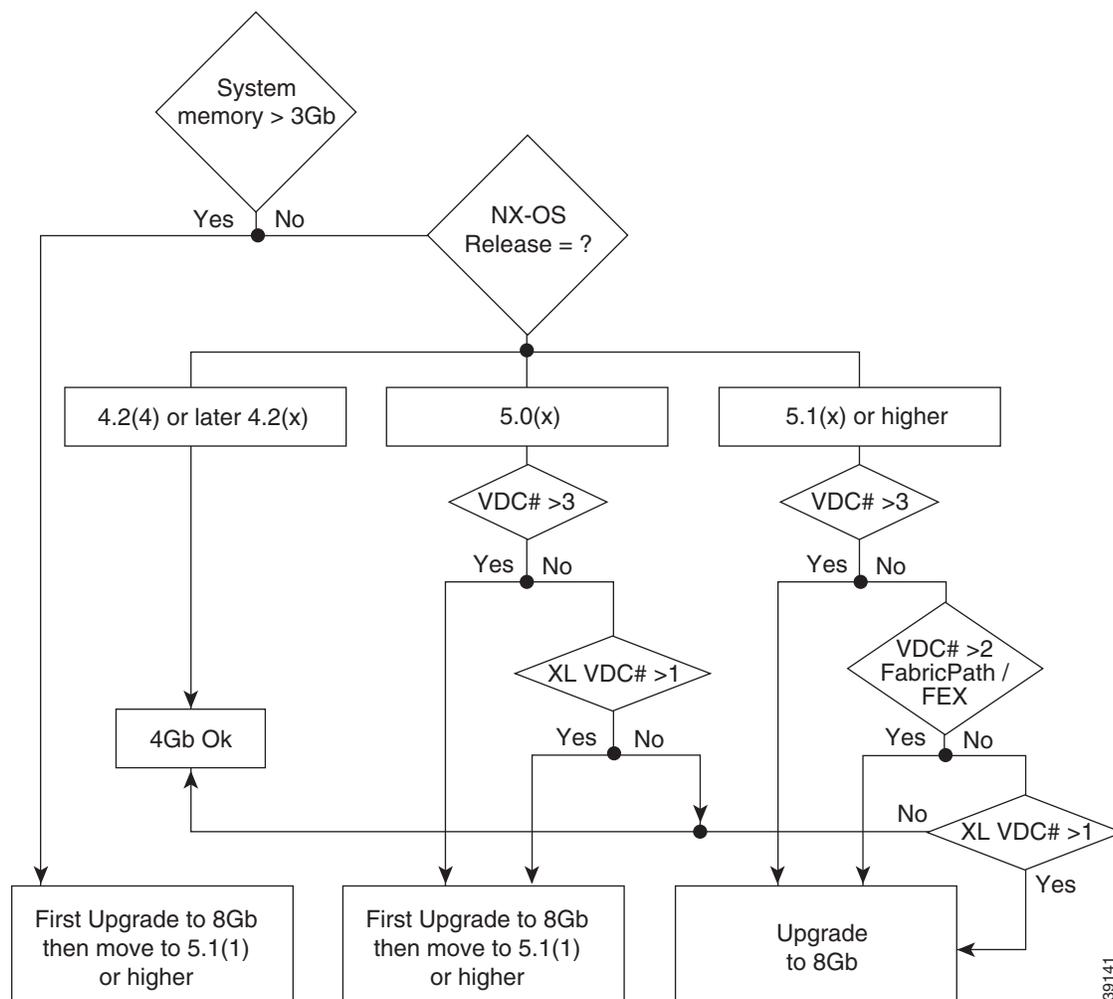
Figure 1 Supervisor Memory Upgrade Decision Flowchart

See for additional guidance about whether or not to upgrade a supervisor module to 8 GB of memory, see [Figure 1](#).

- When the system memory usage exceeds 3 GB (75 percent of total memory), we recommend that you upgrade the memory to 8 GB. Use the **show system resources** command from any VDC context to check the system memory usage:
