CHAPTER 12

Software Images

This chapter describes how to install and upgrade Cisco MDS software images. It includes the following sections:

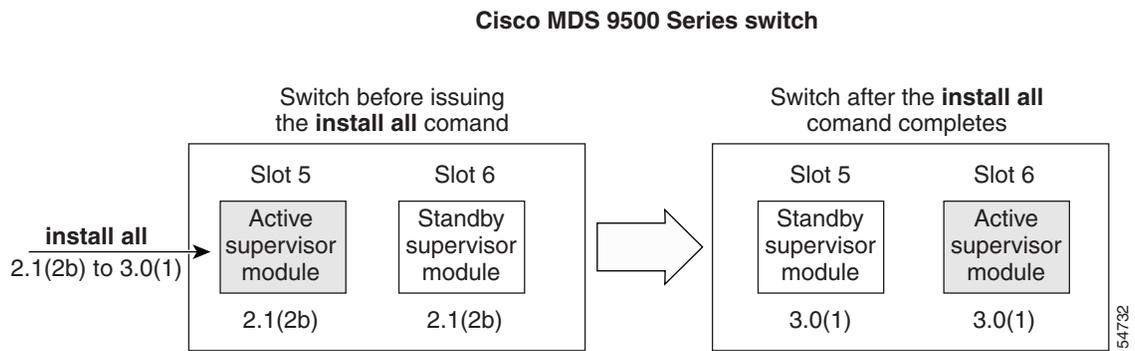
Figure 12-1 The Effect of the Software Install Wizard install all Command

The Software Install Wizard **install all** command upgrades all modules in any Cisco MDS 9000 Family switch. [Figure 12-1](#) provides an overview of the switch status before and after using Software Install Wizard issuing the **install all** command.

The Software Install Wizard **install all** command automatically verifies if the standby supervisor module is functioning (if present). If it is not functioning, it reloads that module and uses the **force download** option **reload module slot force-dnld** command to force it to function.

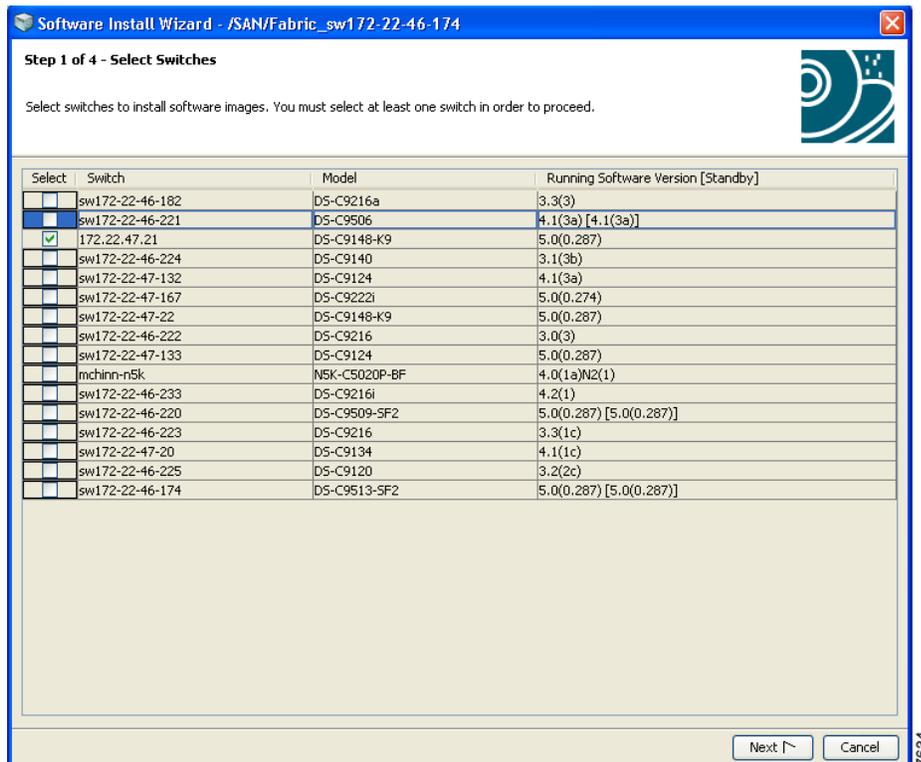
Figure 12-3 Select Switches Dialog Box

You see the Select Switches dialog box with all switches selected by default.

Step 2 Deselect the check box for the switch(es) for which you do not want to install images on. You must have at least one switch selected to proceed (see [Figure 12-3](#)).

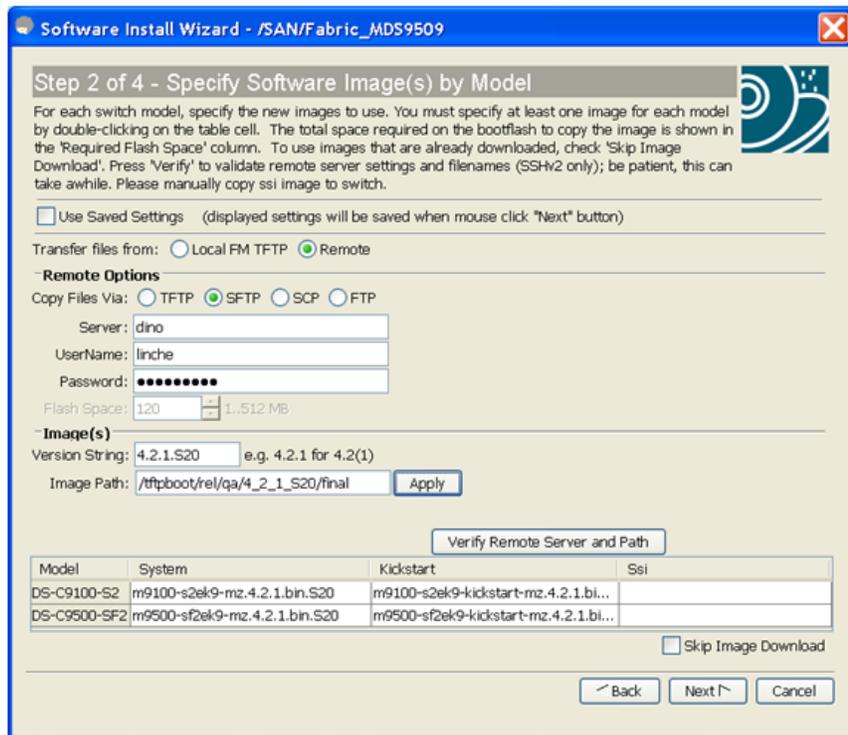
Figure 12-4 Specify Software Image(s) by Model Dialog Box

You see the Specify Software Image(s) by Model Dialog Box shown in [Figure 12-4](#).

- Step 5** Click the **Use Saved Settings** check box to load and display the previously saved settings. Settings are saved each time the Next button is clicked.
- Step 6** Click the radio button for either:
- Local FM TFTP** to transfer files from local computer.
 - Remote** to transfer files from a remote computer.
- Step 7** If you select Local FM TFTP, proceed to [Step 10](#).
- Step 8** If you select Remote, click one of the Copy Files Via radio buttons transfers files (SFTP, SCP, FTP).
- Step 9** Enter the server name, user name and password.
- Step 10** Enter the version and the image path and then click **Apply**.

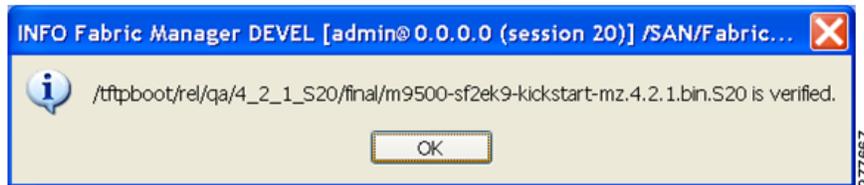
Figure 12-5 Validation Result

- Step 11** Click the row under the System, Kickstart or SSI columns to enter image URIs. You must specify at least one image for each switch to proceed.
- Step 12** Click **Verify Remote Server and Path**.
DCNM-SAN will validate the file path and server credentials. You see the output as shown in [Figure 12-5](#)

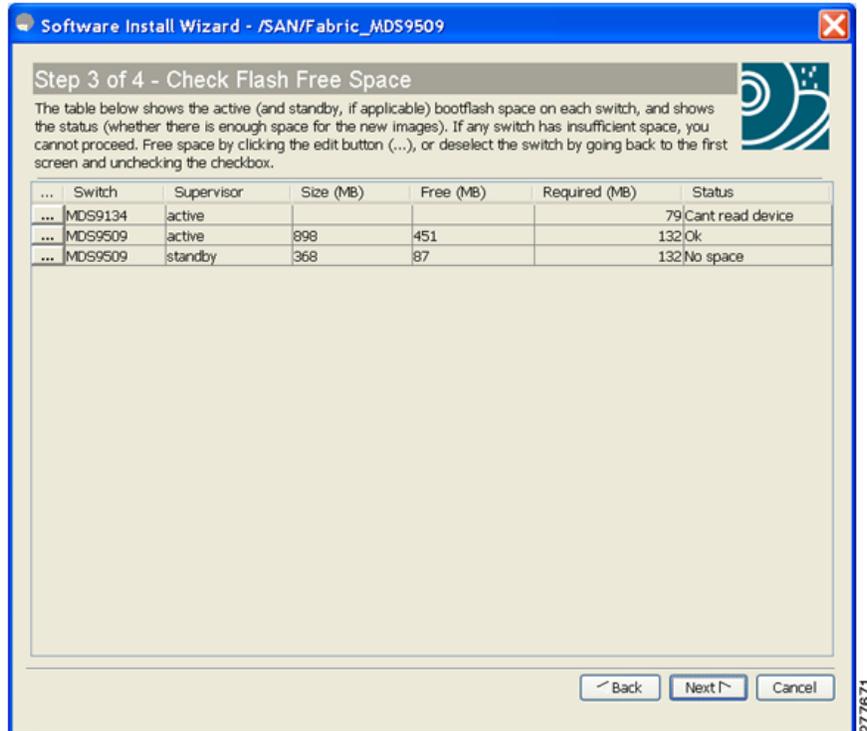
Figure 12-6 Check Flash Free Space Dialog Box

- Step 13** Click **OK** and then click **Next** in the Specify Software Images by Model dialog box.
You see the Check Flash Free Space dialog box (see [Figure 12-6](#)). This dialog box shows the active (and standby, if applicable) bootflash space on each switch, and shows the status (whether there is enough space for the new images). If any switch has insufficient space, you cannot proceed. Deselect the switch without enough bootflash by going back to the first screen and unchecking the check box for that switch.

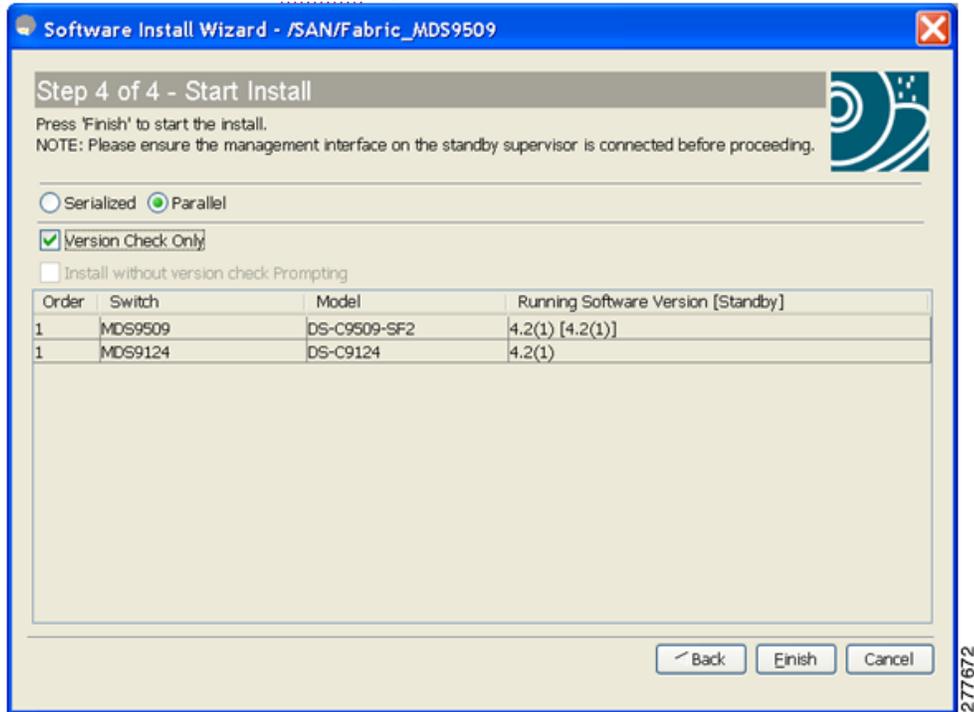
Figure 12-7 Start Install Dialog Box

- Step 14** Click **Next**.
You see the Start Install dialog box shown in .

- Step 15** Click one of the the radio buttons:
- a. **Serialized** to upgrade one switch at a time.
 - b. **Parallel** to simultaneously upgrade multiple switches.
- Step 16** (Optional) Check the **Version Check Only** check box to complete the version check first and then prompt for your input to continue with installation.
- Step 17** (Optional) Click **Finish** to start installation.
- You see the Version Check Results dialog box shown in .

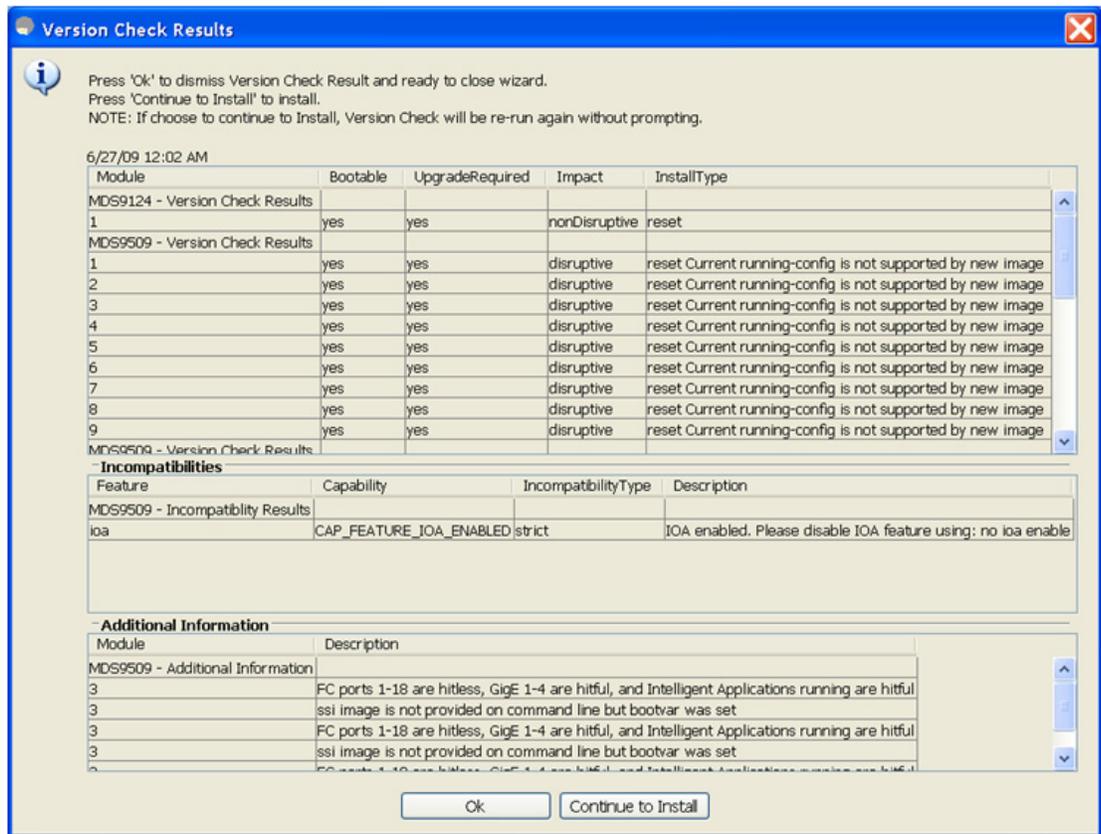
Figure 12-8 Version Check Results Dialog box

Step 18 (Optional) Check the **Install without Version check Prompting** check box to continue with the installation.

Note The version check provides information about the impact of the upgrade for each module on the switch. It also shows any incompatibilities that might result. You see a final dialog box at this stage, prompting you to confirm that this check should be performed. We recommend that you do not ignore the version check results.

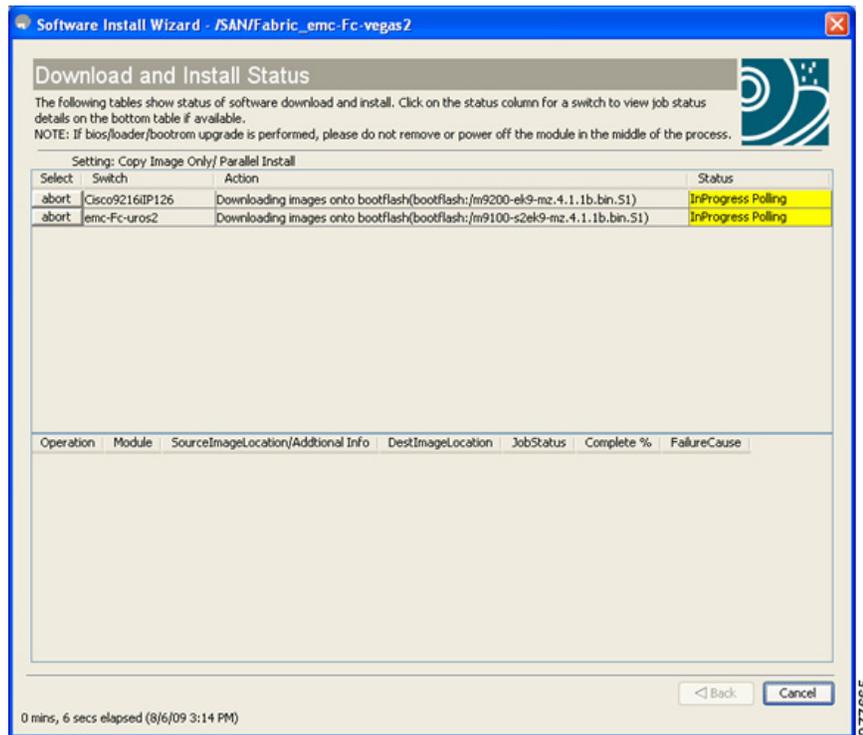
Figure 12-9 Download and Install Status Dialog Box

You see the Download and Install Status dialog box shown in [Figure 12-9](#).
