Cisco Nexus 7000 Series NX-OS Software Upgrade and Downgrade Guide, Release 7.x

Cisco Nexus 7000 Series NX-OS Software Upgrade and Downgrade Guide

This document describes how to upgrade or downgrade the Cisco NX-OS software.

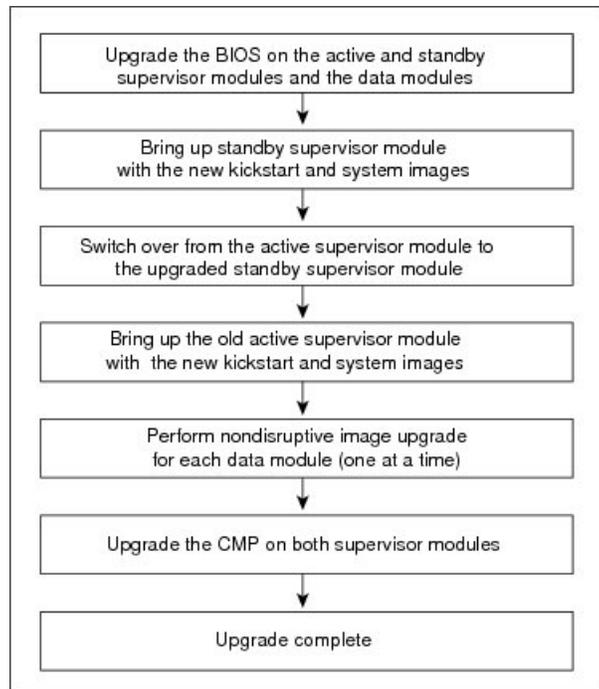
Figure 1: ISSU Process

The Cisco NX-OS software supports in-service software upgrades (ISSUs) on devices with dual supervisor modules. An ISSU can update the software images on your device without disrupting data traffic. Only control traffic is disrupted. If an ISSU will cause a disruption of data traffic, the Cisco NX-OS software warns you before proceeding so that you can stop the upgrade and reschedule it to a time that minimizes the impact on your network.

This figure shows the ISSU process.
