Release Notes for the Catalyst 3750, 3560, 2970, and 2960 Switches, Cisco IOS Release 12.2(40)SE

Revised December 24, 2008

Cisco IOS Release 12.2(40)SE runs on all Catalyst 3750, 3560, 2970, and 2960 switches and on Cisco EtherSwitch service modules.

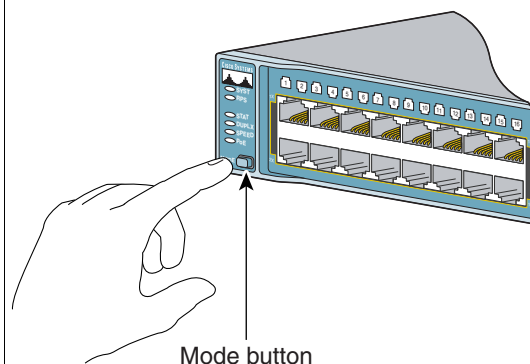
| Step 5 | <p>Press and hold the Mode button for 3 seconds. When all of the LEDs left of the Mode button turn green, release the Mode button.</p> <p>If the LEDs left of the Mode button begin to blink after you press the button, release it. Blinking LEDs mean that the switch has already been configured and cannot go into Express Setup mode. For more information, see the “Resetting the Switch” section.</p> |
| Step 6 | <p>Verify that the switch is in Express Setup mode by confirming that all LEDs left of the Mode button are green. (On some models, the RPS and PoE LEDs remain off.)</p> |

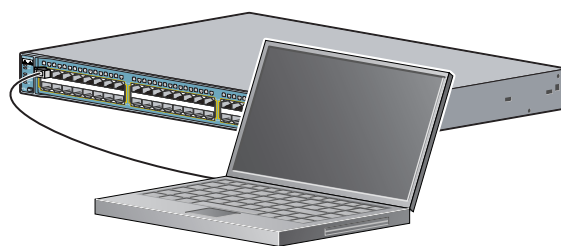
DHCP-enabled PC

Step 7 Connect a Category 5 Ethernet cable to any 10/100 or 10/100/1000 Ethernet port on the switch front panel.

Connect the other end of the cable to the Ethernet port on your PC.
