Release Notes for Catalyst 3750-E and 3560-E Switches, Cisco IOS Release 12.2(53)SE and Later

Revised July 28, 2010

Cisco IOS Release 12.2(53)SE and later runs on Catalyst 3750-E, Catalyst 3560-E switches, and Cisco enhanced EtherSwitch service modules.

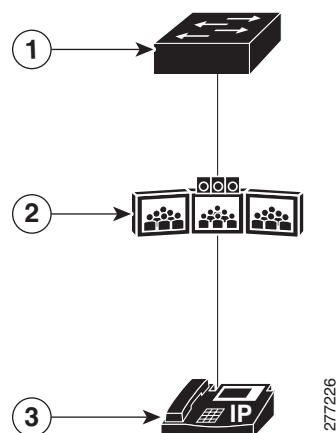
Figure 1 Phone-Codec-Switch Connection

You can use a Cisco IP phone as a user interface in a Cisco TelePresence System. See in Figure 1. In this configuration, the IP phone must always be on and available for emergency calls. If the power to the codec in the Cisco TelePresence System fails, is disrupted or if the codec fails, the IP phone is not available.

1	Switch	3	IP phone
2	Cisco TelePresence System with a codec

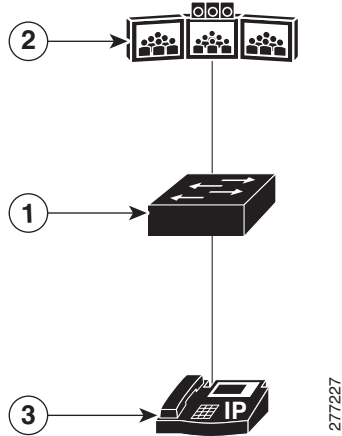
Figure 2 Phone-Switch-Codec Connection

The switch forwards all CDP packets received on the ingress port to the egress port. If multiple IP phones are connected to the codec through a single port on the switch, only one phone communicates with it through the IP network. This phone is usually the one that sent the first CDP packet received by the codec.

1	Switch	3	CDP-enabled IP phone
2	Cisco TelePresence System with a codec

Use the TelePresence E911 IP phone support feature to ensure that the IP phone is always on and available for emergency calls. When a CDP-enabled IP phone is connected to the codec through a switch, you can configure the switch to forward CDP packets from the IP phone only to the codec in the Cisco TelePresence System. The switch adds *ingress-egress port pairs* to the CDP forwarding table. An ingress-egress port pair is a one-to-one mapping between an ingress switch port connected to the IP phone and an egress switch port connected to the codec.
