# Release Notes for the Cisco IE 3000 Switch, Cisco IOS Release 12.2(58)SE1 and Later

Cisco IOS Release 12.2(58)SE1 runs on all Cisco IE 3000 switches.

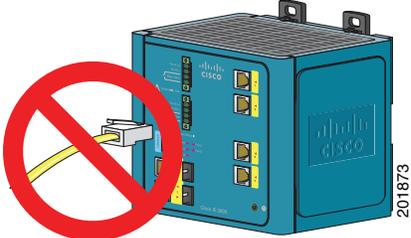
<b>Step 5</b>	<p>Press the Express Setup button. This button is recessed behind the front panel, so you can use a simple tool, such as a paper clip.</p> <p>When you press the Express Setup button, a switch port LED begins blinking green.</p>

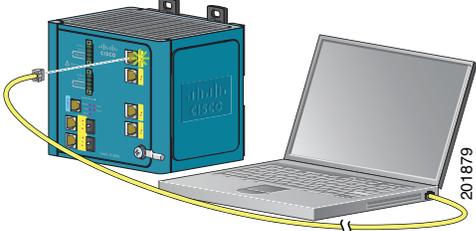
<b>Step 6</b>	<p>Connect a Category 5 Ethernet cable (not provided) from the blinking switch port to the Ethernet port on your PC.</p> <p>The port LEDs on your PC and the switch blink green while the switch configures the connection.</p>
