# Release Notes for the Cisco IE 3000 Switch, Cisco IOS Release 15.0(2)SE and Later

September 15, 2017

Cisco IOS Release 15.0(2)SE and higher runs on all Cisco IE 3000 switches.

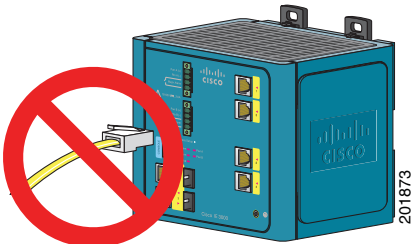
<b>Step 1</b>	<p>Make sure that nothing is connected to the switch.</p> <p>During Express Setup, the switch acts as a DHCP server. If your PC has a static IP address, change your PC settings before you begin to temporarily use DHCP.</p>

<b>Step 2</b>	<p>Connect power to the switch.</p> <p>See the wiring instructions in the “Grounding the Switch” section and the “Wiring the DC Power Source” section.</p>	
<b>Step 3</b>	<p>When the switch powers on, it begins the power-on self-test (POST). During POST, the System LED blinks while a series of tests verify that the switch functions properly. Wait for the switch to complete POST, which takes approximately 1 minute.</p>	
<b>Step 4</b>	<p>Make sure that POST has completed by verifying that the System LED is solid green. If the switch has not been configured, the Setup LED blinks green. If the Setup LED stops blinking, you can still continue with the next step.</p> <p>If the switch fails POST, the System LED turns red. See the “In Case of Difficulty” section if your switch fails POST.</p>

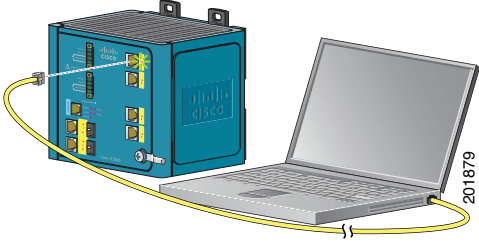
<b>Step 6</b>	<p>Connect a Category 5 Ethernet cable (not provided) from the blinking switch port to the Ethernet port on your PC.</p> <p>The port LEDs on your PC and the switch blink green while the switch configures the connection.</p>
