# Release Notes for the Catalyst 3750 Metro Switch Cisco IOS Release 12.2(54)SE

Cisco IOS Release 12.2(54)SE runs on the Catalyst 3750 Metro switch.

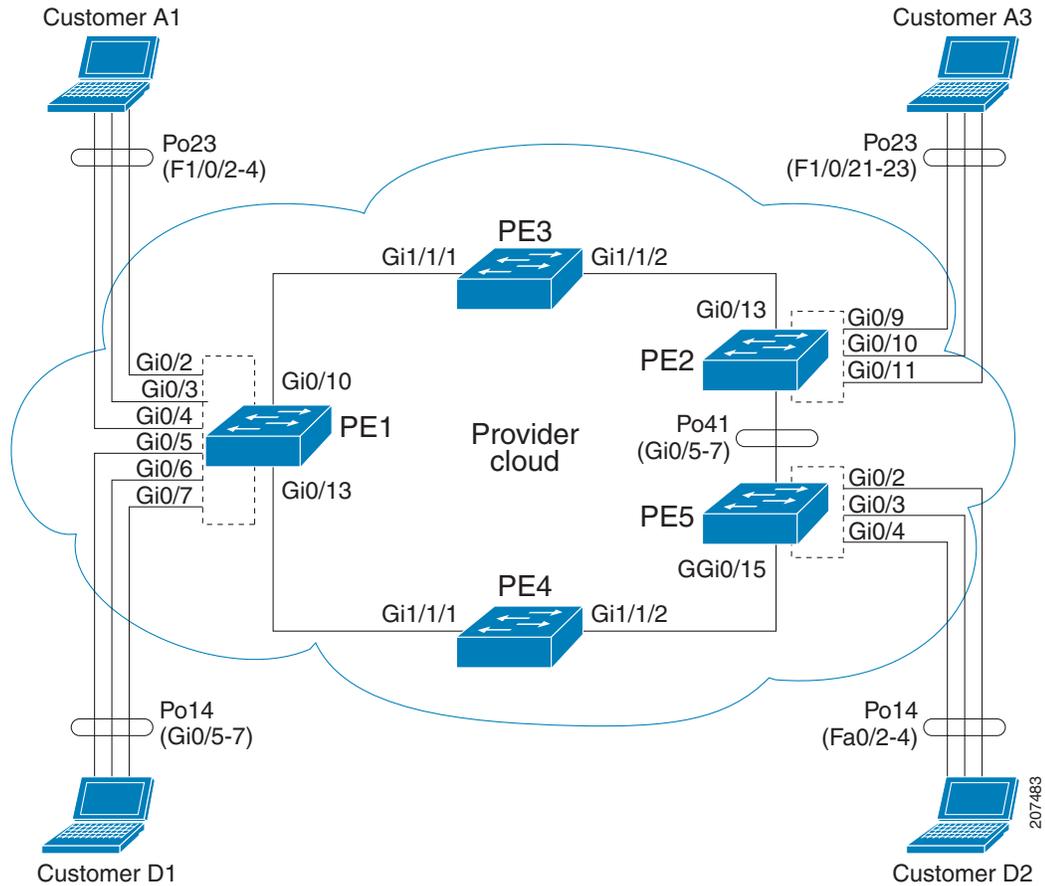
For end-to-end PAgP EtherChannel tunneling between CE devices, you should extend the CE connections through the service provider network as a point-to-point service when the PE device has no EtherChannels in **on** mode. See the software configuration guide section “Configuring Layer 2 Tunneling for EtherChannels” in the “Configuring IEEE 802.1Q and Layer 2 Protocol Tunneling” chapter. The same procedure applies to 802.1ad tunnels.

**Figure 1-1 802.1ad End-to-End PAgP EtherChannels**
