Release Notes for Cisco MGX Route Processor Module (RPM-PR) IOS Release 12.3(11)T9 for MGX Releases 1.3.14 and 5.2.10

Part Number OL-9468-01 Revision A0, February 17, 2006.

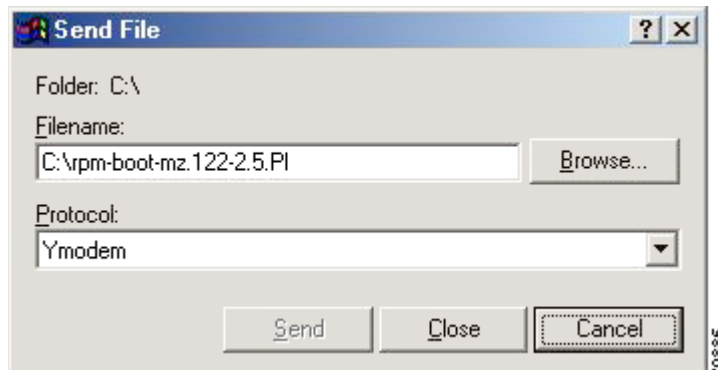
**Step 4** To start the image transfer, use the **Transfer > Send File** option in HyperTerminal.

In the Filename box, browse and choose the image file to be downloaded. Also because you used the `-y` option while invoking the xmodem, set the transfer protocol to ymodem or use Xmodem protocol by not specifying the `-y` option on the command line.
