Release Notes for Cisco MGX Route Processor Module (RPM-PR) IOS Release 12.3(11)T9 for MGX Releases 1.3.14 and 5.2.10

Part Number OL-9468-01 Revision A0, February 17, 2006.

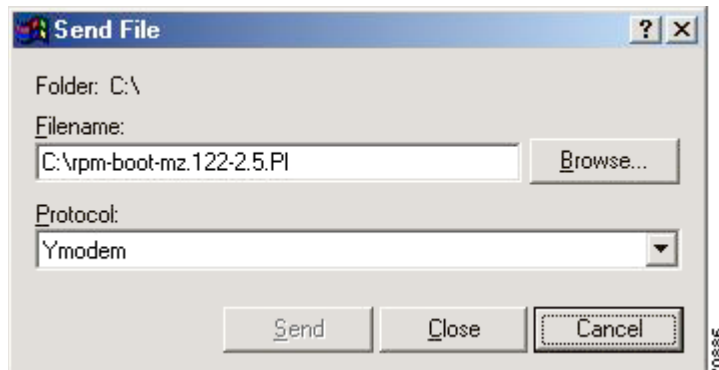
**Step 4** To start the image transfer, use the **Transfer > Send File** option in HyperTerminal.

In the Filename box, browse and choose the image file to be downloaded. Also because you used the `-y` option while invoking the xmodem, set the transfer protocol to ymodem or use Xmodem protocol by not specifying the `-y` option on the command line.

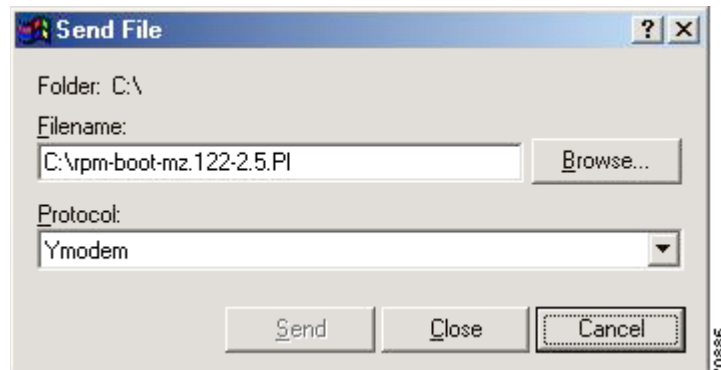
**Step 4** To start the image transfer, use the **Transfer > Send File** option in HyperTerminal.

In the Filename box, browse and choose the image file to be downloaded. Also because you used the `y` option while invoking the `xmodem`, set the transfer protocol to `ymodem` or use `Xmodem` protocol by not specifying the `-y` option on the command line.
