Release Notes for Cisco MGX Route Processor Module (RPM-PR) IOS Release 12.4(6)T5 for MGX Releases 1.3.14 and 5.3.20

Part Number OL-11769-01, November 27, 2006

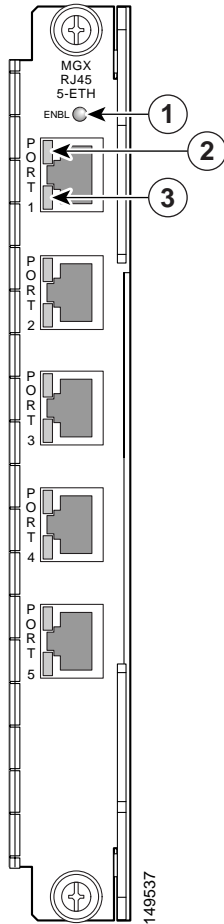
Figure 1 MGX-RJ45-5-ETH Back Card

Figure 1 shows the MGX-RJ45-5-ETH faceplate.

<p>1 ENABLE LED</p> <ul style="list-style-type: none"> • Green—The back card is active. • Off—The back card is not active. 	<p>3 Port 0 status LED</p> <ul style="list-style-type: none"> • Green <ul style="list-style-type: none"> - Data present (flashing). - The link is up.
<p>2 Port 0 speed LED</p> <ul style="list-style-type: none"> • Orange—1000 Mbps. • Green—100 Mbps. • Off—10 Mbps

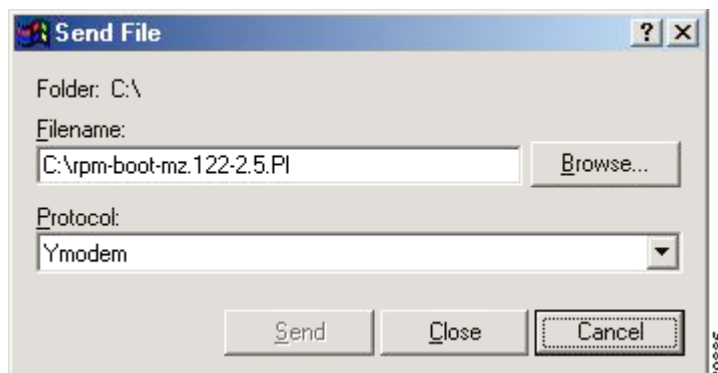
**Step 4** To start the image transfer, use the **Transfer > Send File** option in HyperTerminal.

In the Filename box, browse and choose the image file to be downloaded. Also because you used the y option while invoking the xmodem, set the transfer protocol to ymodem or use Xmodem protocol by not specifying the -y option on the command line.
