# Release Notes for Cisco MGX Route Processor Module (RPM-XF) Cisco IOS Release 12.4(6)T5 for PXM45-based Switches, Release 5.3.20

Part Number OL-11770-01 November 27, 2006

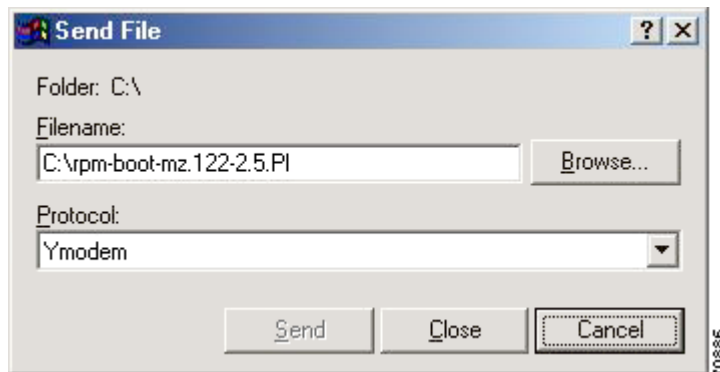
**Step 3** To start the image transfer, use the **Transfer > Send File** option in HyperTerminal.

In the Filename box, browse and choose the image file to be downloaded. Because we used the y option while invoking the xmodem, set the transfer protocol to ymodem or use Xmodem protocol by not specifying the -y option on the command line.
