Release Notes for Cisco TelePresence System Software Release TX 6.x

Created: October 4, 2012

These release notes describe new features and open and closed hardware and software caveats for the Cisco TelePresence System software release TX 6.x.

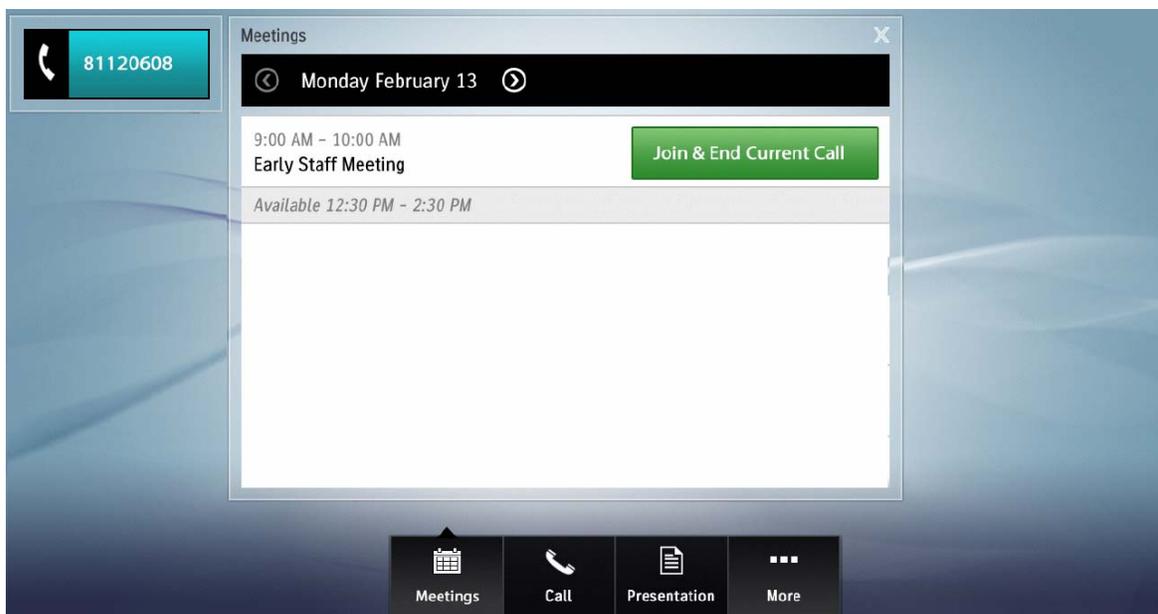
- If you are in a call, and wish to join a scheduled conference, the choice to Join has been replaced with **Join & End Current Call**.

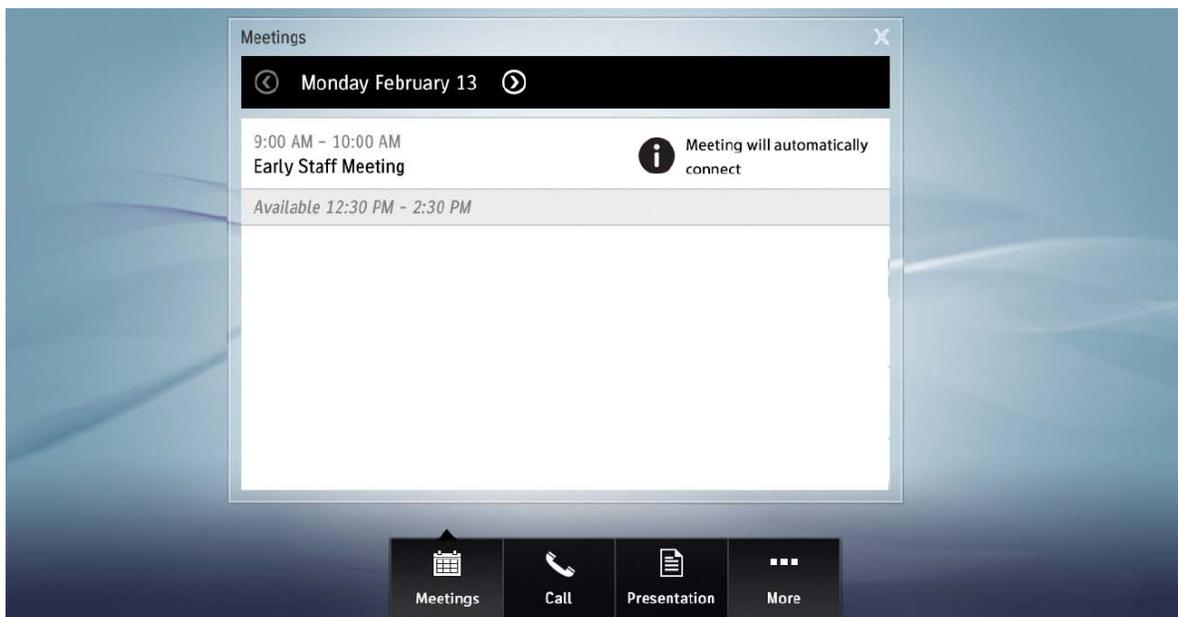
- In an AutoConnect meeting, the choice to join the meeting is disabled, and is replaced by text saying that the meeting will automatically connect.

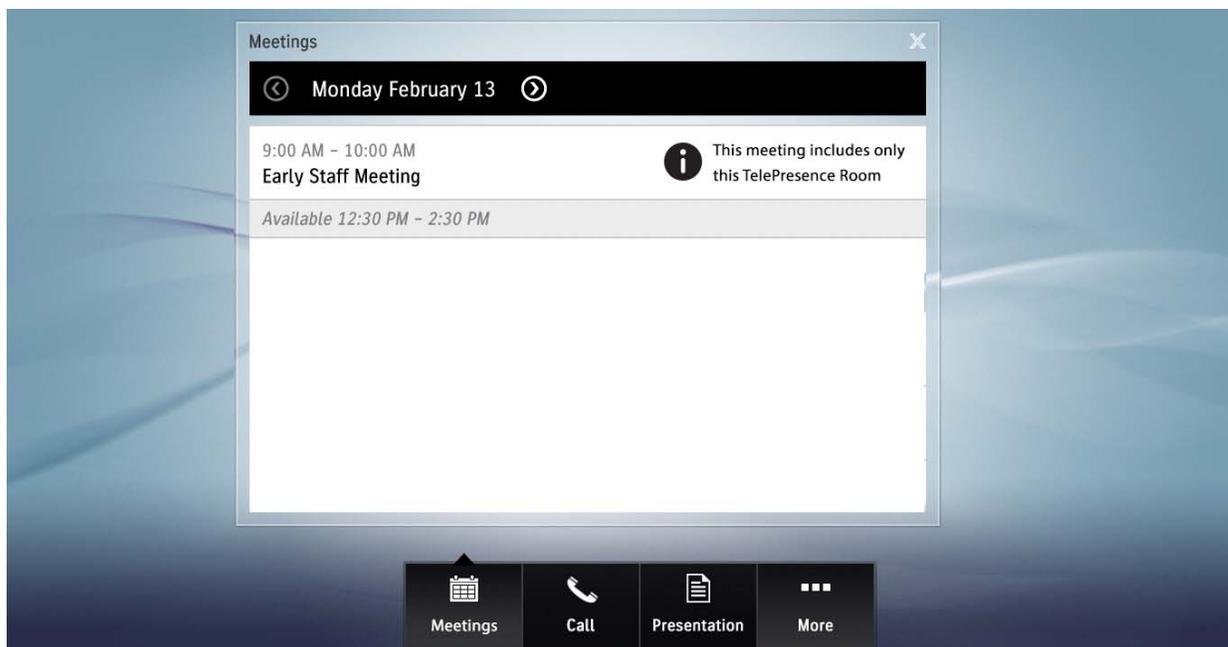
- If a meeting includes only one TelePresence room, and no WebEx OneTouch (also known as one-button-to-push) number has been defined, the text in the meeting informs you that the meeting only includes the TelePresence room.

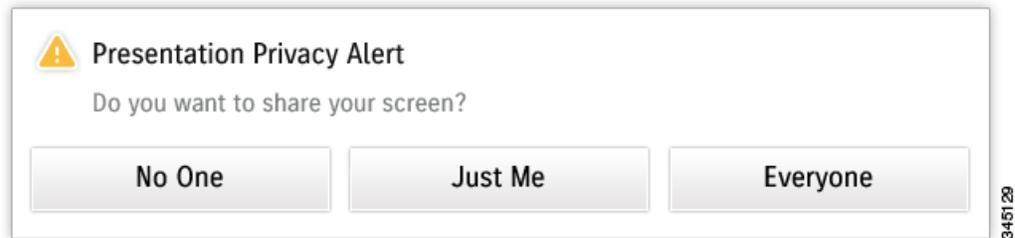
Figure 1 *Presentation Privacy Message*

In other cases, to disable auto-sharing, enter the **set presentation auto-share disable** command. After auto-sharing is disabled, each time a user plugs in the presentation, the Touch device displays a Presentation Privacy Alert message such as the one shown in [Figure 1](#). You then tap the Touch screen to select whether to share the presentation or not.

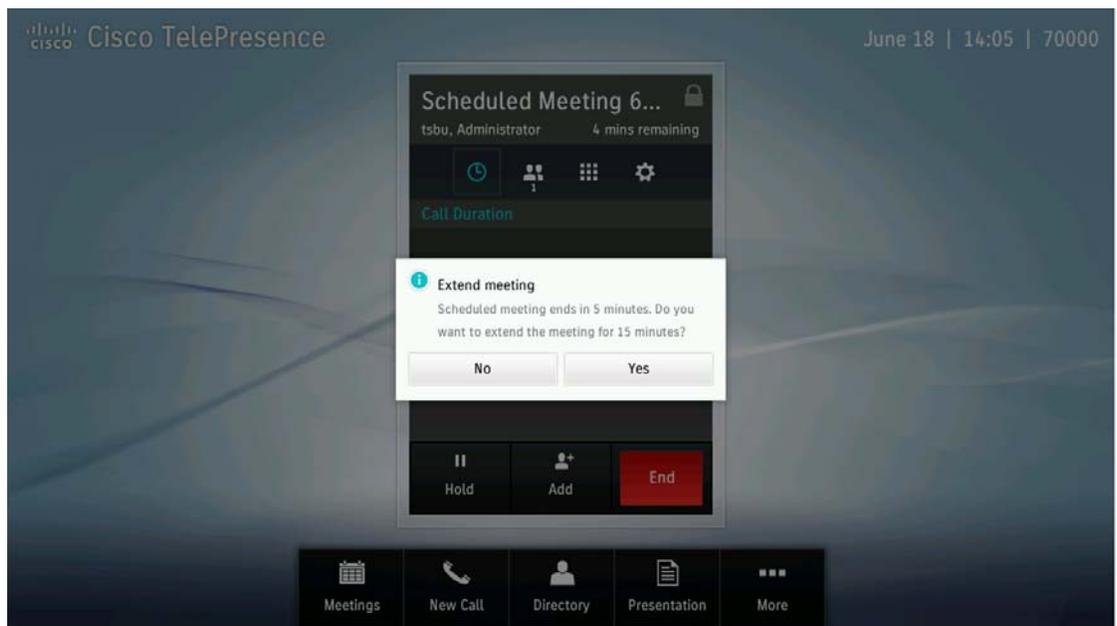
Figure 2 TMS Meeting Extension Prompt to Administrator

This software release enhances the use of TMS as a call scheduling and management platform. If your system uses TMS, some new messages appear on your Touch 12 device. For example, if you are the video conference master (VC master) of your meeting, a prompt appears a few minutes before your meeting ends that gives you the option to extend your meeting. See [Figure 2](#) for an example of this prompt.

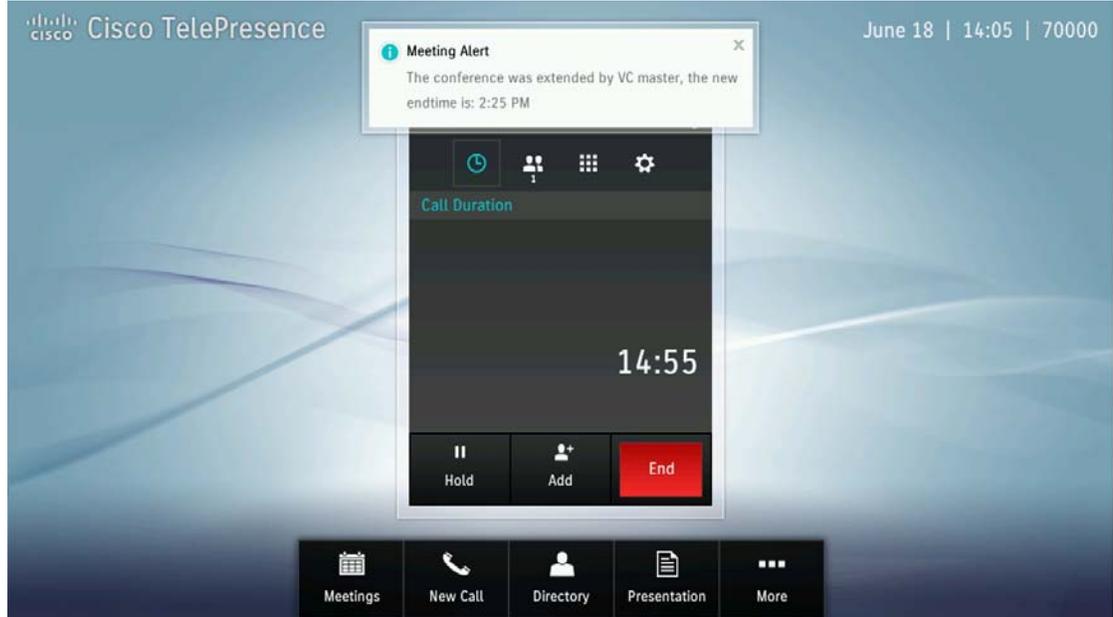
Figure 3 TMS Meeting Extended Alert

If you tap **Yes**, your meeting length extends, and all call participants see an alert like the one shown in [Figure 3](#).
