Upgrading Cisco UCS B-Series Hardware

Upgrading Fabric Interconnects 2

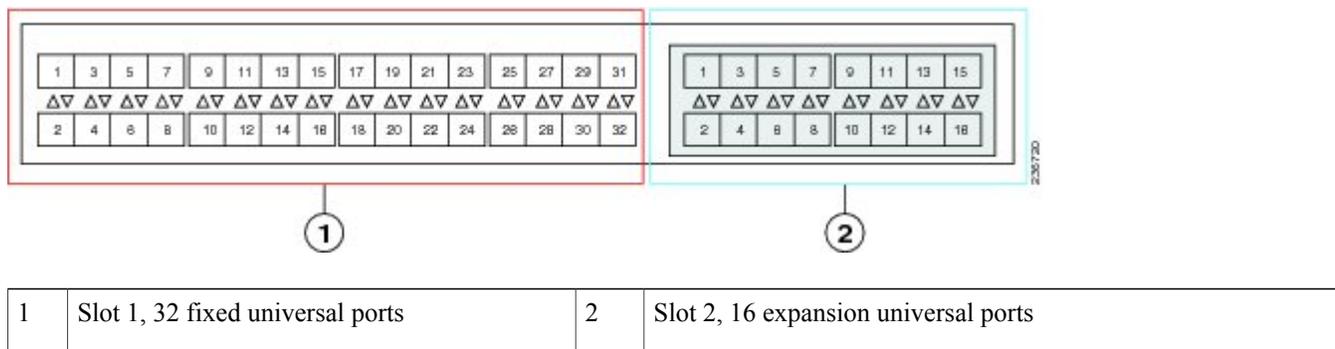
Figure 1: Cisco UCS 6248 Port Numbering

On the UCS 6120 fabric interconnect, the fixed ports on slot 1 are all Ethernet ports, which might be further configured as Server ports or uplink Ethernet ports. On the UCS 6248 fabric interconnect, you can separate the 32 physical ports in slot one into two contiguous pools, low numbered ports being Ethernet ports and high numbered ports being Fibre Channel ports. When upgrading to a UCS 6248, the UCS 6120 port mappings can be directly carried over on fixed ports with no reconfiguration required. When upgrading a UCS 6140 to a UCS 6296, the port mappings can be directly carried over on fixed ports with no reconfiguration required.

Note Since a UCS 6140 has 40 ports on slot 1 and a UCS 6248 has 32 ports, any ports currently configured on ports 1/33 to 1/40 of the UCS 6140 will have to be moved during the upgrade process.

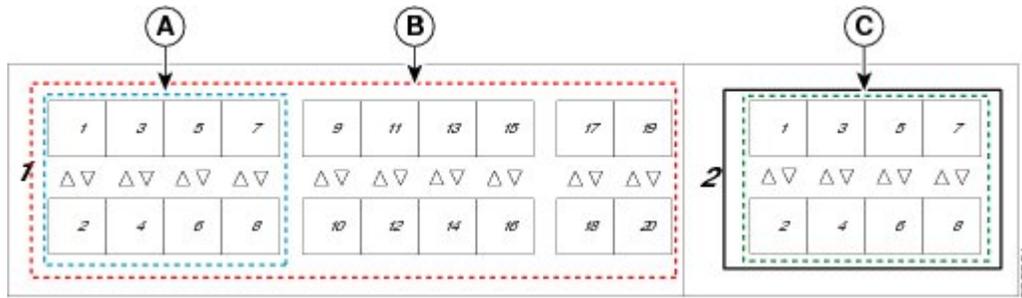
Figure 2: Cisco UCS 6120 Port Numbering when Configured with the N10-E0080 Expansion Module

- If you have an N10-E0080 or N10-E0060 Fibre channel expansion module in your UCS 6120, the existing fibre channel configurations can simply carry over to the new UCS 6248, though this may not be appropriate for all situations as it will mean that all ports in slot 2 are Fibre Channel. If you want to reconfigure ports 2/1 to 2/8 to use ports 2/9 to 2/16, do so after the upgrade is completed.

A	Slot 1, ports 1 through 8: 10-Gigabit or 1 Gigabit Ethernet capable ports	C	Slot 2 Fibre Channel ports 1 through 8
B	Slot 1, ports 1 through 20: 10-Gigabit Ethernet ports

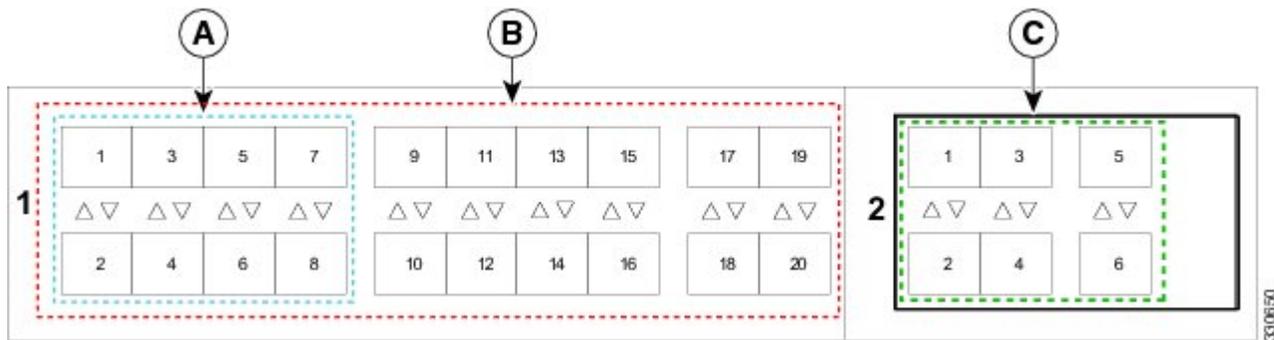
Figure 3: Cisco UCS 6120 Port Numbering when Configured with the N10-E0060 Expansion Module

A	Slot 1, ports 1 through 8: 10-Gigabit or 1 Gigabit Ethernet capable ports	C	Slot 2 Fibre Channel ports 1 through 6
B	Slot 1, ports 1 through 20: 10-Gigabit Ethernet ports

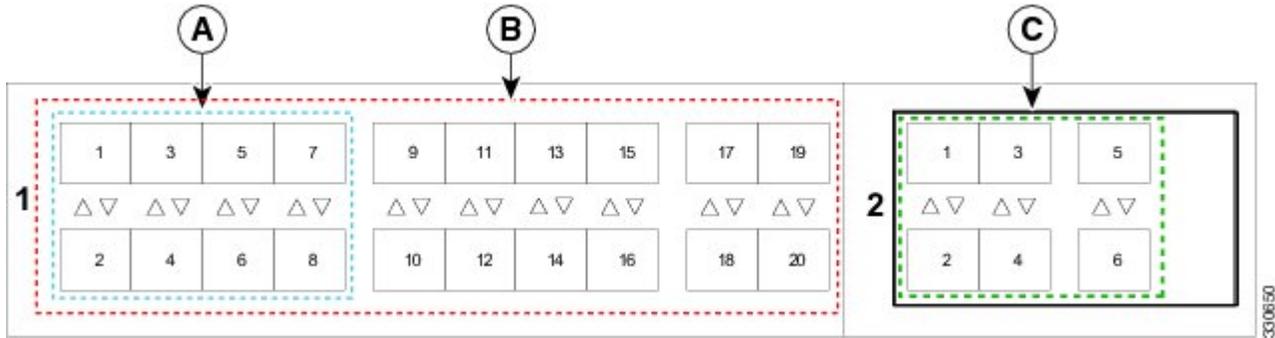
Figure 4: Cisco UCS 6120 Port Numbering when Configured with the N10-E0600 Expansion Module

- If you have an N10-E0600 Fibre Channel expansion module in your UCS 6120, the existing Ethernet configurations can simply carry over to the UCS 6248, with ports 2/7 to 2/16 potentially configurable for either Ethernet or FC.

A	Slot 1, ports 1 through 8: 10-Gigabit or 1 Gigabit Ethernet capable unencrypted ports	C	Slot 2 10-Gigabit Ethernet ports 1 through 6
B	Slot 1, ports 1 through 20: 10-Gigabit Ethernet ports

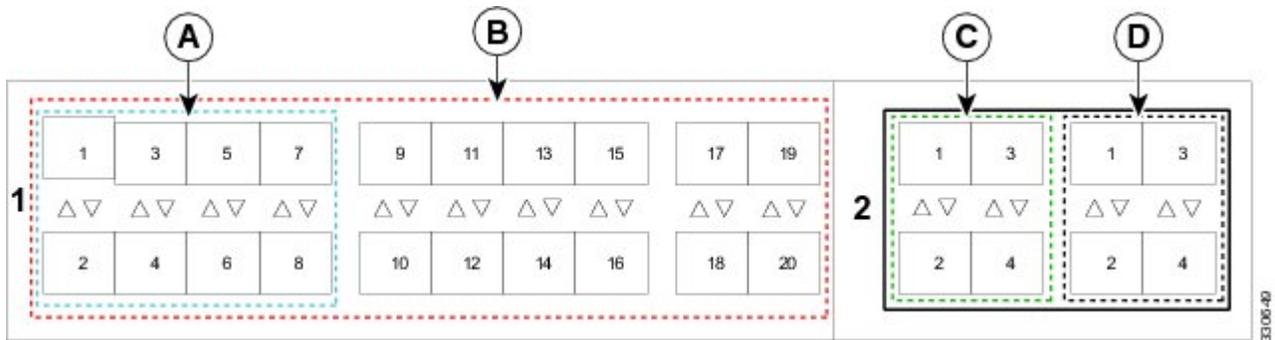
Figure 5: Cisco UCS 6120 Port Numbering when Configured with the N10-E0440 Expansion Module

- If you have an N10-E0440 expansion module in your UCS 6120, the simplest direct mapping would be to allow Ethernet ports 2/1 to 2/4 on the UCS 6248 to carry over, then remap the fibre channel ports to new port numbers on either slot 1 or slot 2.

A	Slot 1, ports 1 through 8: 10-Gigabit or 1 Gigabit Ethernet capable ports	C	Slot 2 10-Gigabit Ethernet ports 1 through 4
B	Slot 1, ports 1 through 20: 10-Gigabit Ethernet ports	D	Slot 2 Fibre Channel ports 1 through 4
