Upgrading Cisco UCS Hardware

Upgrading Fabric Interconnects

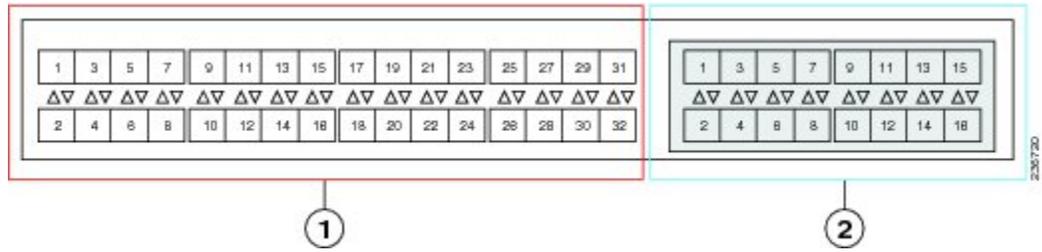
Figure 1: Cisco UCS 6248 Port Numbering

1	Slot 1, 32 fixed universal ports	2	Slot 1, 16 expansion universal ports
---	----------------------------------	---	--------------------------------------

On the UCS 6120 fabric interconnect, the fixed ports on slot 1 are all ethernet ports, which might be further configured as Server ports or uplink Ethernet ports. On the UCS 6248 fabric interconnect, you can separate the 32 physical ports in slot one into two contiguous pools, low numbered ports being Ethernet ports and high numbered ports being Fibre Channel ports. When upgrading to a UCS 6248, the UCS 6120 port mappings can be directly carried over on fixed ports with no reconfiguration required. When upgrading a UCS 6140 to a UCS 6296, the port mappings can be directly carried over on fixed ports with no reconfiguration required.

Since a UCS 6140 has 40 ports on slot 1 and a UCS 6248 has 32 ports, any ports currently configured on ports 1/33 to 1/40 of the UCS 6140 will have to be moved during the upgrade process.

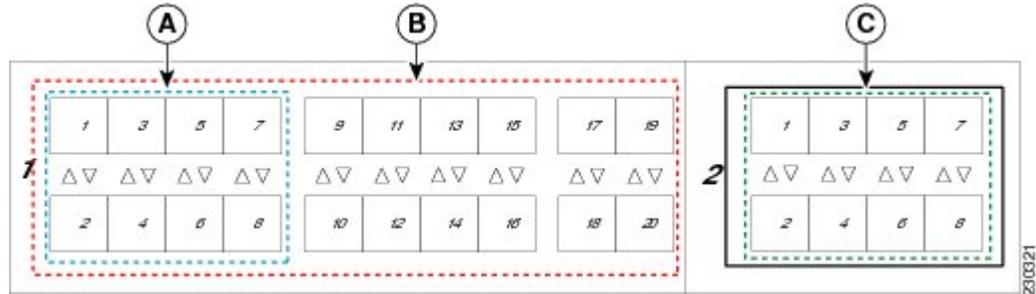
Figure 2: Cisco UCS 6120 Port Numbering when Configured with the N10-E0080 Expansion Module

A	Slot 1, ports 1 through 8: 10-Gigabit or 1 Gigabit Ethernet capable ports	C	Slot 2 Fibre Channel ports 1 through 8
B	Slot 1, ports 1 through 20: 10-Gigabit Ethernet ports

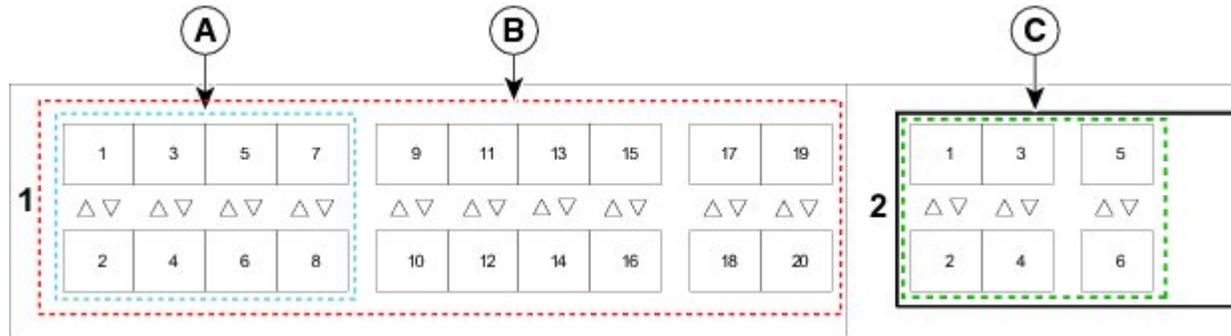
Figure 3: Cisco UCS 6120 Port Numbering when Configured with the N10-E0060 Expansion Module

A	Slot 1, ports 1 through 8: 10-Gigabit or 1 Gigabit Ethernet capable ports	C	Slot 2 Fibre Channel ports 1 through 6
B	Slot 1, ports 1 through 20: 10-Gigabit Ethernet ports

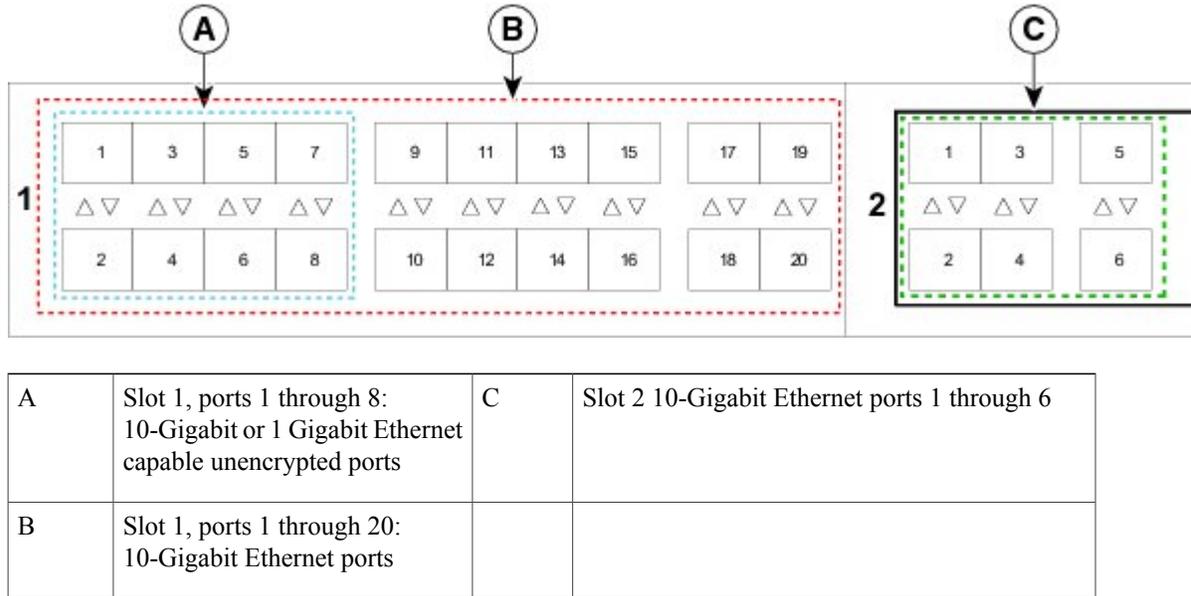
Figure 4: Cisco UCS 6120 Port Numbering when Configured with the N10-E0600 Expansion Module

- If you have an N10-E0600 Fibre channel expansion module in your UCS 6120, the existing Ethernet configurations can simply carry over to the UCS 6248, with ports 2/7 to 2/16 potentially configurable for either Ethernet or FC.

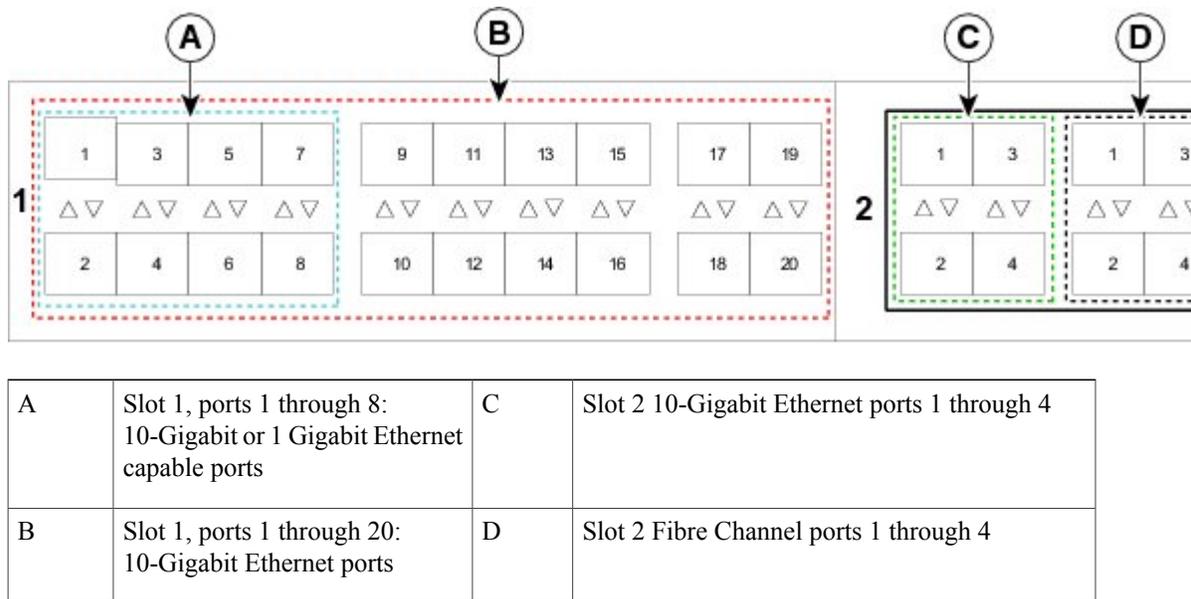
Figure 5: Cisco UCS 6120 Port Numbering when Configured with the N10-E0440 Expansion Module

- If you have an N10-E0440 expansion module in your UCS 6120, the simplest direct mapping would be to allow Ethernet ports 2/1 to 2/4 on the UCS 6248 to carry over, then remap the fibre channel ports to new port numbers on either slot 1 or slot 2.
