Migration Guide for Cisco UCS 6400 Series Fabric Interconnects

First Published: 2020-02-20

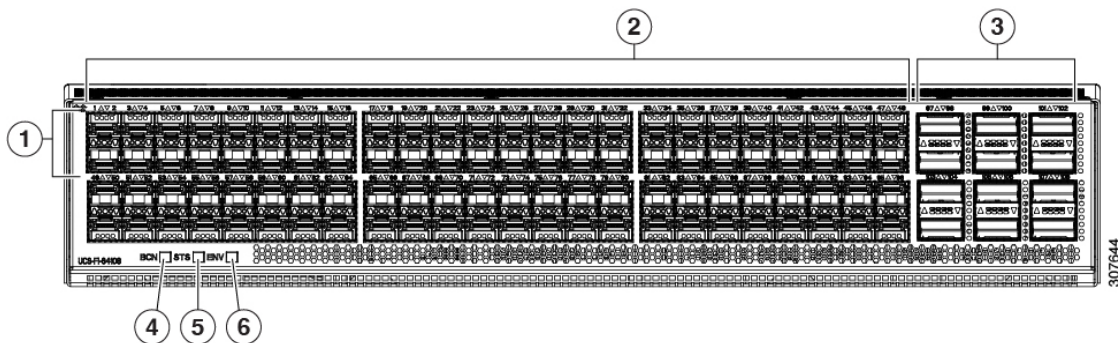
Figure 1: Cisco UCS 64108 Fabric Interconnect Rear View

1	Ports 1-16 Unified ports: • 10/25 Gbps Ethernet or FCoE • 8/16/32 Gbps Fibre Channel	2	Ports 17-88 (10/25 Gbps Ethernet or FCoE)
3	Ports 89-96 • 10/25 Gbps Ethernet or FCoE • 1 Gbps Ethernet	4	Uplink Ports 97-108 (40/100 Gbps Ethernet or FCoE) Each of these ports can be 4 x 10/25 Gbps Ethernet or FCoE uplink ports when using a breakout cable.
5	System environment (fan fault) LED	6	System status LED
7	Beacon LED

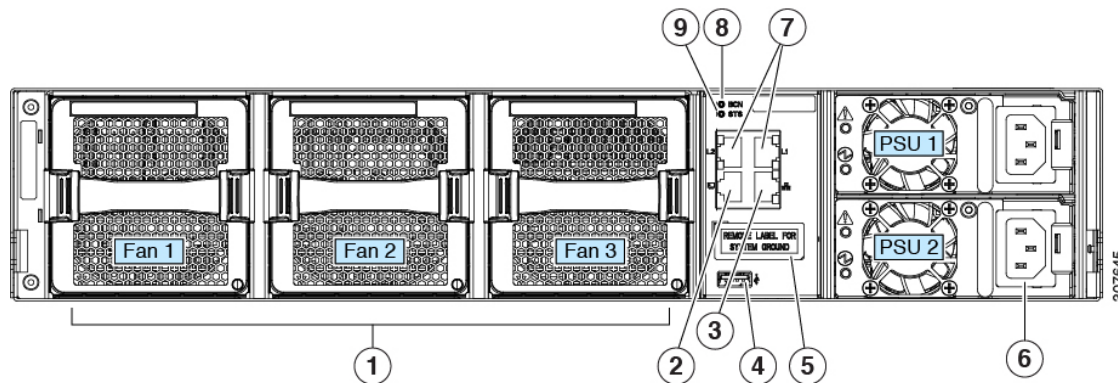
Figure 2: Cisco UCS 64108 Fabric Interconnect Front View

The Cisco UCS 64108 Fabric Interconnect has two power supplies (redundant as 1+1) and three fans (redundant as 2+1).

1	Cooling fans (hot swappable, 2+1 redundancy)	2	RS-232 serial console port (RJ-45 connector)
3	Network management port (RJ-45 connector)	4	USB port
5	Grounding pad for two-hole grounding lug (under protective label)	6	Power supplies Two identical AC or DC PSUs, hot-swappable, 1+1 redundancy)
7	L1/L2 high-availability ports (RJ-45 connector)	8	Beacon LED
9	System status LED

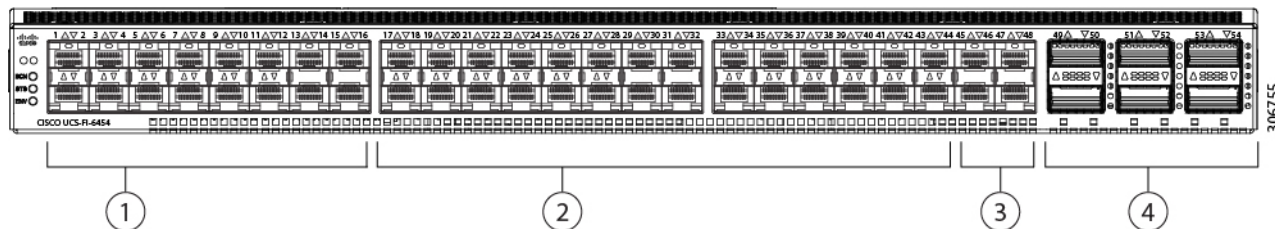
Figure 3: Cisco UCS 6454 Fabric Interconnect Rear View

1	Ports 1-16 (Unified Ports 10/25 Gbps Ethernet or FCoE or 8/16/32 Gbps Fibre Channel) Note When using Cisco UCS Manager releases earlier than 4.0(4), only ports 1-8 are Unified Ports.	2	Ports 17-44 (10/25 Gbps Ethernet or FCoE) Note When using Cisco UCS Manager releases earlier than 4.0(4), ports 9-44 are 10/25 Gbps Ethernet or FCoE.
3	Ports 45-48 (1/10/25 Gbps Ethernet or FCoE)	4	Uplink Ports 49-54 (40/100 Gbps Ethernet or FCoE) Each of these ports can be 4 x 10/25 Gbps Ethernet or FCoE uplink ports when using an appropriate breakout cable.

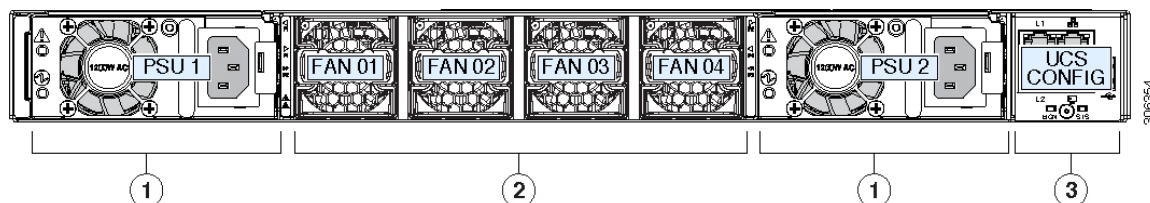
Figure 4: Cisco UCS 6454 Fabric Interconnect Front View

The Cisco UCS 6454 Fabric Interconnect chassis has two power supplies and four fans. Two of the fans provide front to rear airflow.

1	Power supply and power cord connector	2	Fans 1 through 4, numbered left to right, when facing the front of the chassis.
---	---------------------------------------	---	---

3	L1 port, L2 port, RJ45, console, USB port, and LEDs		
----------	---	--	--

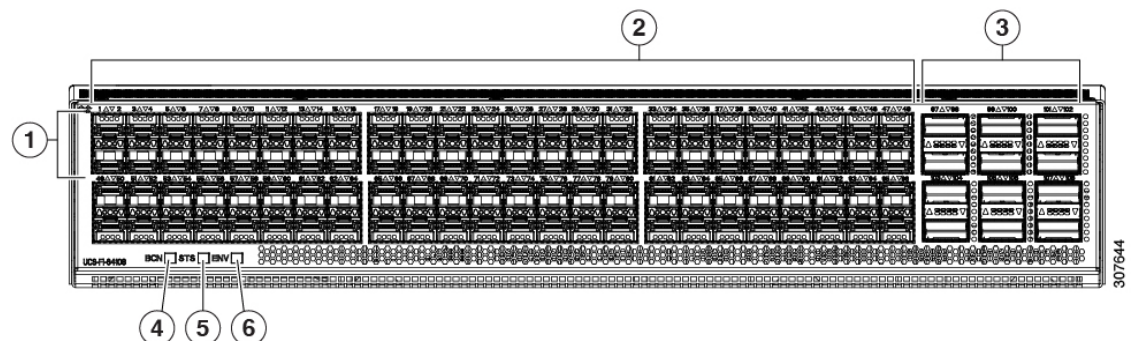
Figure 5: Cisco UCS 64108 Port Numbering

1	Ports 1-16 Unified ports: <ul style="list-style-type: none"> • 10/25 Gbps Ethernet or FCoE • 8/16/32 Gbps Fibre Channel 	2	Ports 1-96 (10/25 Gbps Ethernet or FCoE)
3	Uplink Ports 97-108 (40/100 Gbps Ethernet or FCoE) Each of these ports can be 4 x 10/25 Gbps Ethernet or FCoE uplink ports when using a breakout cable.	4	Ports 89-96 <ul style="list-style-type: none"> • 10/25 Gbps Ethernet or FCoE • 1 Gbps Ethernet
5	System environment (fan fault) LED	6	System status LED
7	Beacon LED

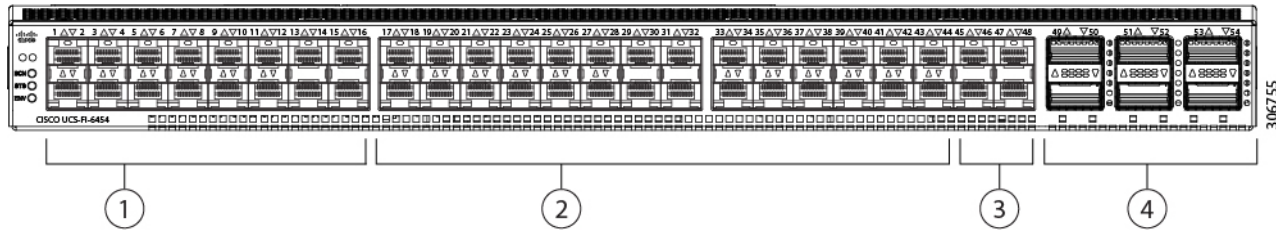
Figure 6: Cisco UCS 6454 Port Numbering

1	Ports 1-16 (Unified Ports 10/25 Gbps Ethernet or FCoE or 8/16/32 Gbps Fibre Channel) Note When using Cisco UCS Manager releases earlier than 4.0(4), only ports 1-8 are Unified Ports.	2	Ports 17-44 (10/25 Gbps Ethernet or FCoE) Note When using Cisco UCS Manager releases earlier than 4.0(4), ports 9-44 are 10/25 Gbps Ethernet or FCoE.
3	Ports 45-48 (1/10/25 Gbps Ethernet or FCoE)	4	Uplink Ports 49-54 (40/100 Gbps Ethernet or FCoE) Each of these ports can be 4 x 10/25 Gbps Ethernet or FCoE uplink ports when using an appropriate breakout cable.

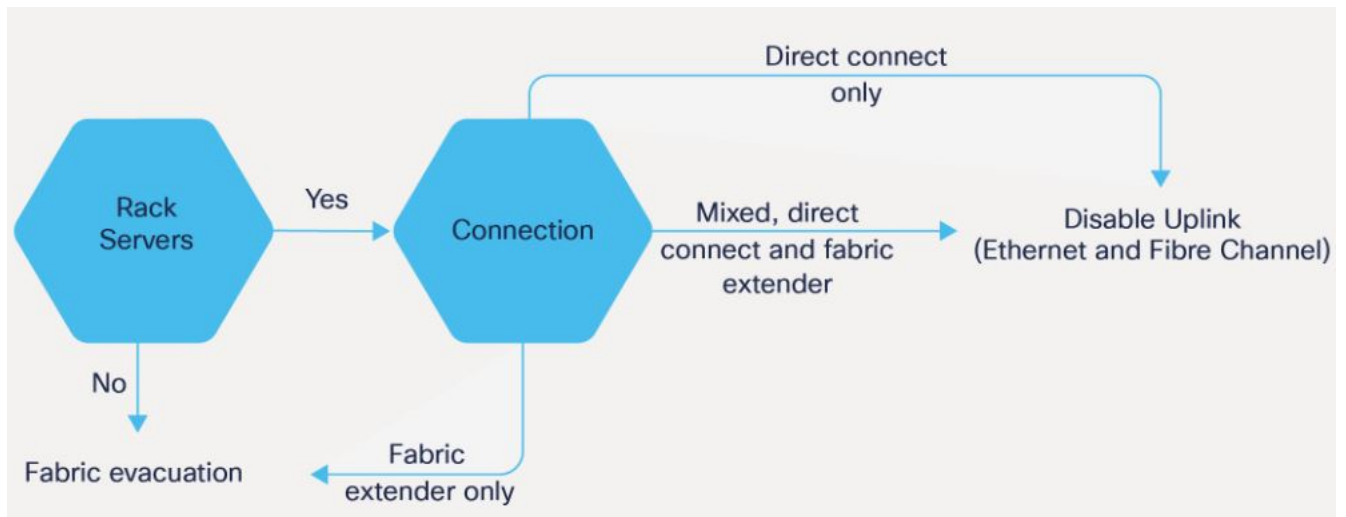
Move the traffic to the primary fabric interconnect(Cisco UCS 6454 or UCS 64108). This can be performed in two ways: fabric evacuation and uplink disablement. Use the below flowchart to choose between the two based on your Cisco UCS domain server and connectivity.

Note For direct-attached rack servers, only uplink disablement is supported.

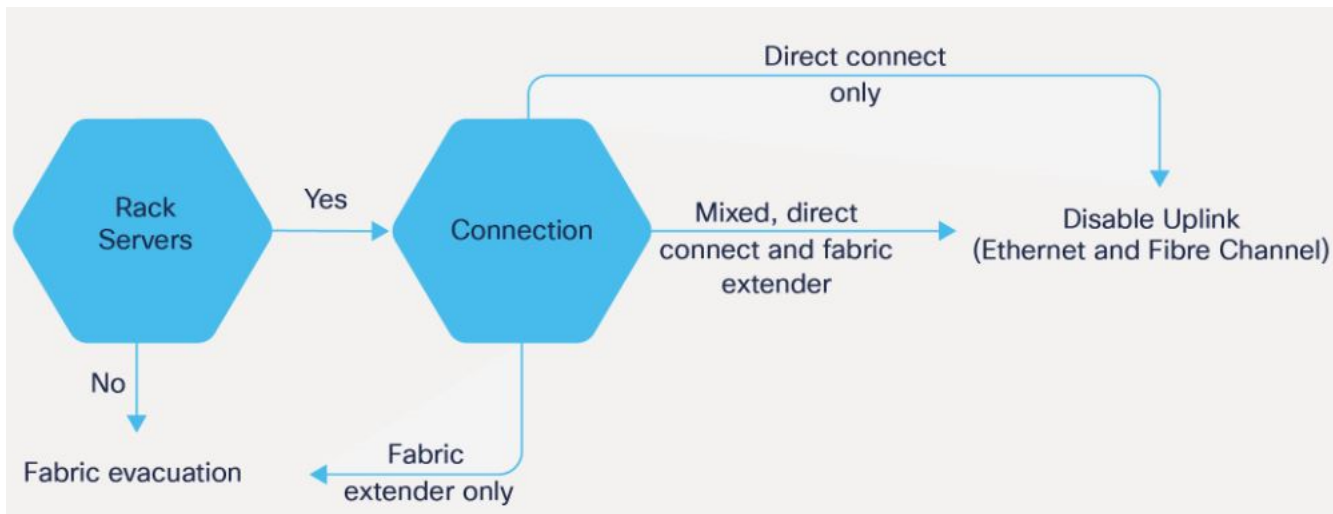
Move the traffic to the primary fabric interconnect (Cisco UCS 6454). This can be performed in two ways: fabric evacuation and uplink disablement. Use the below flowchart to choose between the two based on your Cisco UCS domain server and connectivity.

Note For direct-attached rack servers, only uplink disablement is supported.
