## Troubleshooting Cisco SLT Signaling

Several Cisco 2600 series modular access routers can be utilized as hardware components called Cisco Signaling Link Terminals (SLTs). Cisco SLTs function as signaling link interfaces to SS7 Signal Transfer Point (STP) mated pairs on the SS7 network side. On the LAN side, Cisco SLTs function as IP interfaces to the Cisco Media Gateway Controllers (MGCs). A number of different SS7 messages pass between the Cisco SLTs and STPs and between the Cisco SLTs and Cisco MGCs through Cisco Catalyst Multiswitch Routers (MSRs), which are used as LAN switches.

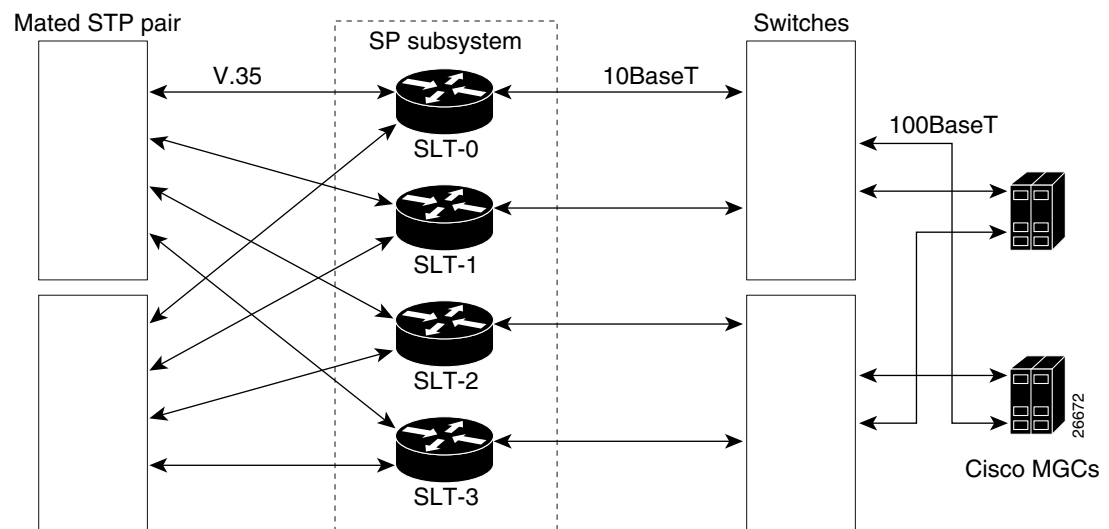
**Figure B-1** Cisco SLT Hardware and I/O Signaling

Each STP in a mated pair is constantly active under normal operating conditions. SS7 message traffic normally flows between both STPs of the mated pair and the Cisco SLTs, as shown in [Figure B-1](#).

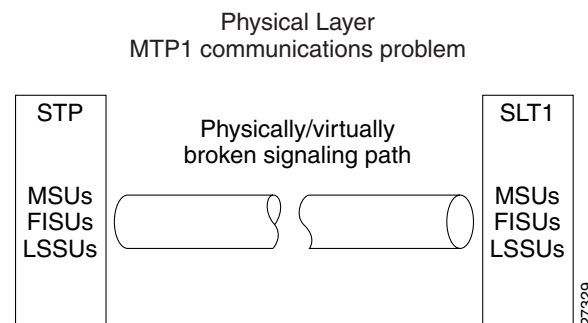
**Figure B-2 Physical Layer, MTP1 Communication Problems**

MTP1 standardizes SS7 signaling link physical connectivity. When an MTP1 problem occurs, there is a physical connection break or a virtual break (something that causes the symptoms of a physical connection break, such as no power to a card slot) in the signaling link path. A break is identified when no Message Signaling Unit (MSU), Fill-In Signaling Unit (FISU), or Link Status Signaling Unit (LSSU) traffic can be sent or received over the SS7 link. MTP1 communication problems are normally the result of either a hardware failure, a cabling problem, or a physical interface problem.

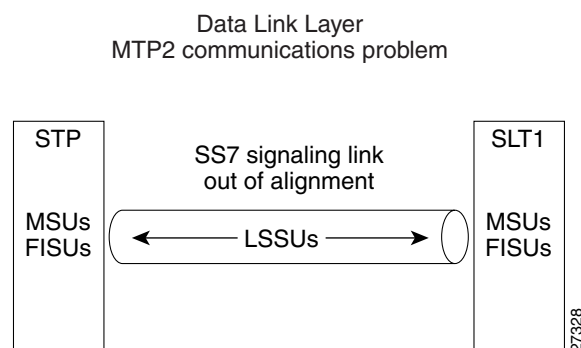
**Figure B-3 Data Link Layer, MTP2 Communication Problem**

MTP2 standardizes SS7 signaling link alignment. MTP2 communication problems occur when Cisco SLTs cannot establish data link alignment with STPs. When this happens the FISUs and MSUs cease to be transmitted. FISUs and MSUs are replaced by LSSUs whenever an SS7 link has good physical connectivity (MTP1), but cannot align to send and receive either FISU or MSU traffic.

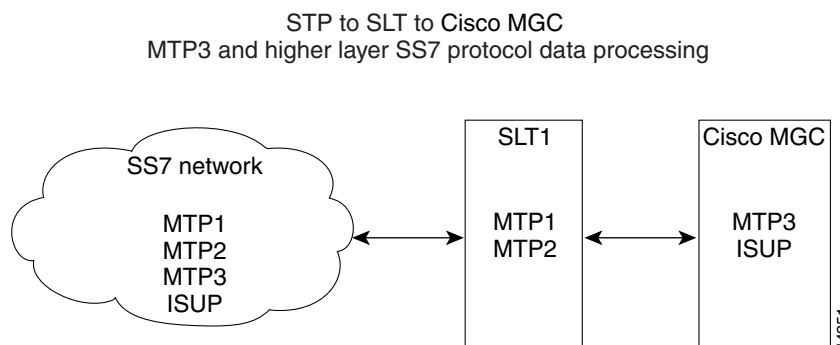
**Figure B-4 MTP3 and Higher-Layer SS7 Protocol Processing**

If a tested SS7 link has connectivity (MTP1) and alignment (MTP2), but SS7 error messages are reported by network management tools, then there is probably an MTP3 or higher layer SS7 communication problem. This problem requires testing to verify Cisco SLT operation.
