# Release Notes for Cisco Aironet 340 and 350 Series Access Points and 350 Series Bridges Running Firmware Version 12.01T

These release notes describe features and caveats for Cisco Aironet 340 and 350 Series Access Points and 350 Series Bridges running firmware version 12.01T.

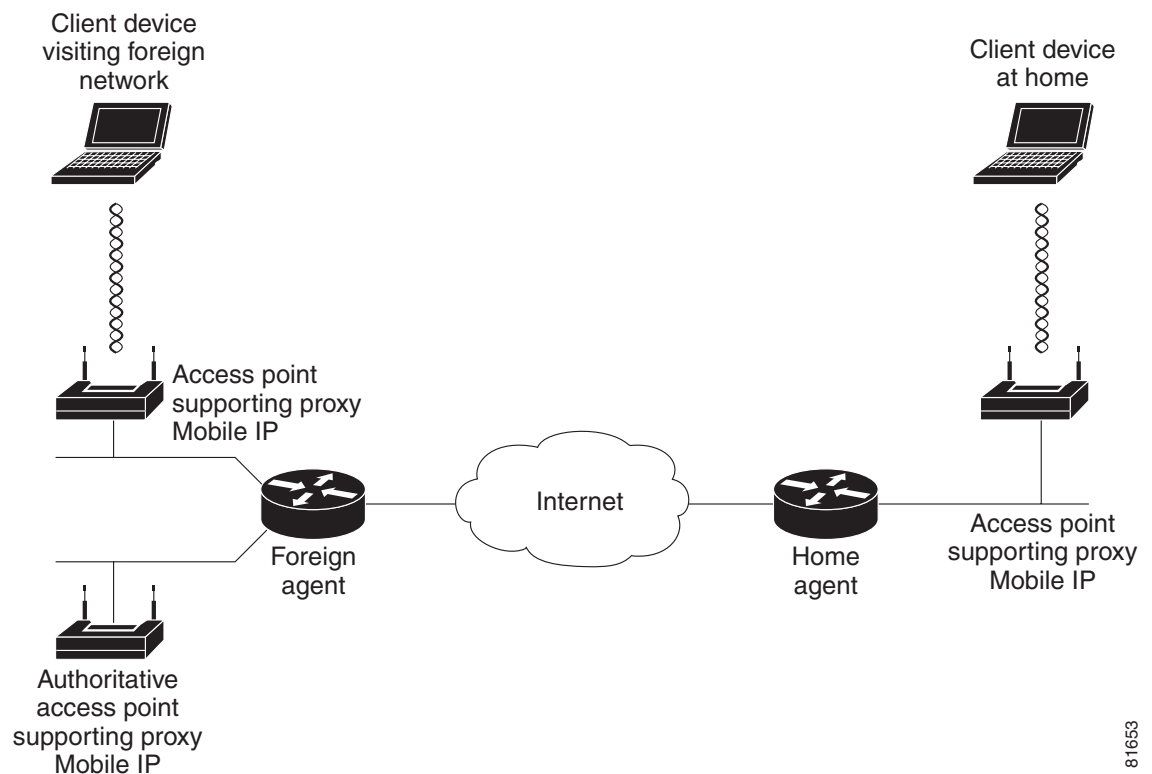
Figure 1 shows the five participating devices.

**Figure 1** Participating Devices in Proxy Mobile IP
