Release Notes for Cisco Aironet 340 and 350 Series Access Points and 350 Series Bridges Running Firmware Version 12.01T

These release notes describe features and caveats for Cisco Aironet 340 and 350 Series Access Points and 350 Series Bridges running firmware version 12.01T.

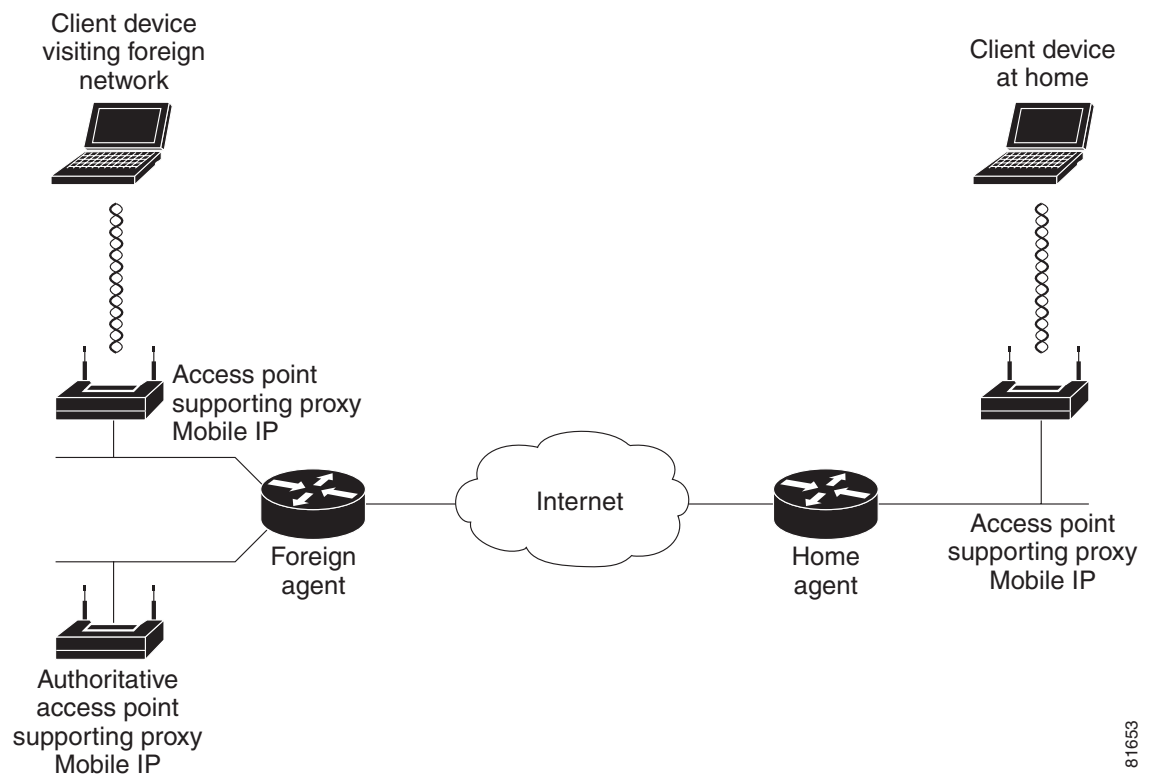
Figure 1 Participating Devices in Proxy Mobile IP

Figure 1 shows the five participating devices.
