# Release Notes for Cisco Aironet 1310 Outdoor Access Point/Bridge for Cisco IOS Release 12.3(2)JA5

September 12, 2005

These release notes describe caveats for Cisco IOS Release 12.3(2)JA5. They also provide important information about the Cisco Aironet 1310 Outdoor Access Point/Bridge (hereafter called the *access point/bridge*).

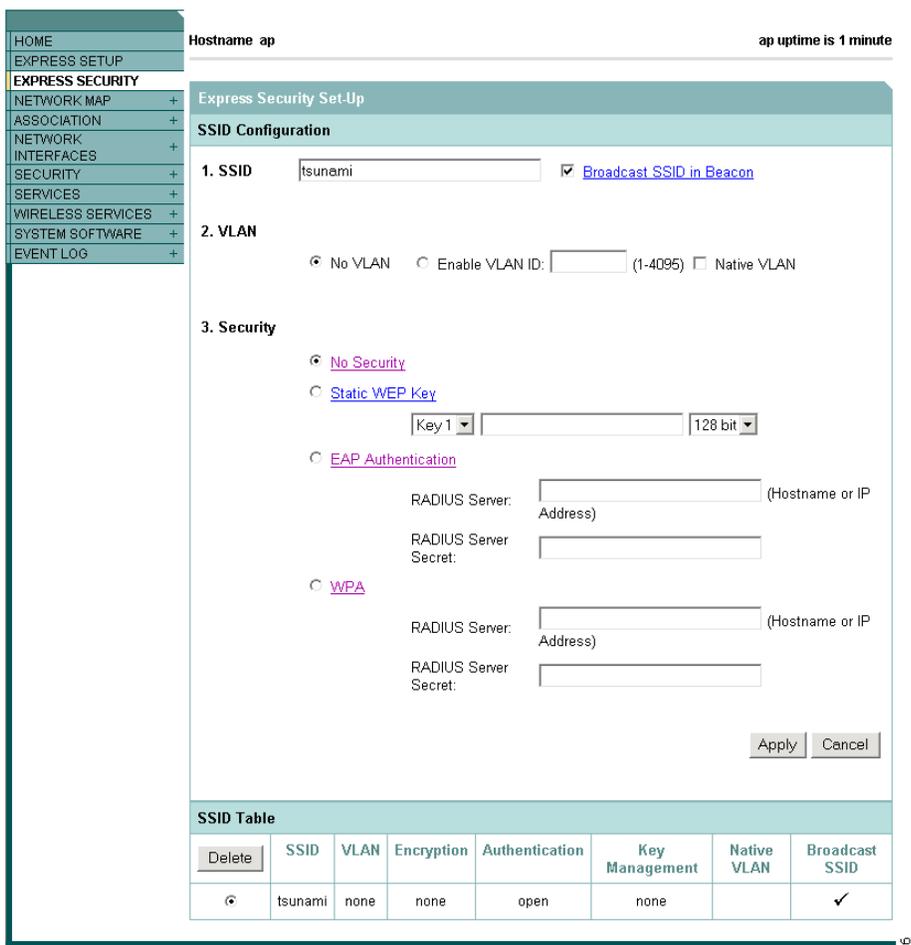
**Figure 1 Express Security Page**

The new Express Security page in the 1310 web-browser interface makes it easier to create SSIDs and assign security settings to them. [Figure 1](#) shows the Express Security page.

For complete instructions on using the Express Security page, see the “Configuring Basic Security Settings” section on page 2-11 in the *Cisco IOS Software Configuration Guide for Cisco Aironet Access Points*. Click this URL to browse to that document:  
[http://www.cisco.com/en/US/products/hw/wireless/ps4570/tsd\\_products\\_support\\_configure.html](http://www.cisco.com/en/US/products/hw/wireless/ps4570/tsd_products_support_configure.html)
