Release Notes for Cisco Aironet Access Points for Cisco IOS Release 12.3(8)JEC

October 25, 2007

These release notes describe minor features and caveats for Cisco IOS Release 12.3(8)JEC. They also provide important information about Cisco Aironet 1100, 1200, and 1230 series autonomous access points. The Cisco Aironet 350 series is no longer supported in this release or any future release.

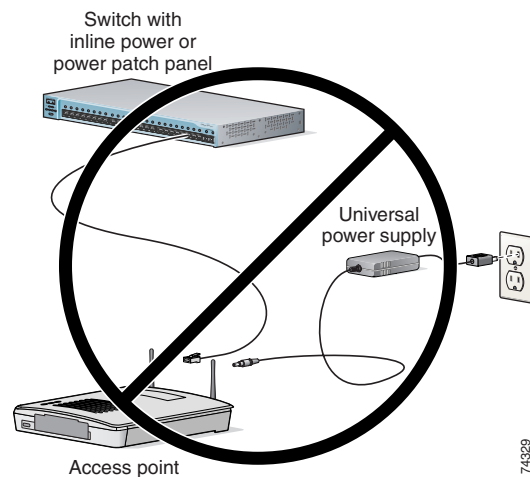
Figure 2 *Improper Power Configuration Using Two Power Sources*

You cannot provide redundant power to 1100 and 1200 series access points with both DC power to its power port and inline power from a patch panel or powered switch to the access point Ethernet port. If you apply power to the access point from both sources, the switch or power patch panel might shut down the port to which the access point is connected. [Figure 2](#) shows the power configuration that can shut down the port on the patch panel or powered switch.
