Release Notes for Cisco Aironet Access Points and Bridges for Cisco IOS Release 12.4(10b)JA

October 26, 2007

These release notes describe features, enhancements, and caveats for special technology early deployment release Cisco IOS Release 12.4(10b)JA. This release supports 32-MB Cisco autonomous access points, including Cisco Aironet 1130, 1240, and 1250 series access points, 1300 series access point/bridges, and 1400 series bridges.

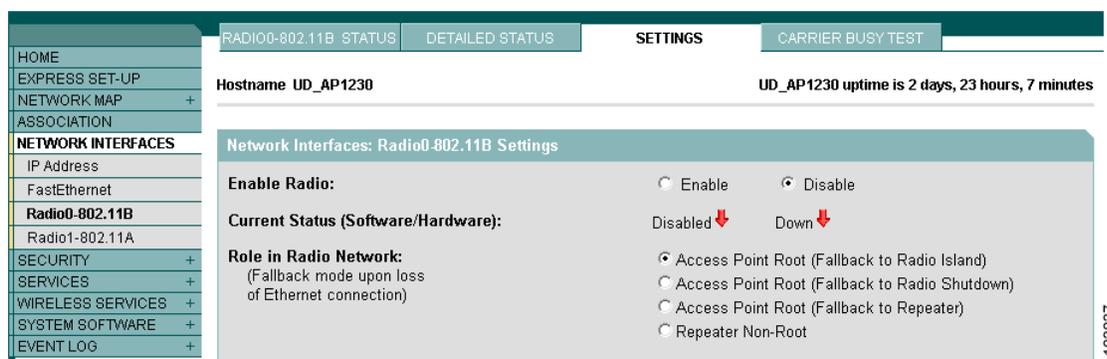
Figure 1 Network Interfaces: Radio Settings Page

- Step 1** Browse to the Network Interfaces: Radio Settings page. [Figure 1](#) shows the top portion of the Network Interfaces: Radio Settings page.

- Step 2** Select **Disable** to disable the radio.
- Step 3** Click **Apply** at the bottom of the page.
- Step 4** If your access point has two radios, repeat these steps for the second radio.

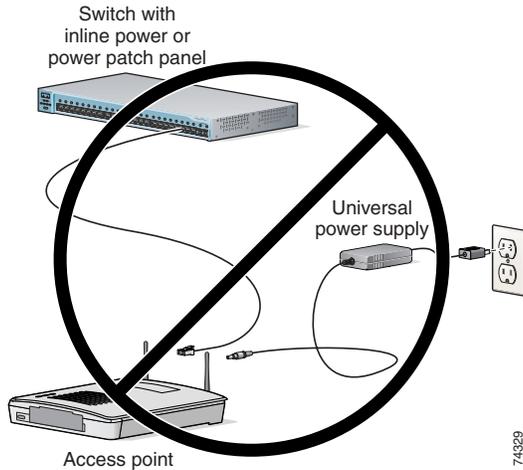
Figure 2 *Improper Power Configuration Using Two Power Sources*

You cannot provide redundant power to 1130 series access points with both DC power to its power port and inline power from a patch panel or powered switch to the access point Ethernet port. If you apply power to the access point from both sources, the switch or power patch panel might shut down the port to which the access point is connected. [Figure 2](#) shows the power configuration that can shut down the port on the patch panel or powered switch.
