Release Notes for Cisco Aironet Access Points and Bridges for Cisco IOS Release 15.2(2)JB6

This document describes features, enhancements, and caveats for autonomous mode access points using Cisco IOS Release 15.2(2)JB6.

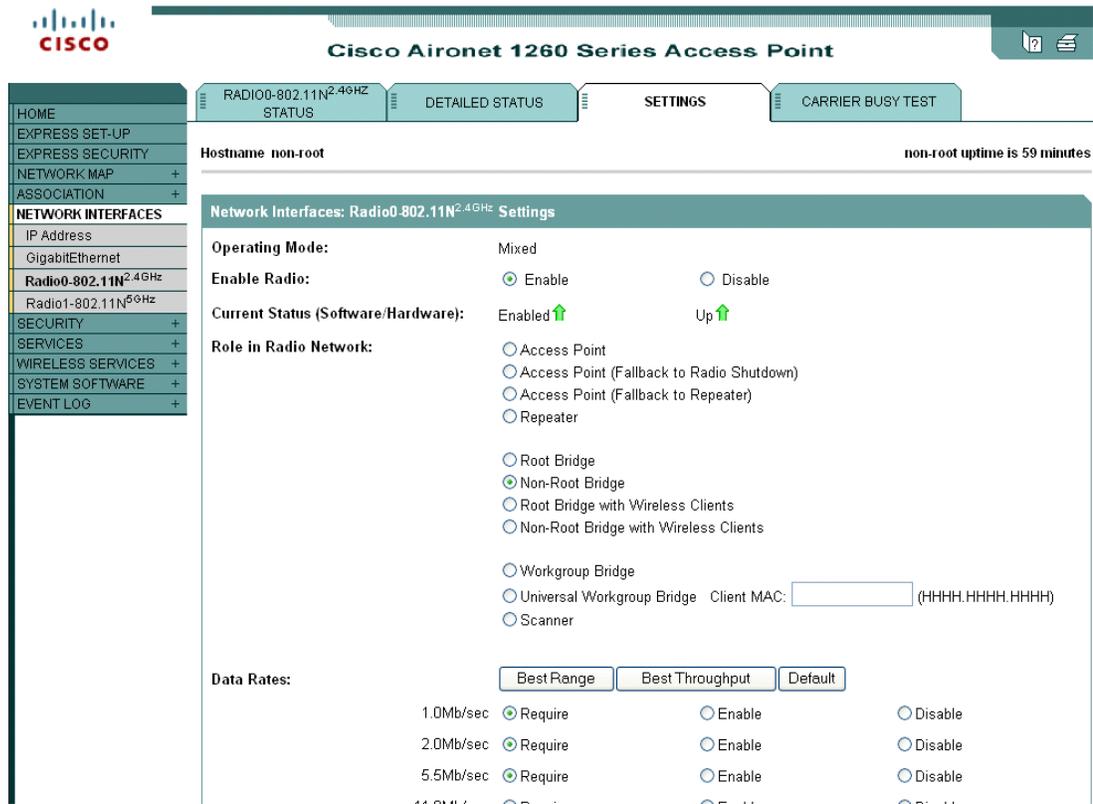
Figure 1 Network Interfaces: Radio Settings Page

-
- Step 1** Browse to the Network Interfaces: Radio Settings page. [Figure 1](#) shows the top portion of the Network Interfaces: Radio Settings page.

- Step 2 Choose **Disable** to disable the radio.
- Step 3 Click **Apply** at the bottom of the page.
- Step 4 If your access point has two radios, repeat these steps for the second radio.
