Release Notes for Cisco Wireless LAN Controllers and Lightweight Access Points for Release 4.1.181.0

July 23, 2007

These release notes describe open and resolved caveats for software release 4.1.181.0 for Cisco 2000, 2100, and 4400 Series Wireless LAN Controllers; Cisco Wireless Services Modules (WiSM); Cisco Wireless LAN Controller Network Modules; Catalyst 3750G Integrated Wireless LAN Controller Switches; Cisco 3201 Wireless Mobile Interface Cards (WMICs); and Cisco Aironet 1000, 1100, 1130, 1200, 1240, 1300, and 1500 (1505 and 1510) Series Lightweight Access Points, which comprise part of the Cisco Unified Wireless Network (UWN) Solution.

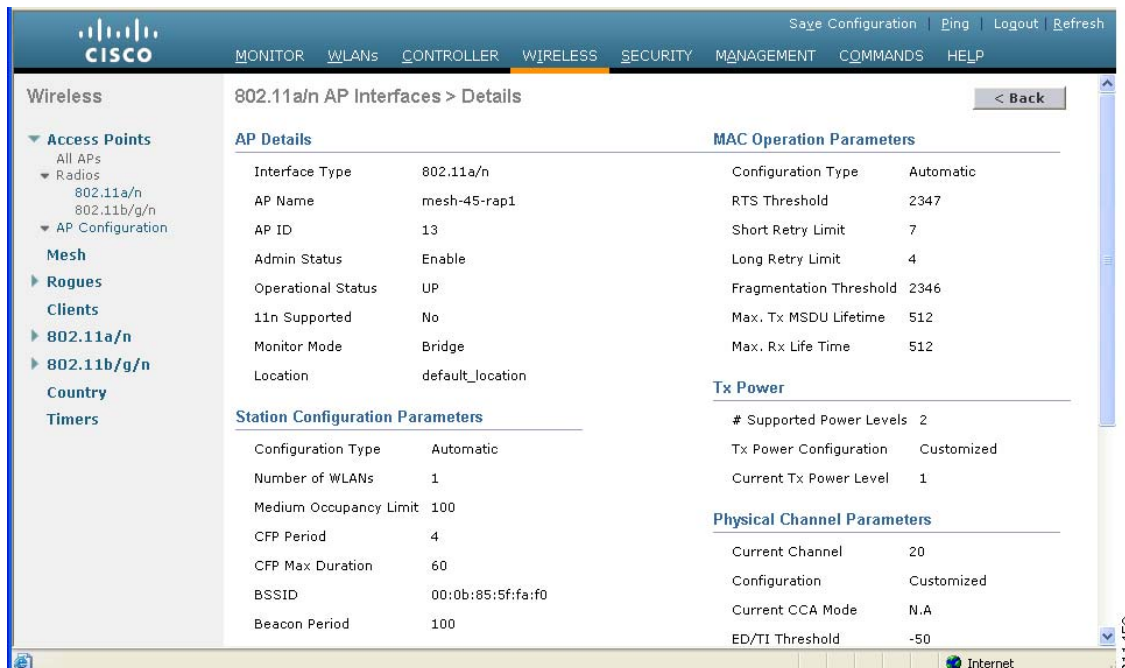
Figure 1 802.11a/n AP Interfaces > Details Page

This page shows the current transmit power level under the “Tx Power” section.

-
- Step 1** Click **Wireless > Access Points > Radios > 802.11a/n** or **802.11b/g/n** to access the 802.11a/n (or 802.11b/g/n) Radios page.
- Step 2** Hover your cursor over the blue drop-down arrow for the desired access point and choose **Detail**. The 802.11a/n (or 802.11b/g/n) AP Interfaces > Details page appears (see [Figure 1](#)).
