# Actualización del firmware del router Cisco y los módulos PIM

Este documento describe el proceso de actualización de los routers compatibles con Cisco Cellular y los módulos PIM P-5GS6-GL, P-5GS6-R16SA-GL y sus firmware de módem.

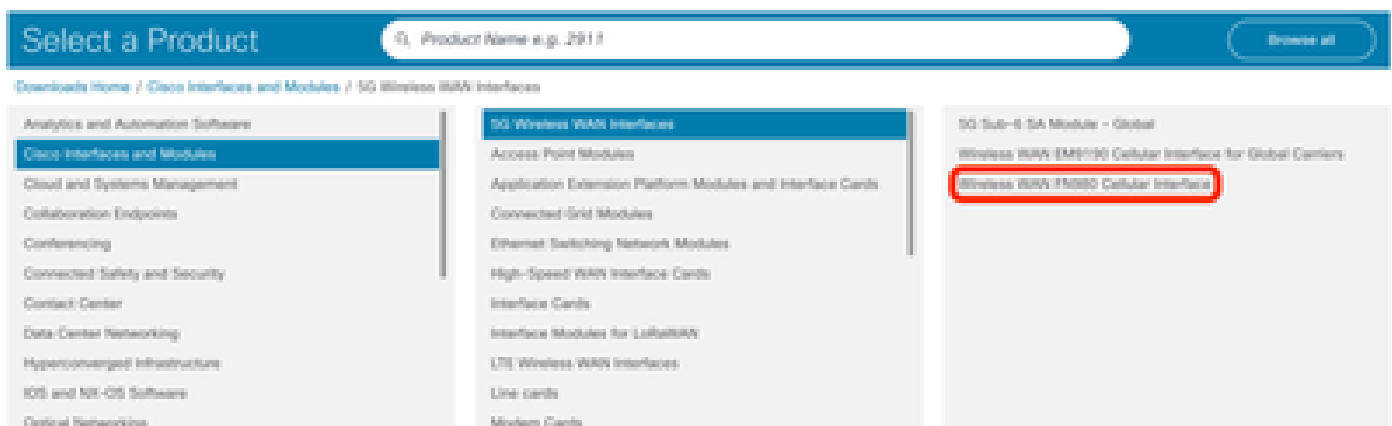
2. Descargue el archivo correcto de software.cisco.com.

Para este ejemplo:

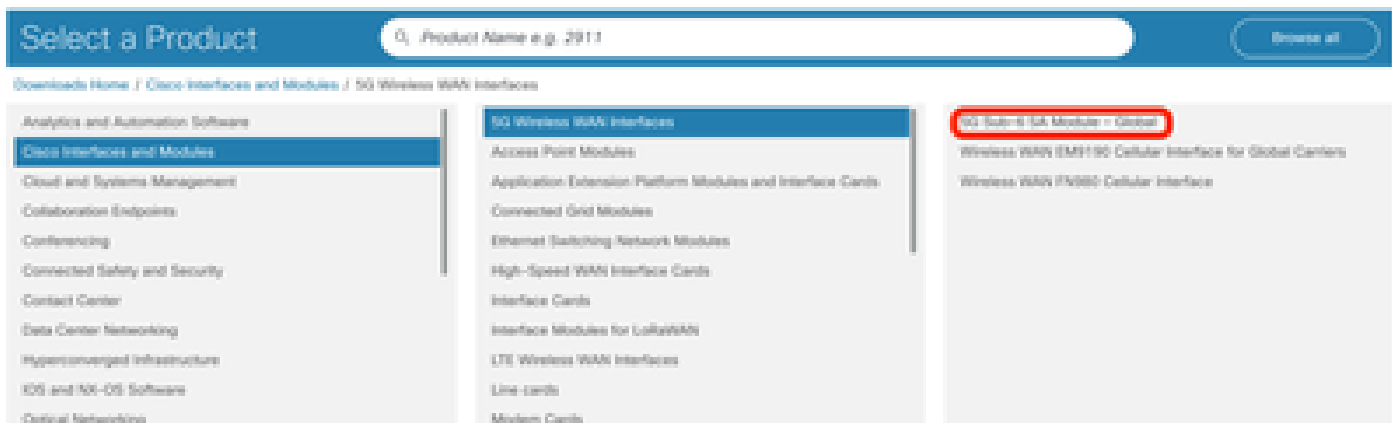
Si el modelo es EM9293, los archivos se deben descargar de la siguiente sección:
