帧中继到 ATM 服务互工作 (FRF.8) 的端到端 PVC 管理

在FRF.8实施协议，[宽带论坛](#) (以前帧中继论坛)定义了相互作用或连接两份第2层协议的帧中继终点和-ATM端点通过路由器或交换机之间的通信。[本文描述在FRF.8服务互通\(IWF\)使用路由器和交换机，连接的永久虚拟电路\(PVC\)管理计划并且提供配置示例。](#)

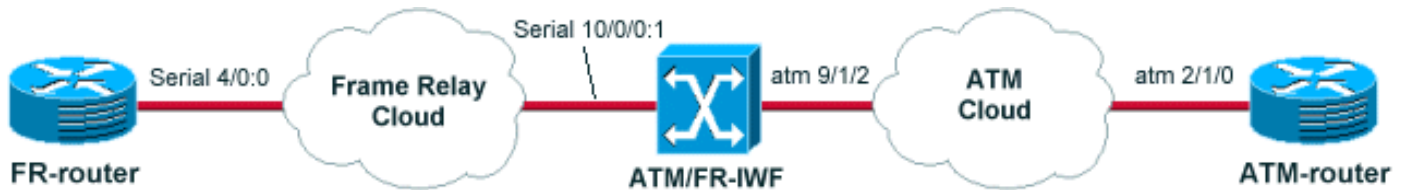
网络图

拓扑出现如下：

注意：ATM路由器是7500路由器使用在VIP2-50和?发器12.1(13)E的一PA-A3-OC3MM。帧中继路由器是7200路由器运行12.1(17)。ATM/FR-IWF-switch是运行12.1(12c)EY的Catalyst 8540MSR。
