在Catalyst 9800上為移動部署配置URWB

簡介

本檔案介紹使用支援URWB且與Catalyst 9800系列WLC關聯的AP進行行動化部署的組態。

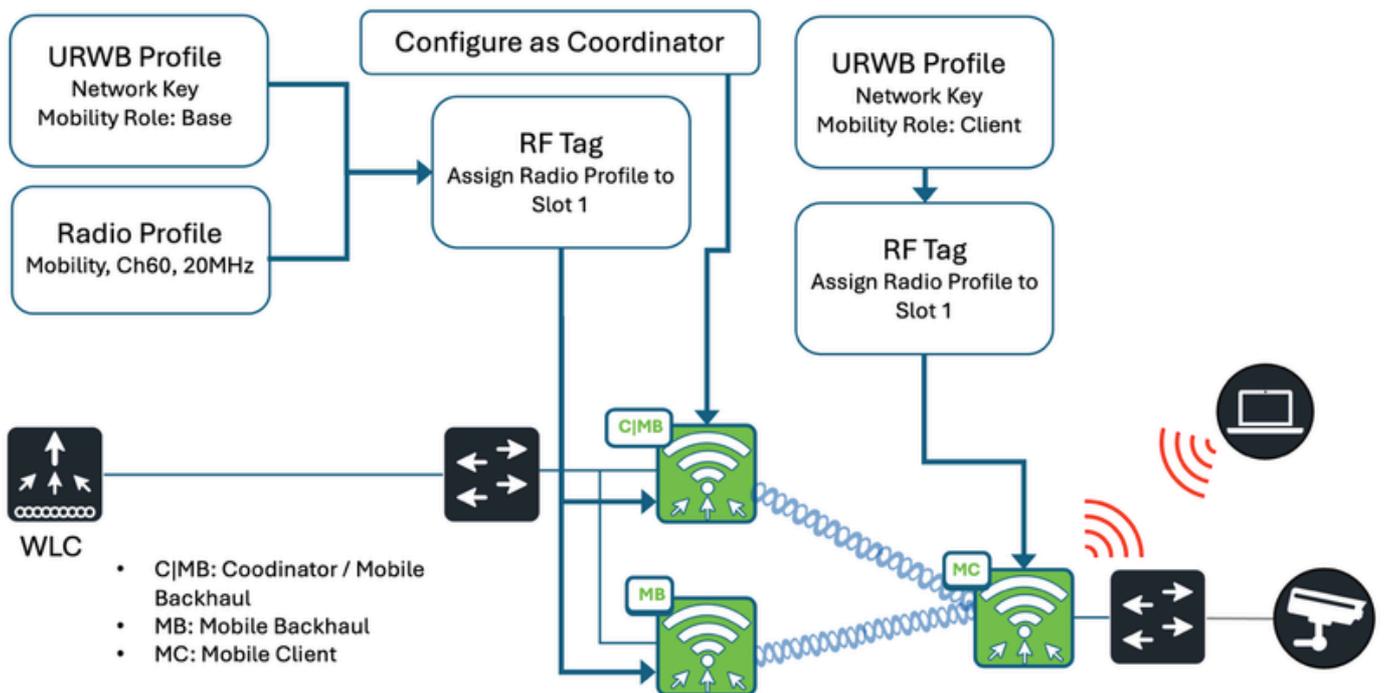
Example: Simple URWB mobility network

使用Catalyst 9800控制器CLI的URWB行動化網路拓撲

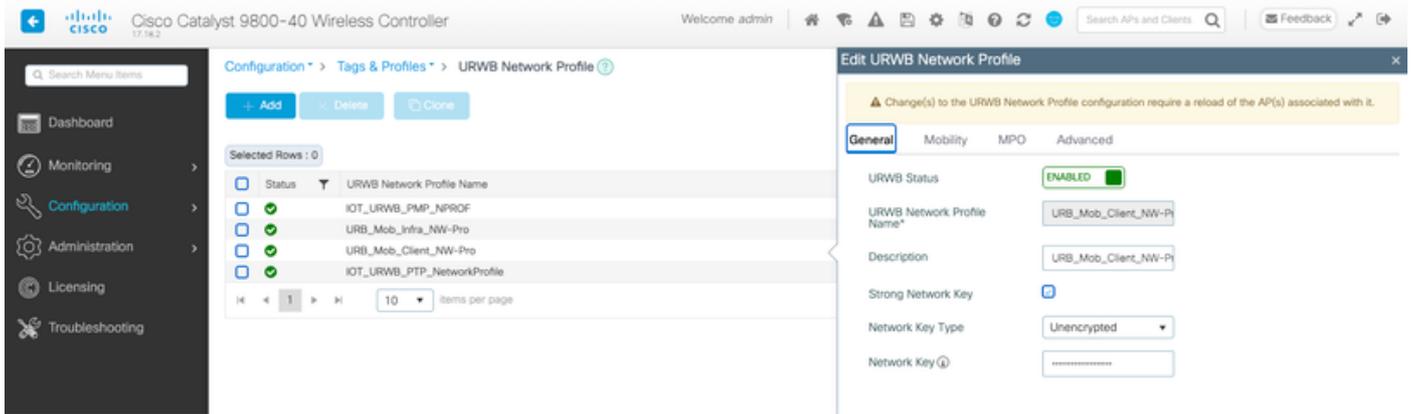
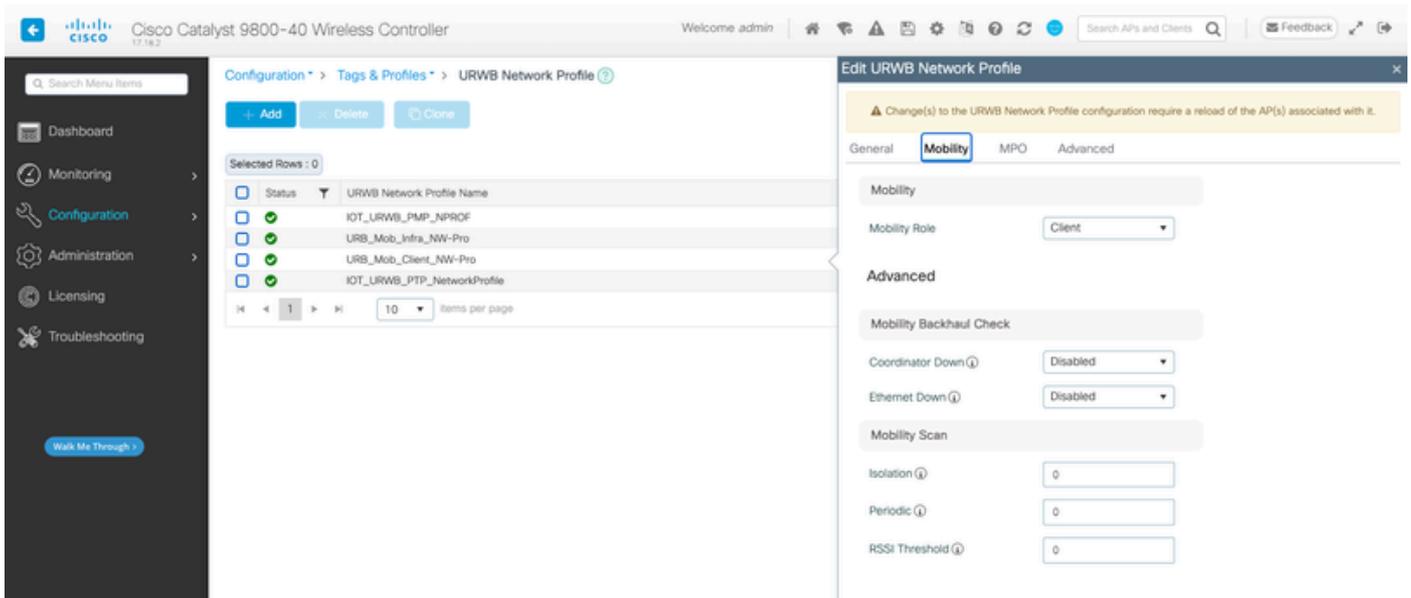
行動化使用者端的網路設定檔

```
wireless profile urwb URB_Mob_Client_NW-Pro
description URB_Mob_Client_NW-Pro
strong-network-key
network-key key 0 S3cretK3y8675309!!!
mobility role client
no shutdown
```

附註：在移動集群中，所有基礎裝置和客戶端裝置的網路金鑰必須相同，才能建立MPLS隧道並彼此通訊。

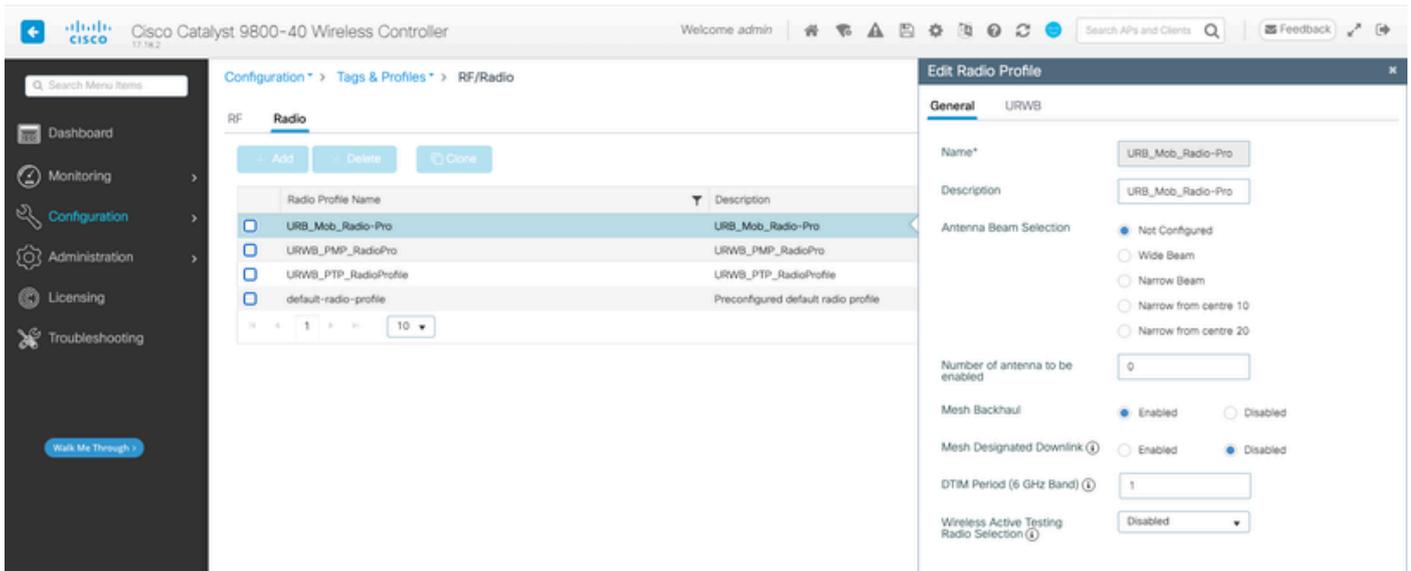
配置無線電配置檔案

(Configuration -> Tags and Profiles -> Radio -> Radio頁籤)

wireless profile radio URB_Mob_Radio-Pro
description URB_Mob_Radio-Pro
urwb channel 5Ghz 60
urwb role mobility

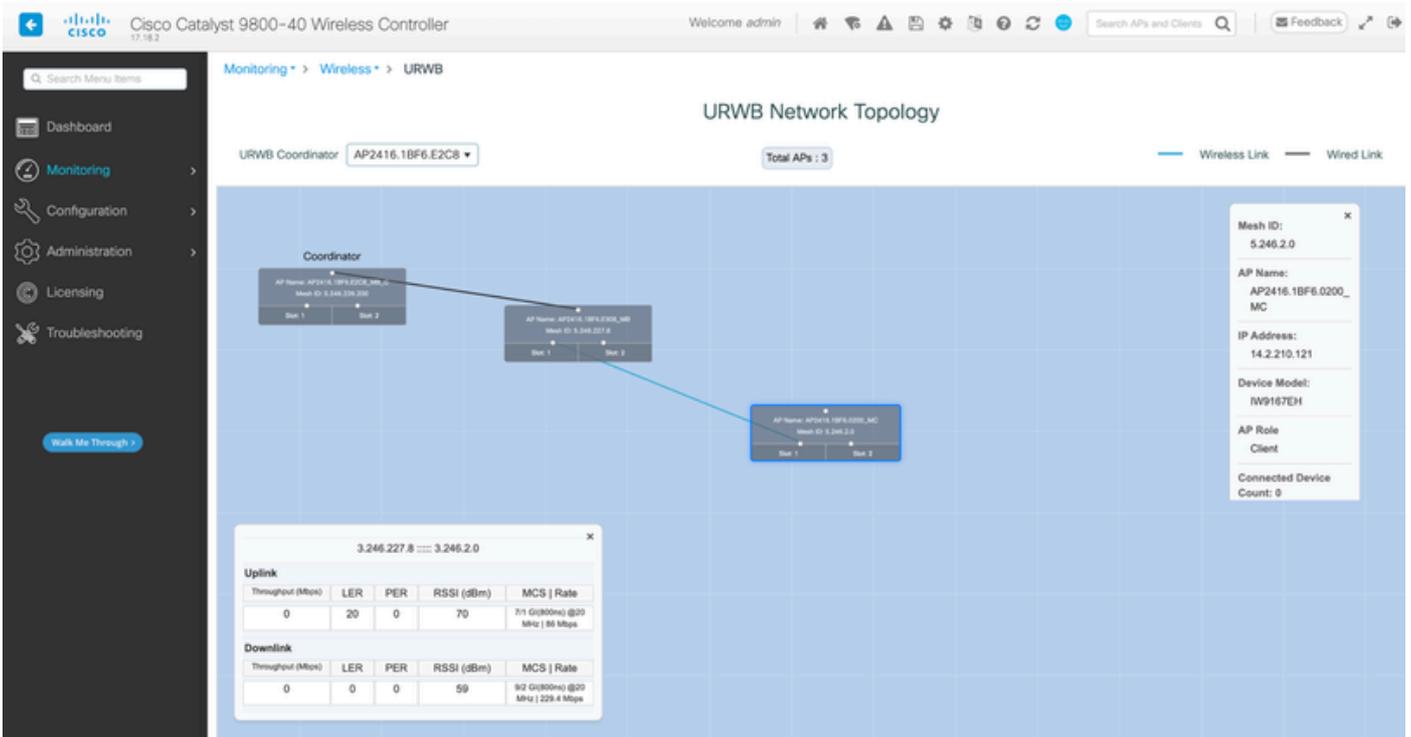
(監控 —>無線 —> URWB)

URWB網路拓撲允許您檢查上行鏈路和下行鏈路的不同網路關鍵引數索引值，例如LER (鏈路錯誤率)、PER (資料包錯誤率)、RSSI (訊號強度)、吞吐量等。

配置完所有設定後，儲存配置並應用更改。如果AP沒有自動重置，它仍可能需要重置以使更改生效。AP表指示AP是否需要重新載入。如果需要，可以從C9800重新載入。一旦接入點(AP)重新啟動並且無線電重新聯機，您就可以從「天線對齊」頁檢查RSSI，並從「URWB網路拓撲」頁監控即時連線。
