Release Notes for Cisco MGX 8950, Software Release 3.0.00

About Release 3.0.00

These release notes describe the system requirements, new features, and limitations that apply to Release 3.0.00 of the MGX 88950 multi-service switch. These notes also contain Cisco support information.

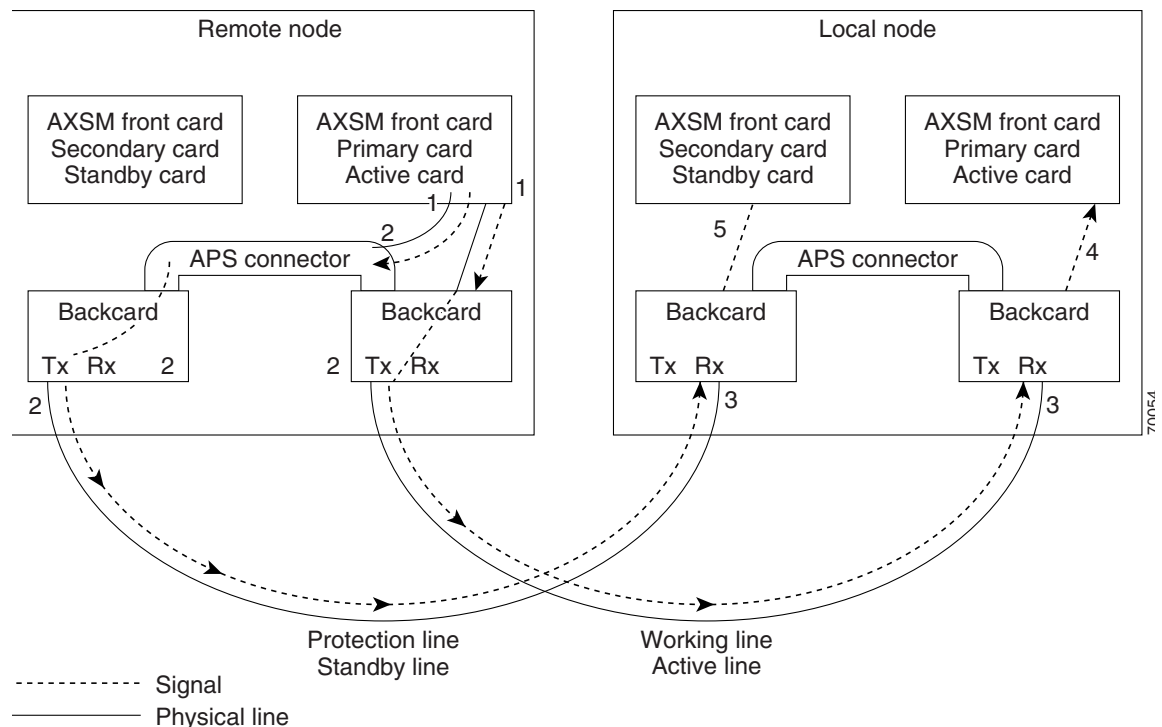
Figure 1 Standard APS Configuration

Figure 1 shows an example of how this process operates in a standard APS configuration, where the primary card monitors the working line and the secondary card monitors the protection line.

1. The signal leaves the front card at the remote end of the line. (See Figure 1 and Figure 2.)

2. The signal passes through the APS connector and both back card transmit ports at the remote end of the line. (See Figure 1 and Figure 2.)
3. The signal travels through both communication lines to the receive ports on both back cards at the local end. (See Figure 1 and Figure 2.)
4. The active front card processes the signal that is received on the active line. (See Figure 1 and Figure 2.)
5. The standby card monitors only the status of the standby line. (See Figure 1 and Figure 2.)
6. If necessary, the signal passes through the APS connector to the front card. (See Figure 2.)

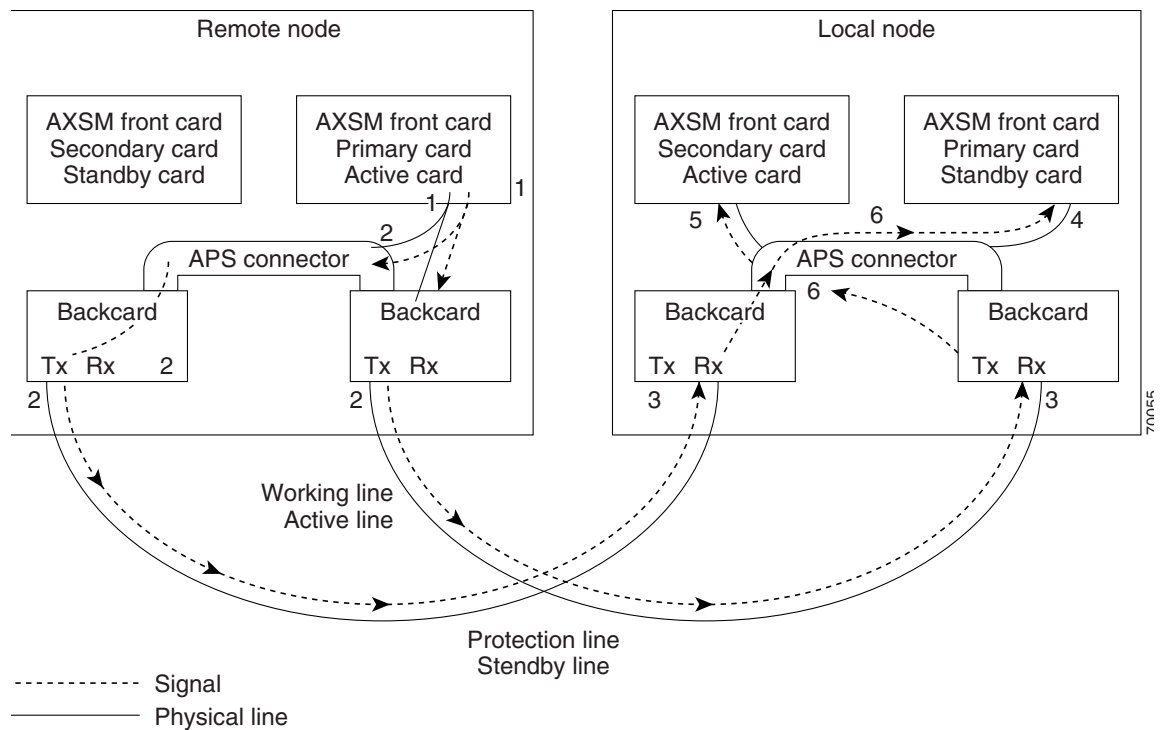
Figure 2 Crossed APS Configuration

Figure 2 shows an example of how the APS communication process operates in a crossed APS configuration, where the secondary card monitors the working line that is attached to the primary card, and the primary card monitors the protection line that is connected to the secondary card.
