# Release Notes for Cisco MGX 8950, Software Release 3.0.10

These release notes are part OL-2915-01 Rev. D0, July 3, 2003

These release notes describe the system requirements, new features, and limitations that apply to Release 3.0.10 of the MGX 8950 multiservice switch. These notes also contain Cisco support information.

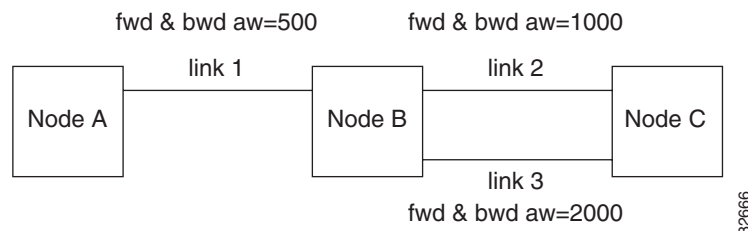
**Figure 1 Configuration Example for rteopt via Parallel Link**

The configuration for [Figure 1](#) and the scenarios in this section are as follows:

- Link 1 has forward and backward admin weight set to 500 (via `cnfnpni-intf`).
- Link 2 has forward and backward admin weight set to 1000.
- Link 3 has forward and backward admin weight set to 2000.
- SPVC connection is routed from Node A to Node C (Master endpoint is at Node A) via link 1 and link 2.

This section lists limitations for rteopt via parallel link. Use [Figure 1](#) as you work through the scenarios in this section.

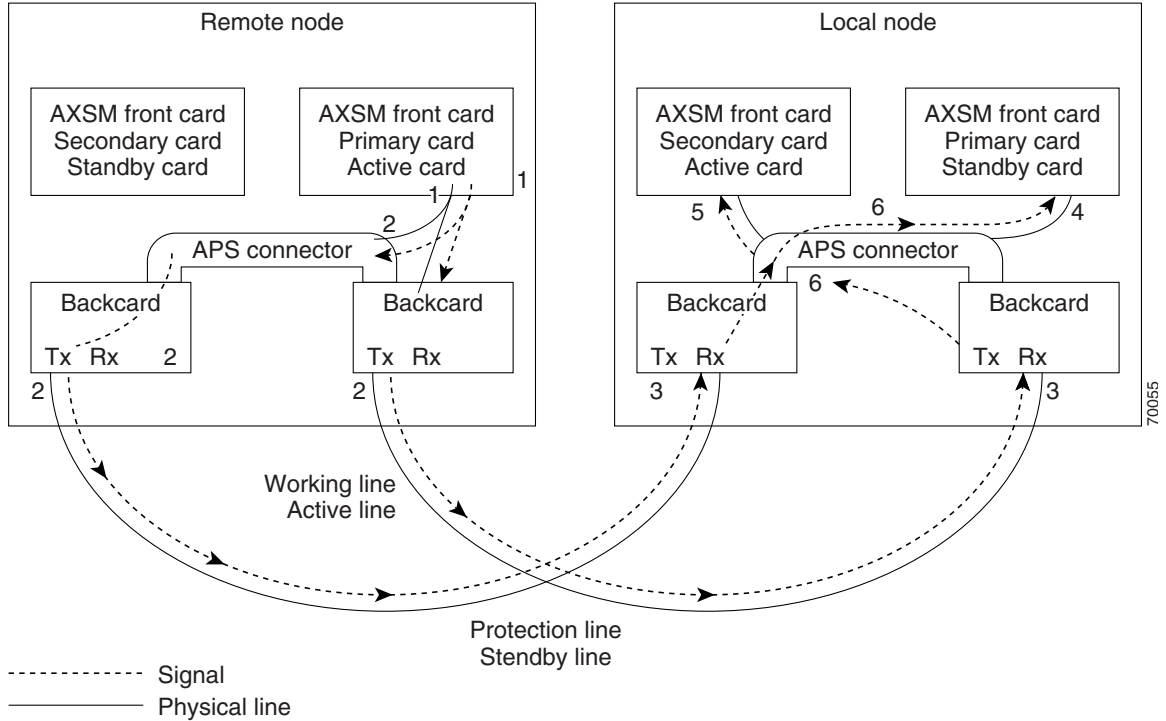
**Figure 3** Crossed APS Configuration

Figure 3 shows an example of how the APS communication process operates in a crossed APS configuration, where the secondary card monitors the working line that is attached to the primary card, and the primary card monitors the protection line that is connected to the secondary card.

1. The signal leaves the front card at the remote end of the line. (See [Figure 2](#) and [Figure 3](#).)
2. The signal passes through the APS connector and both back card transmit ports at the remote end of the line. (See [Figure 2](#) and [Figure 3](#).)
3. The signal travels through both communication lines to the receive ports on both back cards at the local end. (See [Figure 2](#) and [Figure 3](#).)
4. The active front card processes the signal that is received on the active line. (See [Figure 2](#) and [Figure 3](#).)
5. The standby card monitors only the status of the standby line. (See [Figure 2](#) and [Figure 3](#).)
6. If necessary, the signal passes through the APS connector to the front card. (See [Figure 3](#).)
