# Release Notes for Cisco MGX 8850 (PXM1E/PXM45), Cisco MGX 8950, and Cisco MGX 8830, Software Version 4.0.17

These release notes are part number OL-6748-01 Rev. C0, April 5, 2005.

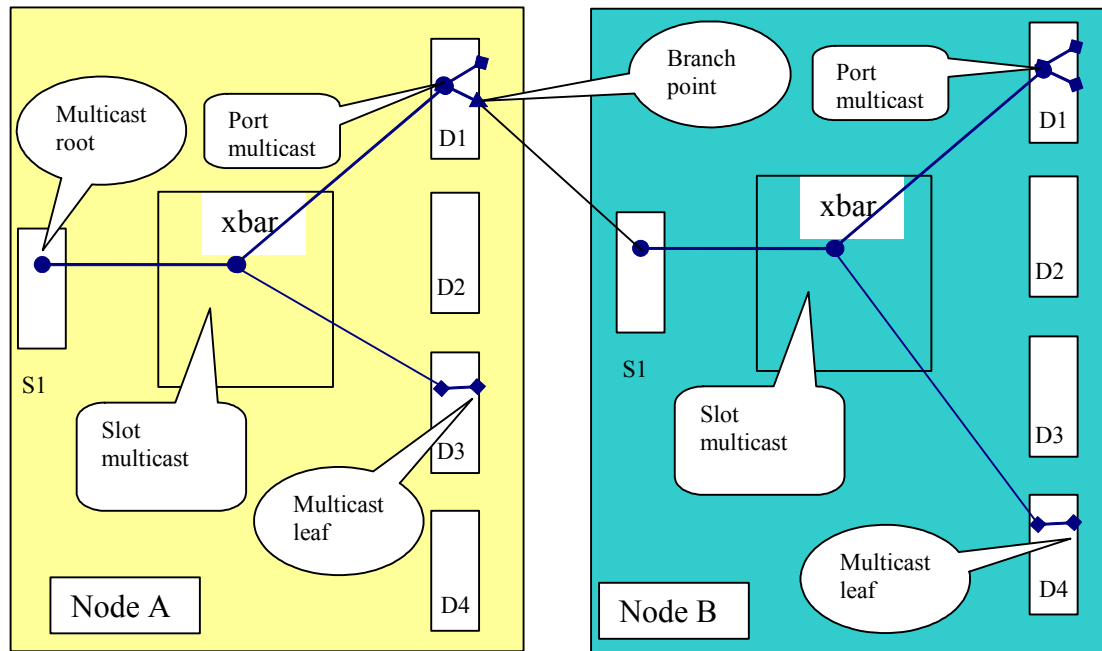
**Figure 1 Replicating Traffic**

The capability to replicate ATM traffic on an MGX varies with the type of hardware used. Figure 1 shows the replication mechanism in MGX and the limitations associated with specific hardware.

In Figure 1, D1–D4 are destination cards in an MGX Node A. S1 is a source card on Node A, where the root endpoint of the P2MP connection is provisioned.

In this example, a P2MP connection has leaves on D1 and D3 of Node A and on D1 and D4 of Node B. The first stage of multicast is called the slot multicast, which is performed by the crossbar module on the MGX. Although the replication takes place on the crossbar, the slots toward which replication should take effect is instructed by the source card S1 on Node A.

Some of the destination cards might not be able to perform the port multicast operation. For example, in [Figure 1](#) if D4 on Node B is incapable of doing port multicast and if there were multiple leaves on it, the replication needs to be performed at D1 on Node A. In this case, two connections would carry the same data from Node A to Node B.

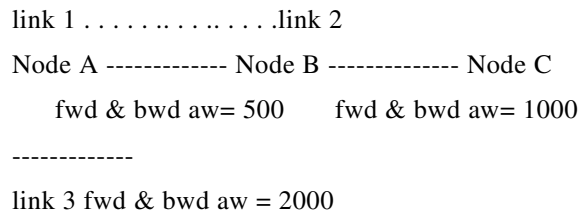
### Limitations for rteopt via parallel links

The following are limitations for rteopt via parallel link.

Configuration:

- link 1 has forward and backward admin weight set to 500 (via cnfpnni-intf)
- link 2 has forward and backward admin weight set to 1000
- link 3 has forward and backward admin weight set to 2000
- SPVC connection is routed from Node A to Node C (Master endpoint is at Node A) via link 1 and link 2
