Release Notes for Cisco MGX Route Processor Module (RPM-XF) for MGX 8850 Release 3.0.00 (PXM45)

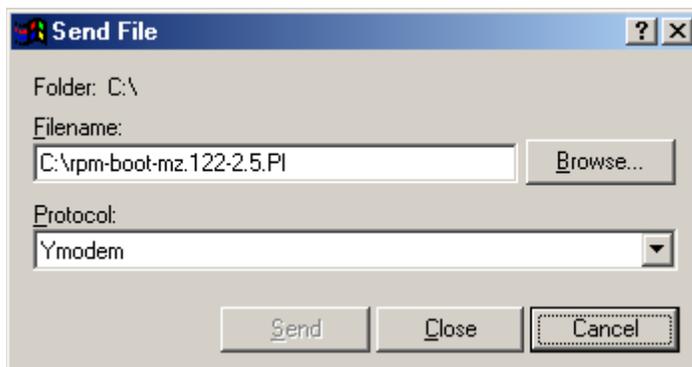
Step 4 Use the Transfer-->Send File option in HyperTerminal to start the image transfer.

In the Filename box, browse and choose the image file to be downloaded. Also since we used the “y” option while invoking the xmodem, set the transfer protocol to ymodem or use Xmodem protocol by not specifying the `-y` option on the command line.
