Release Notes for Cisco MGX Route Processor Module (RPM-XF) IOS Release 12.2(15)T5 for MGX 8850 and MGX 8950 Release 4.0.10 (PXM45)

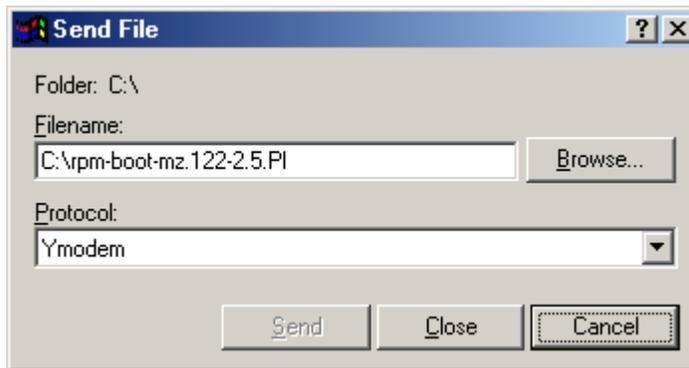
Step 3 Use the Transfer-->Send File option in HyperTerminal to start the image transfer.

In the Filename box, browse and choose the image file to be downloaded. Also since we used the “y” option while invoking the xmodem, set the transfer protocol to ymodem or use Xmodem protocol by not specifying the –y option on the command line.

The transfer screen comes up and transfer starts. (The transfer may not start immediately; wait for some time and it should start.)
