Release Notes for Cisco MGX Route Processor Module (RPM-XF) IOS Release 12.2(11)YP2 for MGX 8850 and MGX 8950 Release 3.0.10 (PXM45)

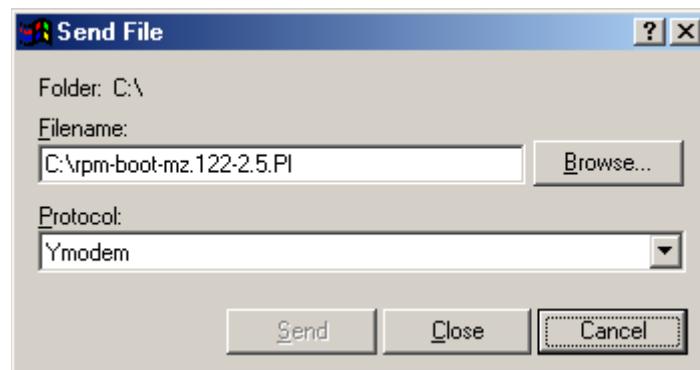
- Step 3** Use the Transfer-->Send File option in HyperTerminal to start the image transfer.

In the Filename box, browse and choose the image file to be downloaded. Also since we used the “y” option while invoking the xmodem, set the transfer protocol to ymodem or use Xmodem protocol by not specifying the –y option on the command line.

The transfer screen comes up and transfer starts. (The transfer may not start immediately; wait for some time and it should start.)
