Text Part Number: 78-10307-01

1.1.21 Version Software Release Notes

Cisco WAN MGX 8850 Software

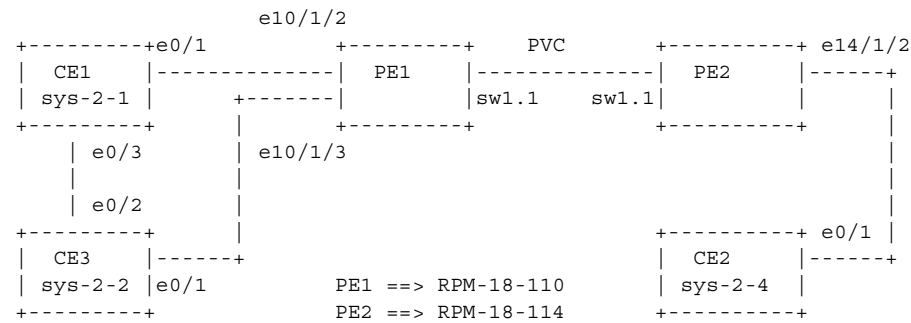
The following is a one PE and two CE VPN configuration.

Note Both RPMs are in the same shelf or chassis.

One PE - Two CE Configuration - OSPF & IBPG Between PEs & EBGp between PE-CE

CE1 Configuration:
