## 1.1.24 Version Software Release Notes

### Cisco WAN MGX 8850, 8230, and 8250 Software

## About the 1.1.24 Release

This is a maintenance release including all features supported up to release 1.1.23. The 1.1.24 release supports two new switches, the MGX 8230 and the MGX 8250.

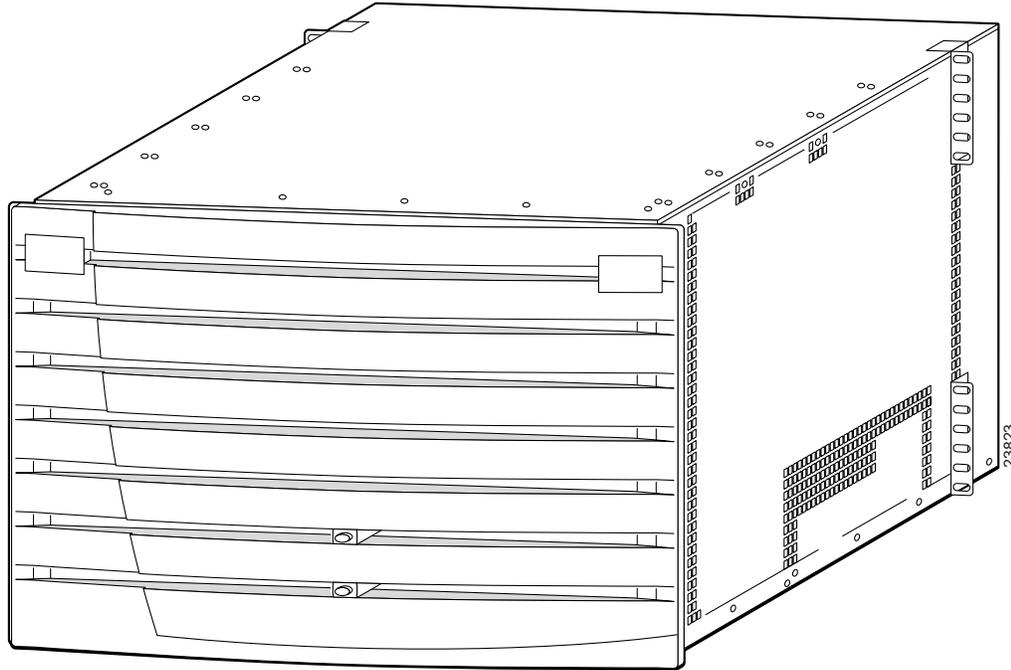
Figure 1 MGX 8230 with Door Attached

Figure 1 shows the MGX 8230 with its door attached. Note that there are light pipes in the door that display the status of the processor models (PXMs). Figure 2 is a conceptual drawing of an MGX 8230 showing the dimensions and the slot numbering. The slot numbering is as it appears from the front of the MGX 8230; slots 8 and 9 refer to back card slots only.

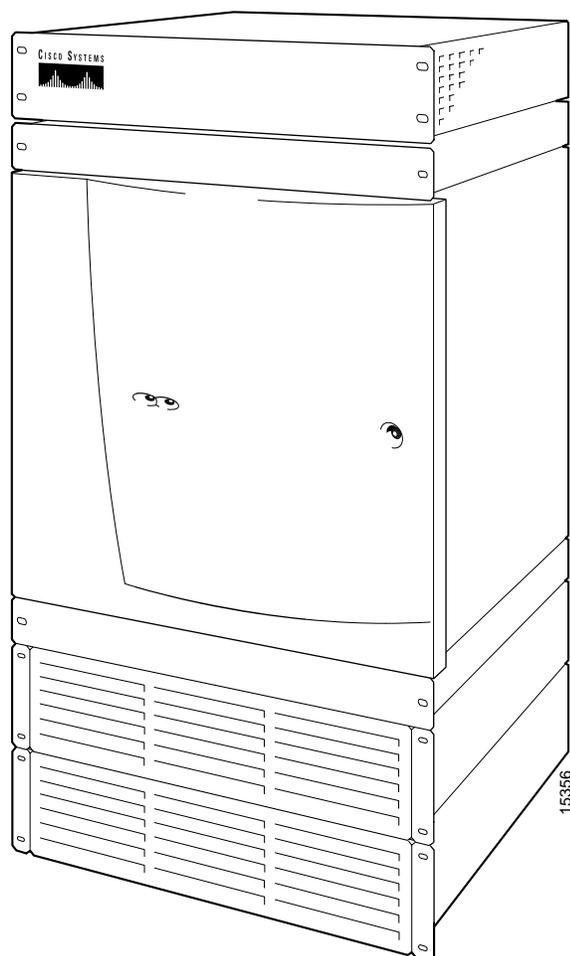
**Figure 3** MGX 8250 Switch

This chapter contains a brief outline of the features of the Cisco MGX 8250 switch. An illustration of the AC-powered version of the switch appears in Figure 3.

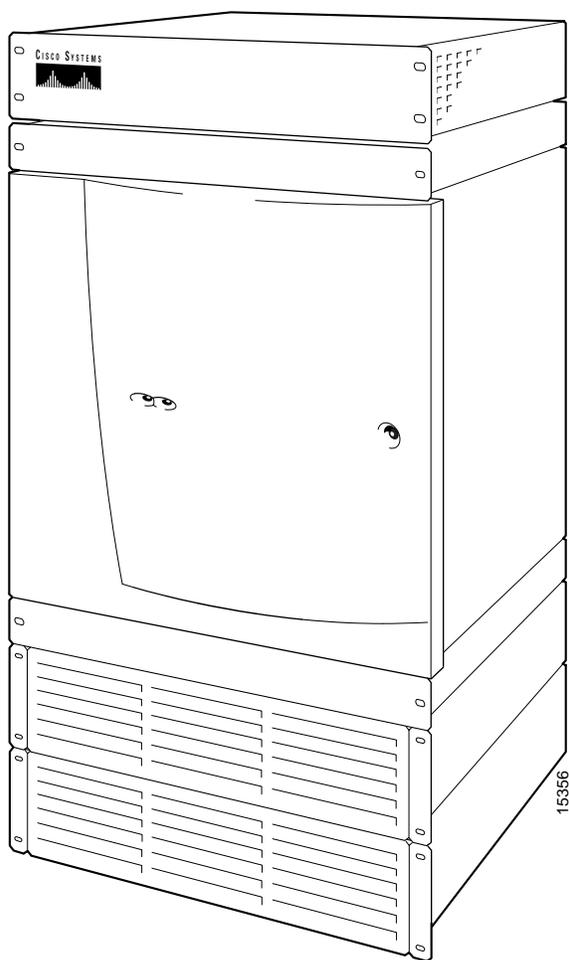
**Figure 4** MGX 8850 Switch

An illustration of the AC-powered version of the switch appears in Figure 4.

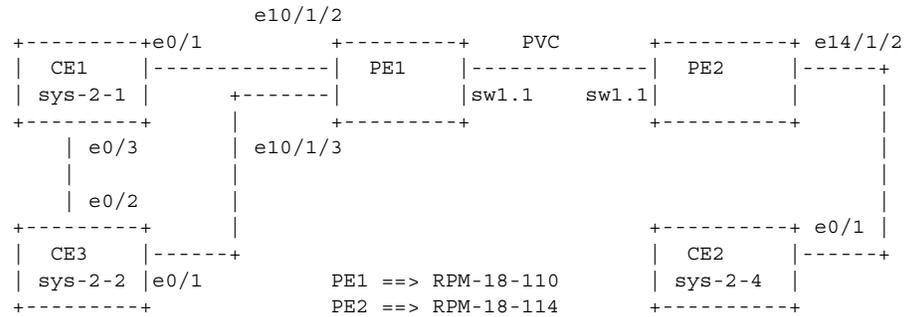
Both RPMs are in the same shelf or chassis.

# One PE - Two CE Configuration - OSPF & IBPG Between PEs & EBGP between PE-CE
