Release Notes for Cisco MGX 8850 Software Version 2.1.75

About Release 2.1.75

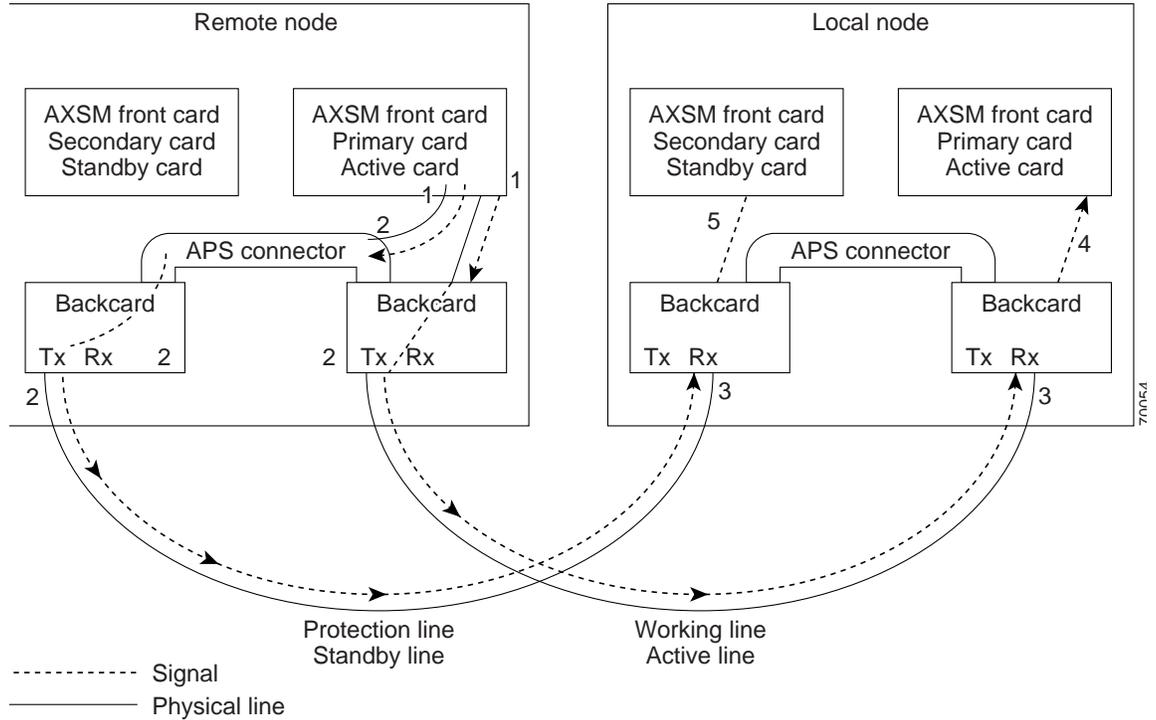
Figure 1 shows an example of how this process operates in a standard APS configuration, where the primary card monitors the working line and the secondary card monitors the protection line.

Figure 1 Standard APS Configuration

1. The signal leaves the front card at the remote end of the line. (See Figure 1 and Figure 2.)
2. The signal passes through the APS connector and both back card transmit ports at the remote end of the line. (See Figure 1 and Figure 2.)
3. The signal travels through both communication lines to the receive ports on both back cards at the local end. (See Figure 1 and Figure 2.)
4. The active front card processes the signal that is received on the active line. (See Figure 1 and Figure 2.)
5. The standby card monitors only the status of the standby line. (See Figure 1 and Figure 2.)
6. If necessary, the signal passes through the APS connector to the front card. (See Figure 2.)

Line failures are always detected at the receive end of the line. This is where a switchover occurs when a failure is detected. Two different types of switchovers can occur, depending on whether the APS was configured as unidirectional or bidirectional in the **cnfapsln** command:

- When a failure occurs on a line configured for unidirectional switching, the switch changes lines at the receive end only. A switchover is not necessary at the transmit end because the transmitting back cards send signals on both lines in the 1 +1 APS configuration.
- When a failure occurs on a line configured for bidirectional switching, a switchover occurs at both ends of the line.

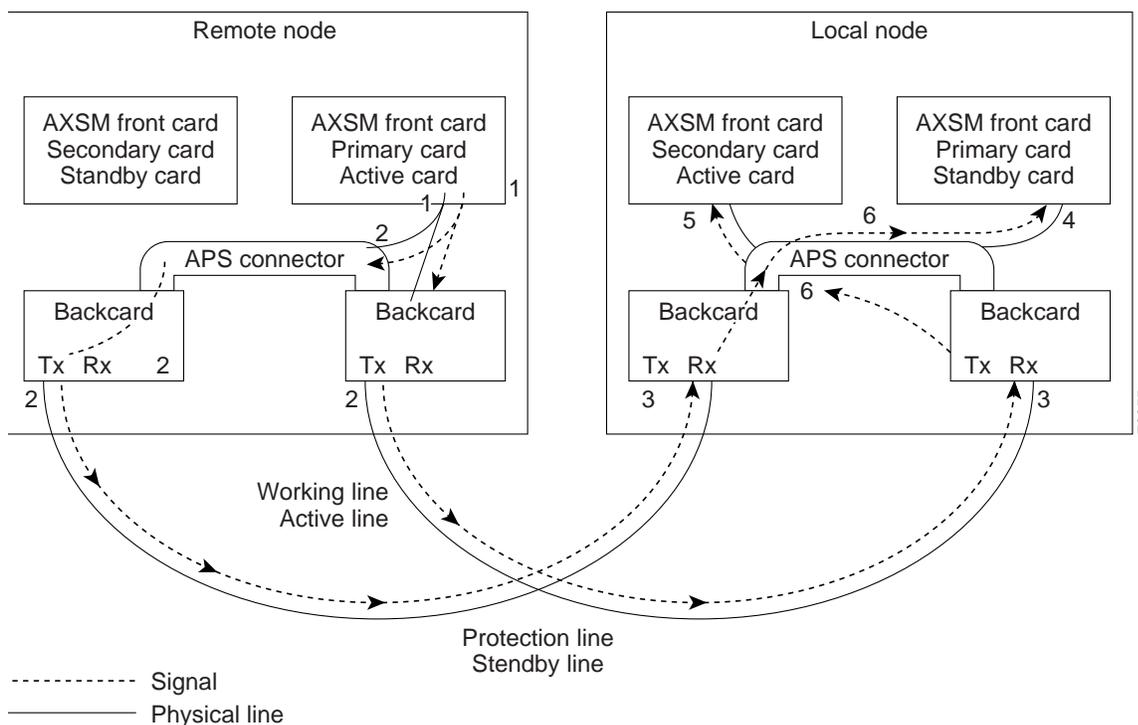
Figure 2 shows an example of how the APS communication process operates in a crossed APS configuration, where the secondary card monitors the working line that is attached to the primary card, and the primary card monitors the protection line that is connected to the secondary card.

Figure 2 Crossed APS Configuration

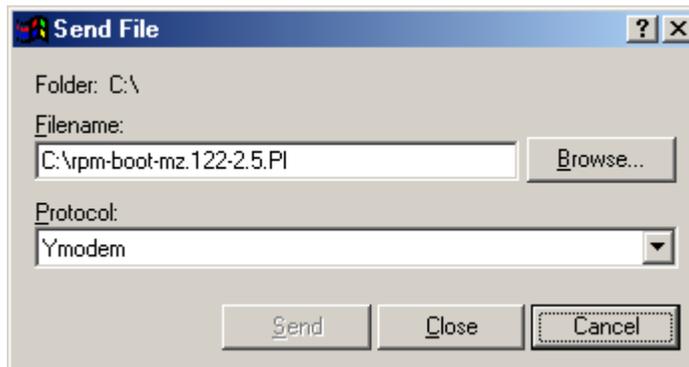
**Step 4** Use the Transfer-->Send File option in HyperTerminal to start the image transfer.

In the Filename box, browse and choose the image file to be downloaded. Also since we used the “y” option while invoking the xmodem, set the transfer protocol to ymodem or use Xmodem protocol by not specifying the -y option on the command line.
