Release Notes for Catalyst 6000 Family Software Release 6.x

6.4(21)—February 20, 2006

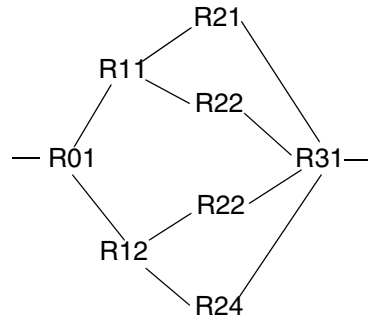
Figure 1 Network Example

- A new CLI command has been added to include Layer 4 ports in a load-balancing hash. When multiple paths are available to reach a destination (see Figure 1), the new hash is applied to pick the path to be used for forwarding. Prior to this enhancement, the CEF load balancing on PFC2 only used a source IP/destination IP-based hash.

For the above network topology, the following configuration is recommended:

- Use the defaults for load balancing in routers R01, R21, R22, R23, and R24
- Include Layer 4 ports for load balancing in routers R11 and R12

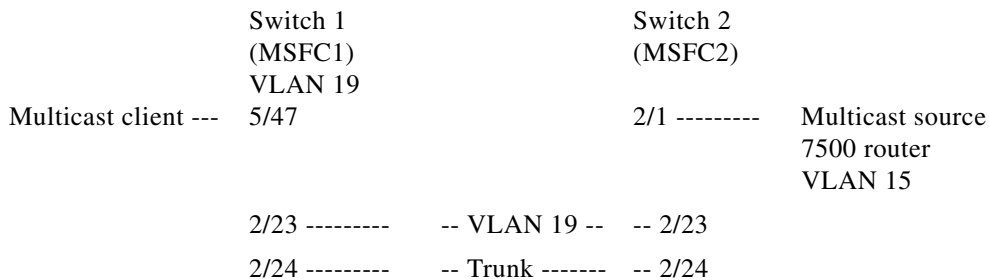
- IGMP snooping and multicast MLS might not work reliably because the router ports are not selected correctly in hardware. This problem is resolved in software release 6.3(1). (CSCdt31924)
- Octets associated with ifInDiscard packets might not be counted. This problem is resolved in software release 6.3(1). (CSCdt62359)
- When the ifOperStatus value for the port changes (the port is enabled and disabled, or the link is brought up and down), the ifLastChange value for the port does not change. This problem is resolved in software release 6.3(1). (CSCdt69418)
- When IGMP snooping is enabled and the QoS default action is set to non-zero on one of the two switches in the topology below, both MSFCs might experience high CPU utilization (99 percent). The problem does not occur if the QoS default action is set equally on both switches or if IGMP snooping is disabled.

This problem is resolved in software release 6.3(1). (CSCdt73910)

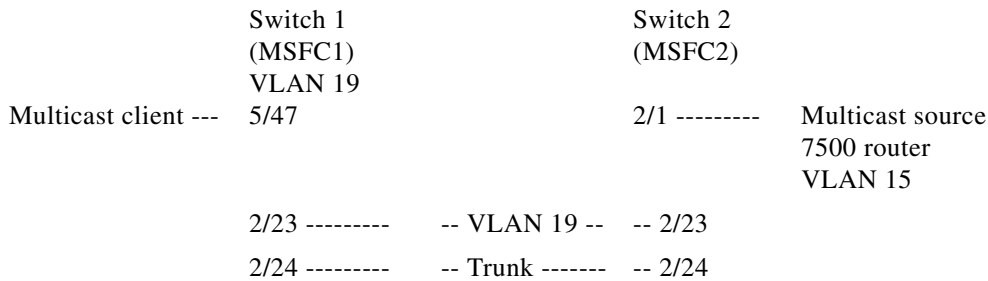
- IGMP snooping and multicast MLS might not work reliably because the router ports are not selected correctly in hardware. (CSCdt31924)
- When the ifOperStatus value for the port changes (the port is enabled and disabled, or the link is brought up and down), the ifLastChange value for the port does not change. (CSCdt69418)
- When IGMP snooping is enabled and the QoS default action is set to non-zero on one of the two switches in the topology below, both MSFCs might experience high CPU utilization (99 percent). The problem does not occur if the QoS default action is set equally on both switches or if IGMP snooping is disabled.

(CSCdt73910)

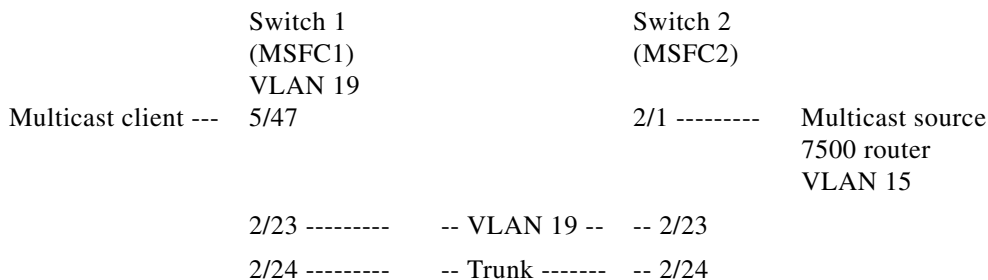
- When IGMP snooping is enabled and the QoS default action is set to non-zero on one of the two switches in the topology below, both MSFCs might experience high CPU utilization (99 percent). The problem does not occur if the QoS default action is set equally on both switches or if IGMP snooping is disabled.

(CSCdt73910)
