# Operations Alert Bulletin

## Cabling Connector Cautions for the Explorer 8300DVB

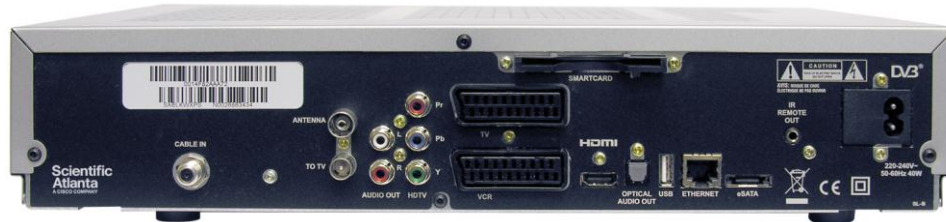
On the rear panel of the Explorer 8300DVB, the VCR SCART and HDMI connectors are in close proximity, as shown in the following graphic.

Rear panel of the Explorer 8300DVB

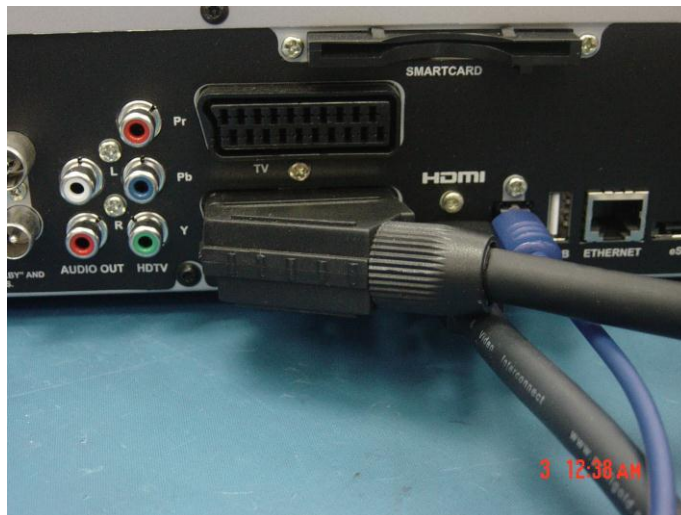
Because of this proximity, if you use both the VCR SCART and HDMI connectors, do not use a "right-handed" SCART cable in the VCR SCART connector. Using this type of SCART connector will interfere with the HDMI connector, as shown in the following graphic.

"Right-handed" SCART cable interfering with the HDMI connection

This could result in physical damage to the motherboard on the Explorer 8300DVB and make the HDMI connector inoperable.

Cisco recommends that you use a straight or "left-handed" type of SCART connector if you use both the VCR SCART and the HDMI connectors to avoid potential physical damage to the Explorer 8300DVB motherboard, as shown in the following graphics.

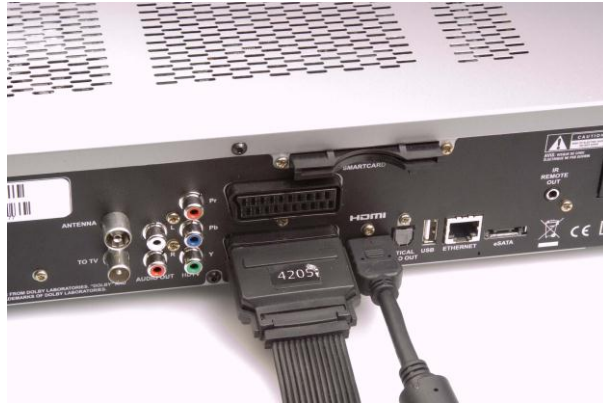
Straight SCART connector

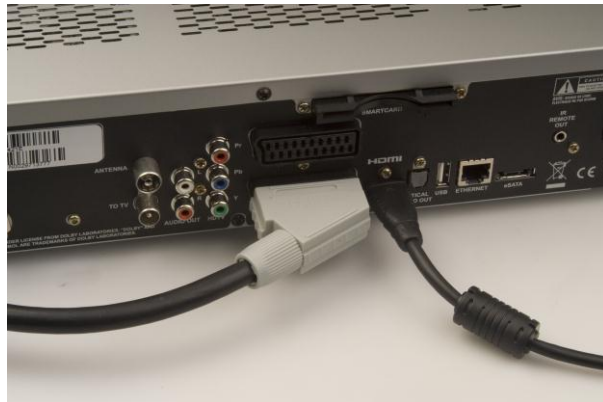
"Left-handed" SCART connector
